CASE STUDIES OF PLASTIC FAILURES ASSOCIATED WITH METAL FASTENERS

Jeffrey A. Jansen, The Madison Group

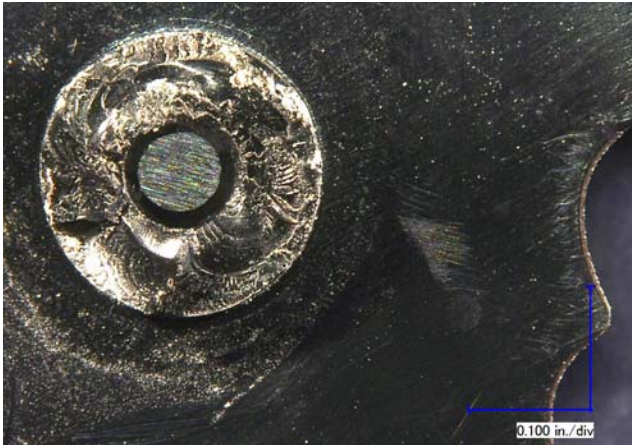
The initial microscopic examination of the failed panels showed catastrophic transverse fractures within multiple cylindrical bosses on each of the parts. The cracking displayed features associated with brittle fracture, without appreciable macro ductility (Figure 1). No evidence of significant damage or abuse was apparent during the inspection.

The SEM examination of the panel boss fracture surfaces showed very consistent features, which were associated with brittle cracking. Multiple individual cracks were apparent, with distinct points of initiation along the inner diameter of the boss wall. The fracture surface within the origin zones displayed a relatively smooth surface texture characteristic of a slow crack initiation and growth mechanism. No evidence was found to indicate significant micro ductility. The crack origin areas were bounded by a series of band-like features (Figure 2), and at high magnification it was evident that these features represented opened craze remnants (Figure 3).

Together, the visual, microscopic, and SEM examinations indicated that the panel bosses failed via brittle fracture. The fractures were associated with the initiation of multiple cracks, leading to subsequent propagation and coalescence. The observed features were indicative of a slow crack initiation and growth mechanism, transitioning into more rapid crack extension remotely. Overall, the observed features were indicative of environmental stress cracking. Environmental stress cracking (ESC) is a failure mechanism whereby a plastic material cracks due to contact with an incompatible chemical agent while under tensile stress. It is a solvent-induced failure mode, in which the synergistic effects of the chemical agent and mechanical stresses result in cracking.

The requisite mechanical stress apparently resulted from stress imparted on the boss from the mating self tapping screw. This stress included longitudinal and torsional stresses from the fastening process, essentially pulling the boss axially, as well as hoop stress resulting from interference between the boss and the fastener. This situation was aggravated by the use of an improper, oversized screw, which increased the level of interference.

Fig. 1 - The fracture surface from one of the failed panel bosses is shown exhibiting features characteristic of brittle fracture. Multiple individual crack origins are present around the inner diameter of the boss.

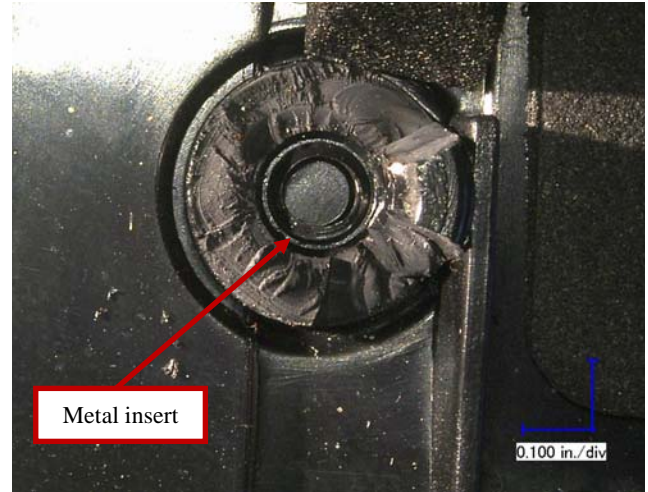
The fractographic examination of the failed parts showed both transverse and longitudinal cracking. The fracture surfaces exhibited sharp and distinct features characteristic of brittle fracture, and no signs of significant macro ductility were found (Figure 4).

Fig. 4 - The fracture surface of the housing insert boss is shown exhibiting brittle fracture features, without apparent macro ductility.

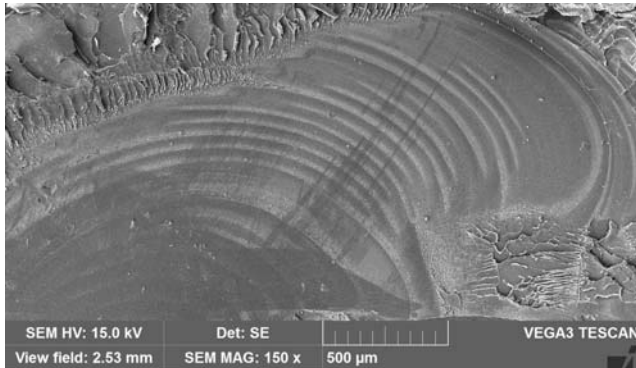
Fig. 2 - SEM micrograph showing a series of band-like features radiating from the crack origin.

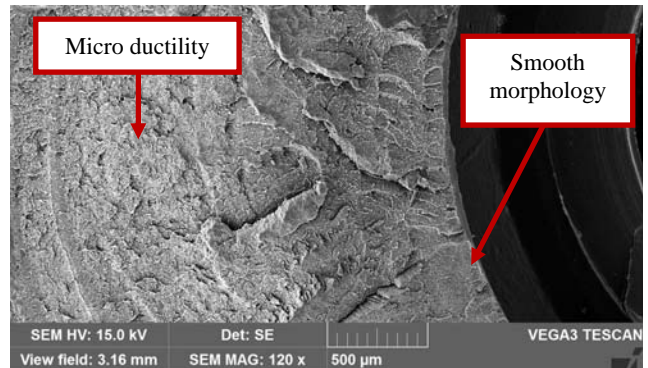
The SEM inspection revealed features indicating multiple crack origins around the inner diameter of the boss (Figure 5). The fracture surface within the crack origins presented a generally smooth surface texture. The origins were bounded by an increased level of micro ductility (Figure 6), indicating a relatively brittle fracture initiation that transitioned to increased ductility as the crack extended. Areas outside of the crack origins displayed significant levels of micro ductility, as indicated by the presence of stretched flaps and fibrils. These areas on the fracture surface also showed hackle marks and river markings, associated with rapid crack extension.

Fig. 5 - SEM image showing the presence of multiple crack origins around the inner diameter of the boss. The fracture surface transitioned from a relatively smooth surface to one exhibiting more ductile characteristics.

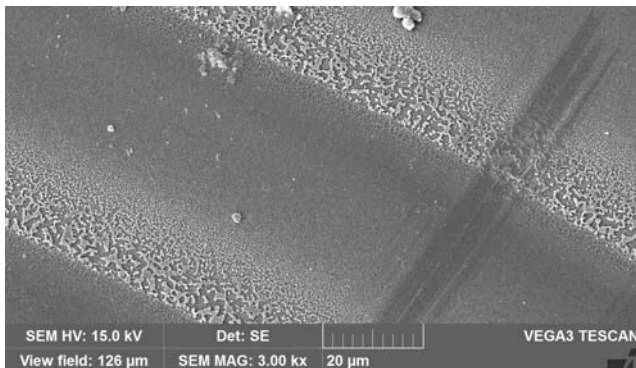
Fig. 3 - SEM micrograph showing that the band features represent a series of opened craze remnants.

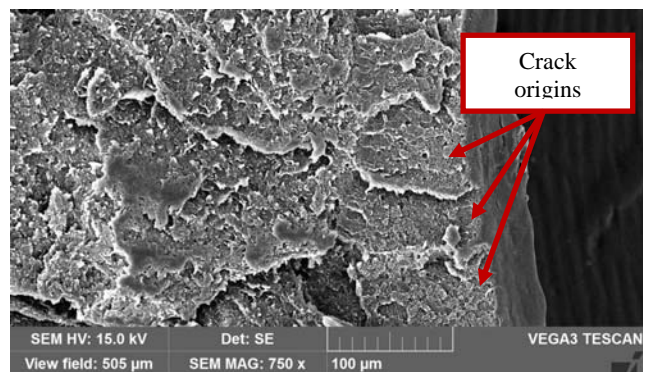
The sum of the fractographic examination observations indicated that the cracked housings failed via a mechanism that produced significant micro ductility, but lacked substantial macro ductility. The combined features observed during the fractographic examination were characteristic of an overload mechanism, corresponding to stresses that exceeded the short-term strength of the material. The combination of the brittle macro features and the ductile micro features was indicative of overload through a relatively rapid load application. The crack initiation sites were positioned at a corner in the boss wall formed by compliance with a sharp feature in the mating overmolded metal insert. This corner resulted in a significant stress concentration factor, thereby multiplying the applied loads.

Fig. 6 - SEM image showing significant micro ductility immediately adjacent to the crack origins.

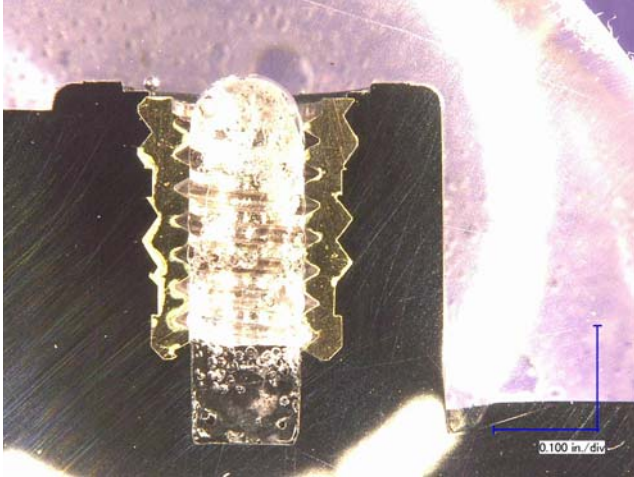
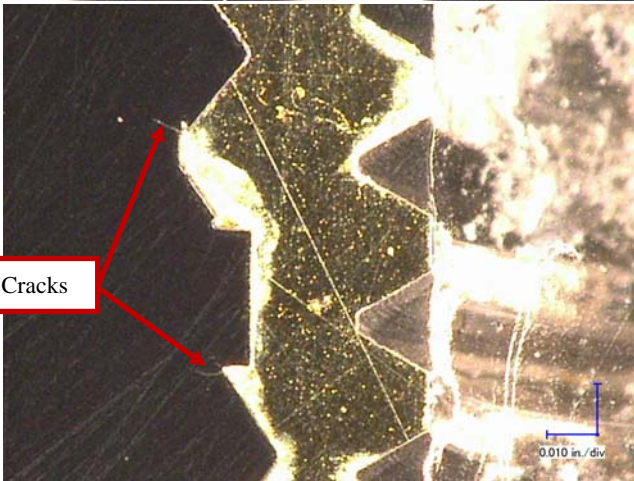
Cracks

A cross-section was prepared through one of the bosses on an apparently uncracked reference part that had been molded and recently assembled, but not put into service. The cross-section (Figure 7) showed that the insert was designed with relatively sharp corners that acted as points of stress concentration on the formed plastic. Additionally, relatively small cracks were observed extending from the sharp corners. This indicated that cracking within the boss initiated shortly after installation of the display into the housing.

Based upon the fracture surface features, the overload event that caused the cracking was the insertion of the screws into the threaded metal inserts, exacerbated by the stress concentration of the sharp corner. Once cracking initiated,

Fig. 7 - The cross-section prepared through the insert exhibited cracking within the boss material. The insert is designed with relatively sharp features, and the cracks extend from these corners.

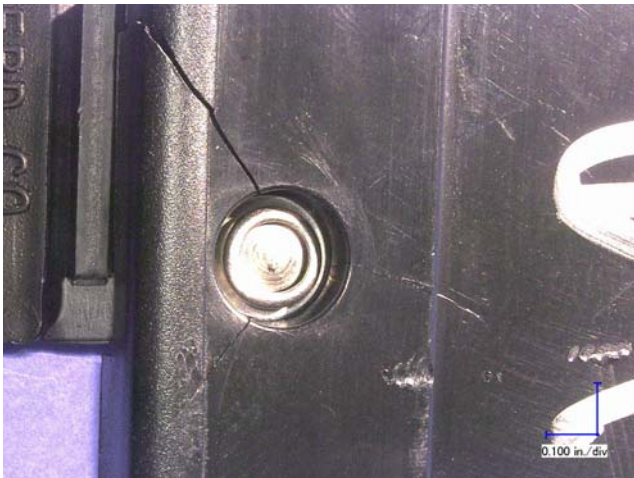
The fractographic examination of the cracking associated with the rivets showed that the cracks were relatively consistent across all of the failed parts. The cracks were positioned adjacent to the rivet (Figure 8). From the exterior, the crack features lacked significant macro ductility, and instead exhibited characteristics of brittle fracture on a macroscopic level. Under optical microscopy, the fracture surfaces displayed further characteristics of brittle fracture (Figure 9). The observed features indicated crack initiation along the inner diameter of the rivet hole at a location adjacent to the mating rivet.

Fig. 8 - Cracks were present adjacent to the door hinges. The cracking shows no signs of significant macro ductility.

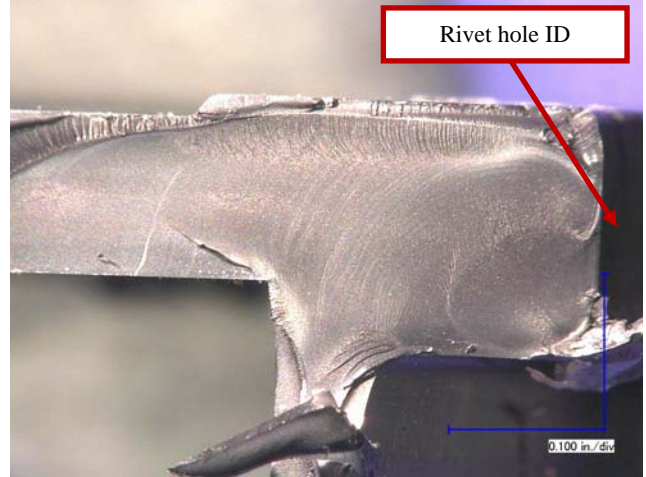
Fig. 9 - The fracture surface exhibits a relatively smooth surface texture indicative of brittle fracture. The features indicate crack initiation along the inner diameter of the rivet hole.

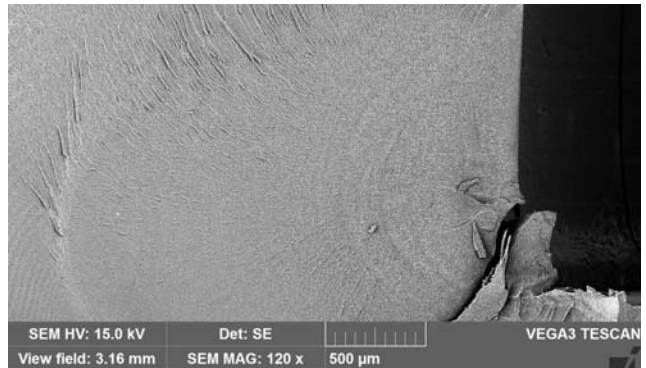
The SEM examination of the fracture surface revealed evidence of a single area of crack initiation along the inner diameter of the rivet bore. The crack origin area displayed a relatively smooth morphology, without evidence of significant macro ductility (Figure 10). The features were consistent with brittle fracture via a slow crack initiation mechanism. The origin was located immediately adjacent to some mechanical damage, thought to have resulted from the insertion of the rivet. The fracture surface adjacent to the crack origin showed an increase in the level of micro ductility, as indicated by an overlapping morphological structure, and the formation of stretched flaps. Indications of radiating bands were also present. Remote to the crack origin signs of rapid crack extension, including hackle marks and river markings were present, indicating a transition from slow crack growth to rapid crack extension (Figure 11). This portion of the fracture surface represented overload of the plastic material when the remaining ligament could no longer withstand the applied stress.

Fig. 10 - SEM micrograph showing a very smooth surface morphology at the crack origin indicative of brittle fracture through slow crack growth.

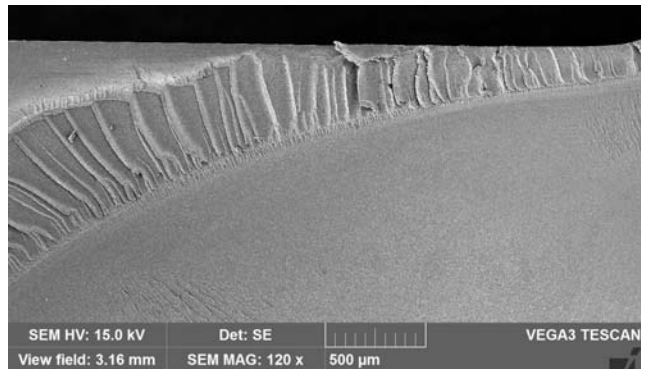
Fig. 11 - SEM micrograph showing the transition from a smooth surface morphology representing slow crack growth to features, including hackle marks and river markings associated with rapid crack extension.

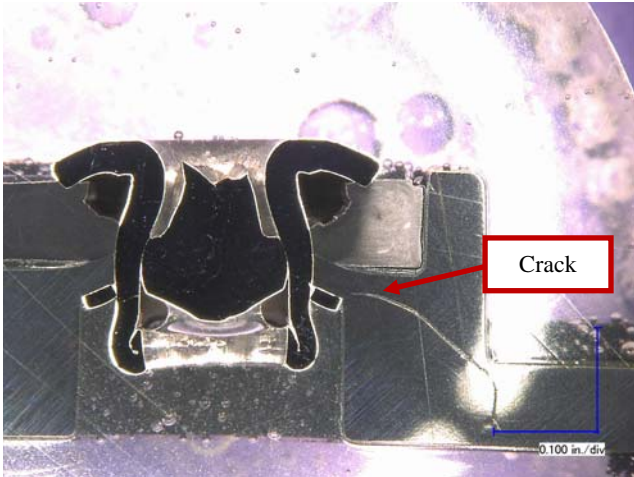
and polished to reveal the area of interest. Microscopic examination of the prepared cross-section showed the presence of cracking that was not externally visible (Figure 12). The cross sectional examination showed that the crack origins observed during the microscopic inspection corresponded to a mechanical feature in the metal rivet. It was apparent that the rivet exerted stress onto the mating plastic.

From the fractography, it was concluded that the cracks within the hinges associated with the rivets were created via slow crack initiation and growth through a creep rupture mechanism. Creep is a phenomenon that occurs within plastic materials as a consequence of relatively low stresses continuously applied over an extended period of time. Creep is the result of the polymer molecules slowly disentangling over time, and causes the material to slowly strain until failure occurs. This was most apparent in the cross-section produced on the boss from the as-molded part, which showed cracking extending from the metal insert. Crack initiation sites were positioned at sharp corner features in the rivet. These corners acted as a significant stress concentration factor, thereby, multiplying the applied loads producing stress that exceeded the long-term strength of the material.

Fig. 12 - The cross-section prepared through the riveted hinge showed that the cracking extended from relatively sharp edges within the metal fastener.

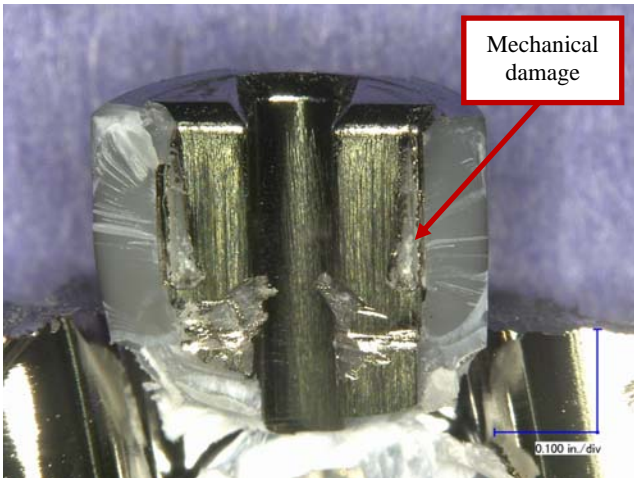
The failed parts were visually and microscopically examined. The knobs exhibited cracking at consistent locations, at a design corner within the bore that interfaced with the mating controller shaft (Figure 13). The cracking was uniform across the received parts in regards to location and form. The cracks did not present signs of significant macroductility, and conversely, exhibited features characteristic of brittle fracture. Continued inspection revealed features indicative of crack initiation along the

inner diameter of the knob bore wall. Importantly, a significant level of mechanical damage was apparent on the inner diameter surface of the bore immediately adjacent to the crack origins. This damage was present as gouging and material loss to both the plastic substrate and the metal plating.

Fig. 13 - The cracking within the knobs did not show signs of significant macro ductility. The crack origins were positioned along the inner diameter of the knob bore wall.

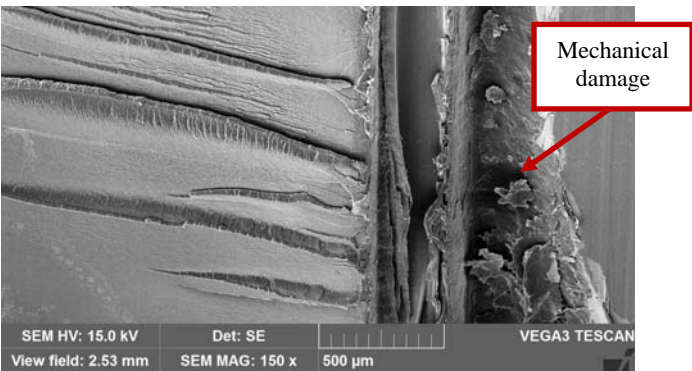
SEM examination of the fracture surface confirmed crack initiation along the inner diameter of the bore wall. Multiple individual crack origins were present along the inner diameter surface. The individual crack origins were separated by ridge-like features representing crack unions (Figure 14). As identified during the microscopic examination, the crack origins were immediately adjacent to areas of substantial mechanical damage to the knob bore inner diameter surface. The cracking appeared to result from the damage. The surface within the crack origin areas displayed evidence of moderate micro ductility, in the form of stretched fibrils and flaps. Examination of the origin areas at higher magnification revealed the presence of a series of linear stretched fibril and flap formations perpendicular to the crack propagation direction (Figure 15). These features were consistent with a progressive failure mechanism associated with repeated cracking and arrest, such as dynamic fatigue.

Further SEM examination was conducted on the area of the knob bore exhibiting mechanical mutilation. The damaged area exhibited substantial gouging and material loss, as well as tearing. This inspection of the damage also showed that the crack origins extended immediately out of the damaged surface area.

Fig. 14 - SEM micrograph showing crack initiation along the inner diameter of the knob bore wall adjacent to substantial mechanical damage caused by the shaft spring. Ridge-like features representing crack unions are present.

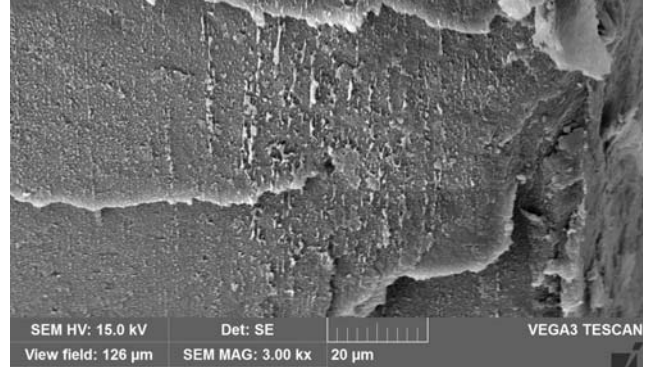
Examination of mid-fracture locations on the crack surface showed a thumbnail marking representing a transition within the crack propagation mechanism. Outside of the thumbnail marking extending to the outer diameter of the bore wall, the fracture surface showed features, including river markings and hackle marks, characteristic of rapid crack extension and mechanical overload.

Fig. 15 - SEM micrograph showing linear stretched fibril and flap formations.

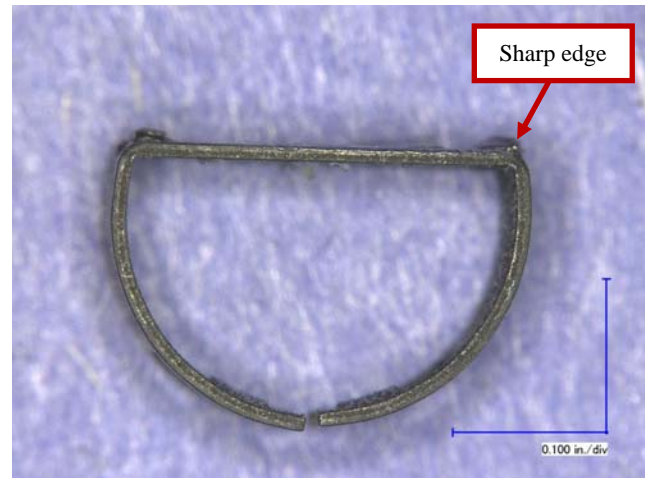
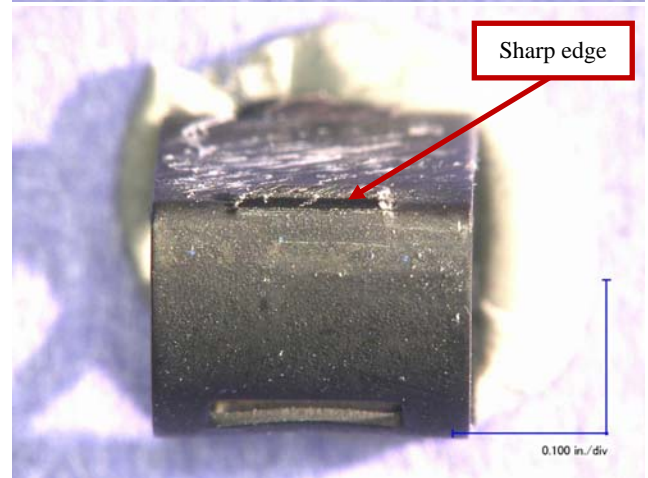
The entirety of the visual, microscopic, and SEM examinations indicated that the control knobs failed via a mechanism associated with no macro ductility, but moderate level of micro ductility. The cracking initiated along the inner diameter surface of the knob bore, and subsequently propagated through the bore wall. The observed features were indicative of crack initiation associated with significant mechanical damage to the inner diameter surface caused by the inserted metal shaft spring. Movement of the spring, and in particular the sharp edge of the retention feature (Figure 16), resulted in gouging and damage to the inner diameter surface. This damage produced a significant stress concentration, in addition to

the stress concentration associated with the corner design. The localized stresses subsequently exceeded the strength of the material and cracking initiated. Crack propagation occurred through a progressive mechanism associated with the repeated actuation of the knob during use. Given the relative level of micro ductility and the spacing of the stretched linear fibril indications, crack propagation was thought to occur through low cycle fatigue, meaning less than 10,000 cycles, and likely significantly fewer. Once the cracking progressed sufficiently through the part wall and the exerted stress exceeded the strength of the remaining ligament, the fracture transitioned to rapid crack extension through mechanical overload.

Fig. 16 - The shaft spring exhibited sharp features that produced mechanical damage along the inner diameter of the knob bore wall.
