# FRACTOGRAPHIC CHARACTERIZATION OF POLYCARBONATE FAILURE MODES

*Jeffrey A. Jansen, Stork Technimet*

## **Abstract**

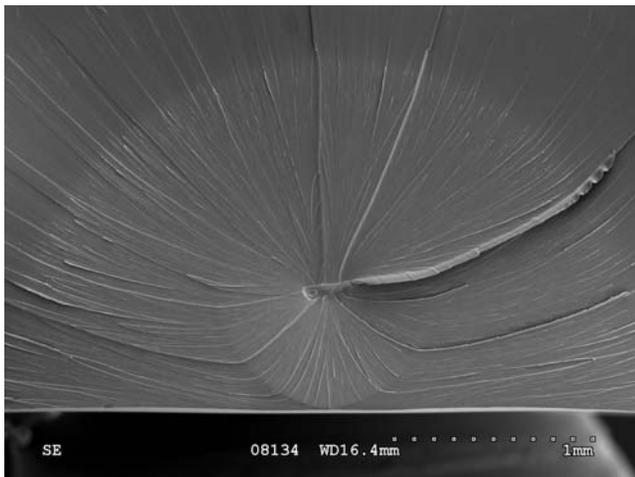
The SEM examination of a typical fracture surface showed that the cracking had initiated within the specimen wall at a local inhomogeneity. The cracking initiated through crazing, and the fracture surface exhibited an opened craze, indicated by a circular feature surrounding the origin, as shown in Figure 1. Radiating stress crack indications, known as hackle marks, were apparent within the remnant craze surface. These ridges were characterized by stretched flaps and represent the union of multiple individual extending cracks. At the outer boundary of the craze, the hackle marks extending toward the specimen wall exhibited a severe change in direction, consistent with the alteration of the external stresses. Within the crack origin area, no evidence was found to suggest the presence of true mirror or mist zones. Such morphologies are characterized by extremely smooth fracture surfaces, and are indicative of slow crack growth. In contrast, the observed features indicated that the crack nucleation occurred relatively rapidly, with unstable crack growth.

**Fig. 1 - Electron image showing the crack origin area of the polycarbonate specimen crack via uniaxial tensile loading.**

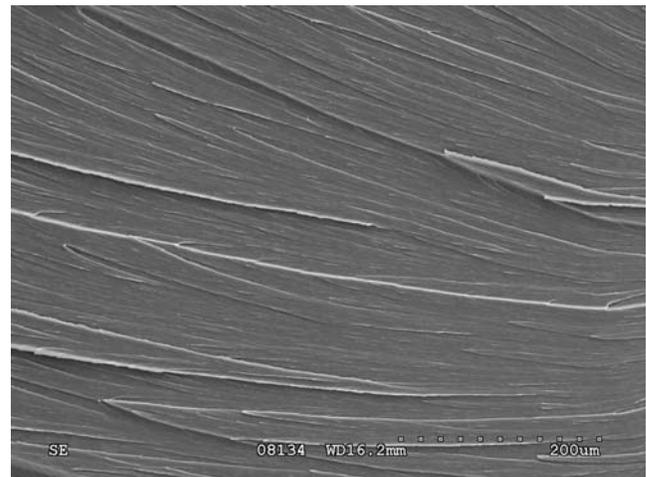
The zone outside of the opened craze was generally smoother than inside, but still exhibited the presence of hackle marks, as illustrated in Figure 2. Remote to the crack origin area, surrounding the boundaries of the tensile specimen, the fracture surface showed a slightly increased level of ductility, as indicated by enhanced stretching within the hackle marks. Overall, the fracture surface showed primarily brittle fracture features, with no substantial evidence of fibril formation. The appearance of the fracture surface was in strong contrast to the obvious macro ductility indicated by the permanent deformation and yielding.

**Fig. 2 - Electron image illustrating the presence of hackle marks on the tensile fracture surface.**

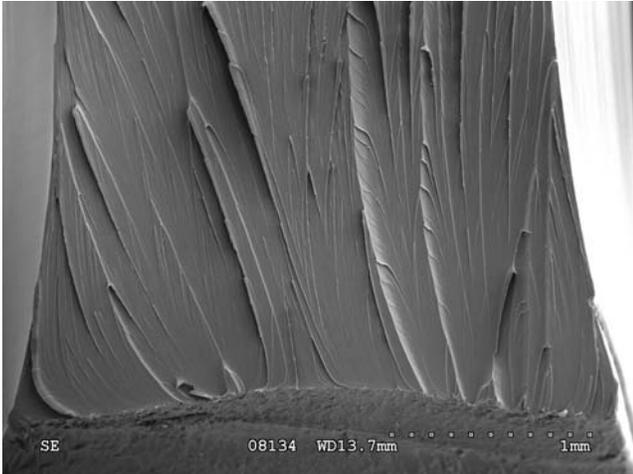
As anticipated, the SEM examination showed that the cracking initiated along the edge of the specimen at the formed notch, as presented in Figure 3. The fracture surface features indicated multiple, distinct crack nucleation sites. The crack origin area was relatively smooth, between the observed hackle marks. The formation of hackle marks was characterized by the presence of chevron markings, otherwise known as a plumose pattern. Such features are commonly associated with ductile fracture. Within the chevron pattern, the hackle marks exhibited slight stretching and had a feather-like appearance. Coalescence of individual cracks within the mid-wall region produced characteristic V-shaped features, as shown in Figure 4.

**Fig. 3 - Electron image showing the crack origin area on the fracture surface created through tear loading.**

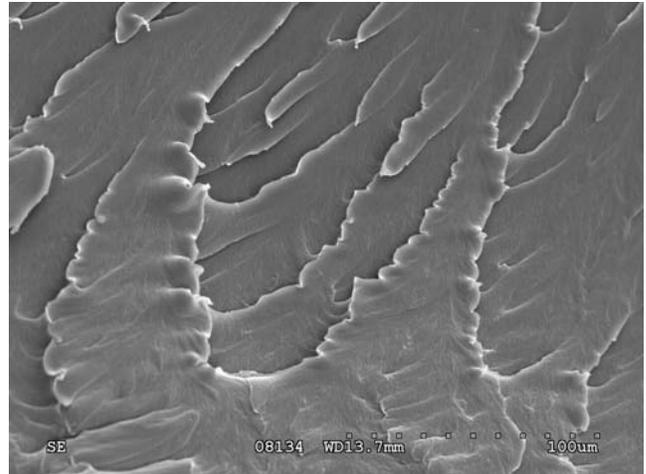
**Fig. 6 - Higher magnification view of the left central portion of Figure 5 showing distinct U-shaped ridges, similar to river lines, on the impact fracture surface.**

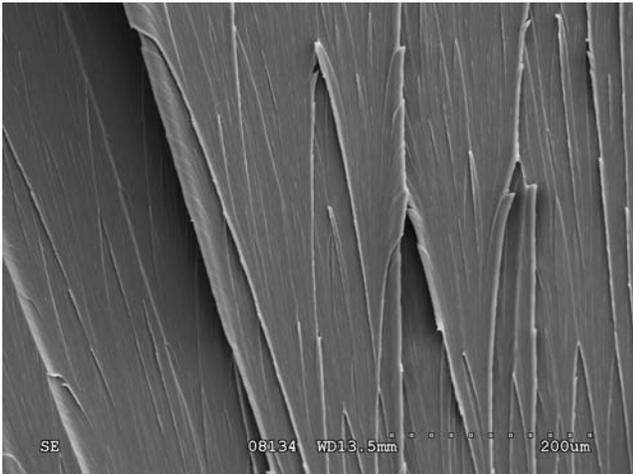
**Fig. 4 - Higher magnification view of the central portion of Figure 3 showing characteristic V-shaped features on the tear fracture surface.**

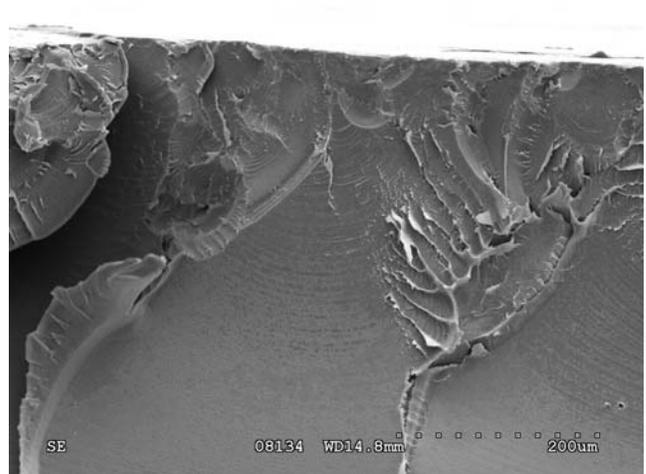
The SEM evaluation revealed multiple apparent crack origins along the outer diameter bend surface, as presented in Figure 7. The crack surface within the origin area exhibited a coarse morphology, suggestive of molecular degradation of the polycarbonate resin. The morphology within the origin area was consistent with crack nucleation through crazing. Between the individual crack origins, crack union ridges, showing minimal micro ductility, were evident. Stretched hackle marks were also evident within isolated locations adjacent to the origins. Immediately outside of the crack initiation sites, radiating indications were apparent. These indications, as shown in Figure 8, consisted of alternating patterns of coarse surface texture

**Fig. 7 - Electron image showing the crack origin area on the hydrolysis polycarbonate specimen.**

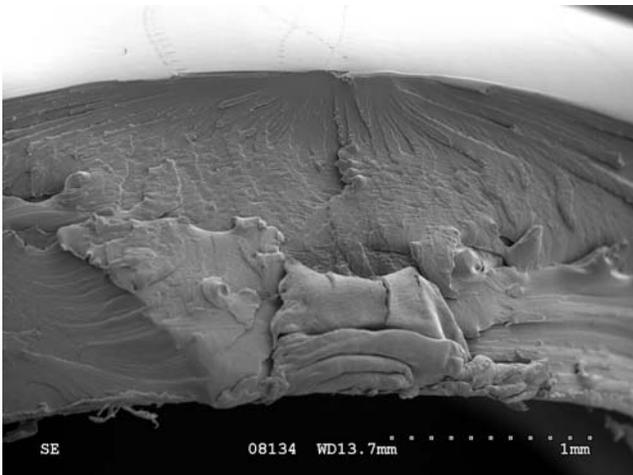
Examination of the fracture surface via SEM, as presented in Figure 5, revealed a single crack origin on the side of the plaque wall opposite the impact surface. This surface was under tensile loading through the impact. The origin area displayed a relatively smooth texture. The zone surrounding the crack origin showed a more coarse morphology and exhibited a series of U-shaped ridges having the general appearance of river lines, as illustrated in Figure 6. River lines are generally produced through a mixed stress field of Mode I crack opening stress and Mode III anti-plane shear stress. These indications showed a moderate level of stretching, and represented the initiation of stresses other than uniaxial loading. These markings were formed through the coalescence of multiple individual cracks, and the observed stretching was indicative of micro ductility. Approximately half way through the test specimen wall, the morphology presented a high level of folding consistent with the compressive loading and mechanical damage sustained by the impacted surface.

**Fig. 5 - Electron image illustrating a portion of the impact fracture surface.**

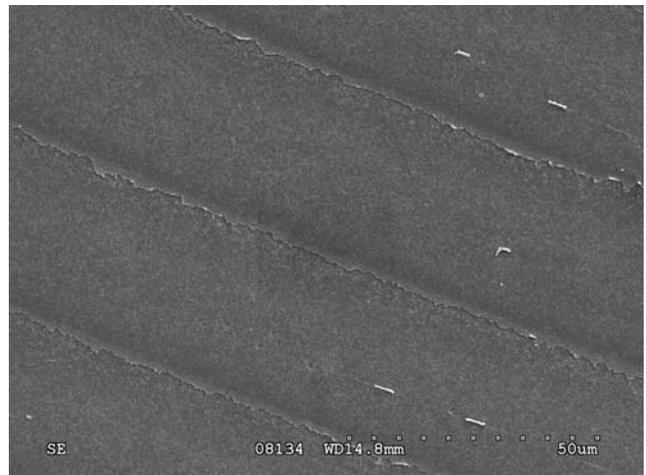
separated by smaller concentric rings having a very smooth morphology. A band of stretched, torn material was present between the two morphologies. The distance between the concentric bands increased progressively away from the crack origin.

The nature and cause of these markings are not completely apparent. Although similar in appearance, they are not thought to be present as Wallner Lines. Wallner lines are normally associated with relatively rapid crack extension and correspondingly high energy dissipation. The cracks within the hydrolysis sample extended over a relatively long period of time, characteristic of slow crack growth. As such, the observed features are thought to represent progressive propagation through alternating cycles of cracking and arrest. It is thought that this mechanism resulted through crack extension exclusively within the damage zone immediately preceding the crack tip. The damage zone is under a state of severe stress concentration and craze formation, and would be highly subject to the effects of the hot water. Given this scenario, the crack would arrest once it extended beyond the damage zone, and the process would begin again. The increase in band width with increasing distance from the crack origin supports this hypothesis, and is commonly seen in other progressive failure mechanisms, such as cyclic fatigue.

**Fig. 8 - Electron image illustrating the presence of concentric bands outside of the crack origin area.**

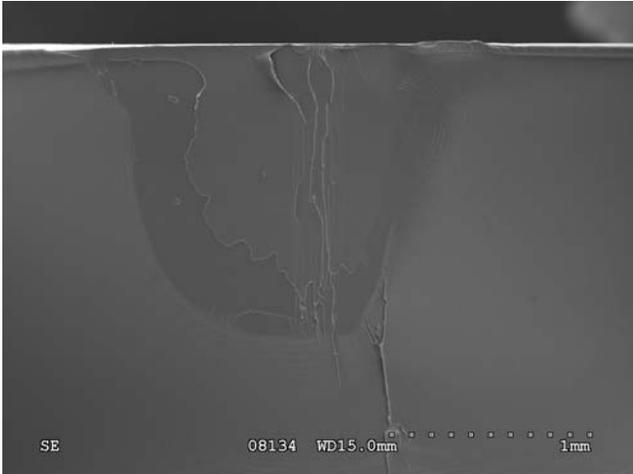
Examination of the fracture surface via SEM revealed multiple distinct crack origins along the outer bend wall, as shown in Figure 9. The observed features indicated that the crack nucleated through craze formation, as indicated by the presence of stretched flaps corresponding to the unions between the individual cracks, and the unique morphological pattern surrounding the crack origin zone. Immediately outside of the origin area, the fracture surface presented a series of radiating indications, generally similar

**Fig. 9 - Electron image showing the crack origin area on the environmental stress crack fracture surface.**

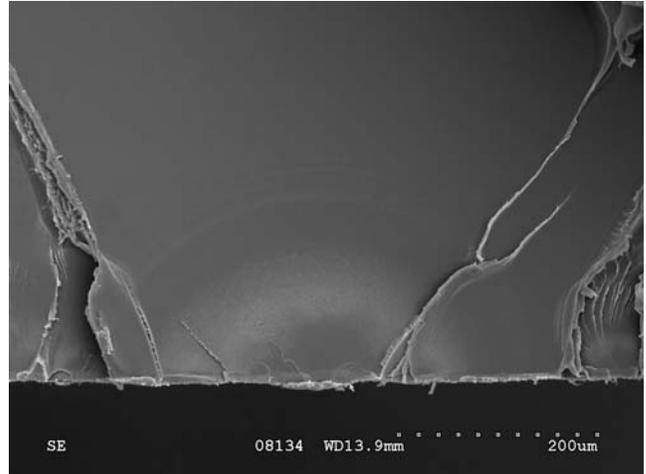
Upon SEM examination, multiple individual crack origins were apparent along the edge of the specimen. Distinct crack union ridges, displaying minimal stretching, were observed between the origins. A crack origin area is presented in Figure 11. The surface within the crack origins exhibited an extremely smooth morphology. A semicircular band was present surrounding the origins. At high magnification, this band displayed distinct micro ductility, as indicated by the presence of stretched fibrils. Within the mid-fracture zone, arrest markings were evident. At high magnification, the arrest markings were differentiated into striations, as shown in Figure 12. The striations appeared to consist of a large band having minimal micro ductility, separated by a smaller band displaying a very smooth surface morphology. With increasing distance from the crack origin, the arrest markings became wider, indicating extended crack propagation per cycle.

**Fig. 11 - Electron image showing the area of crack initiation on the fatigue test specimen.**

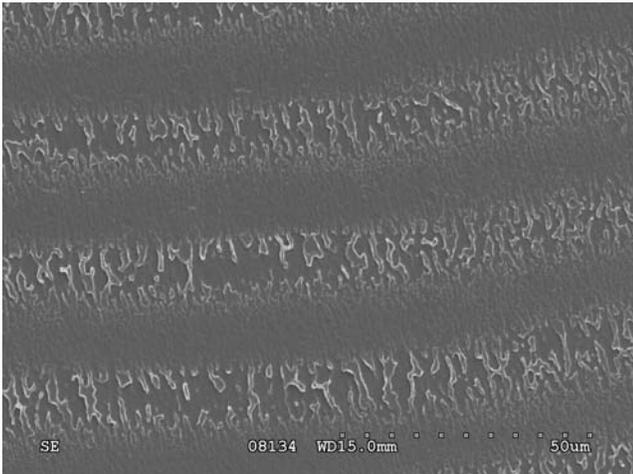
to those present on the hydrolysis fracture surface. However, at high magnification it was apparent that the light concentric bands consisted of craze remnants, as illustrated in Figure 10. This pattern indicated that the cracking propagated in a progressive fashion, through repeated cycles of craze formation, cracking and arrest. The separation between the progression bands extended with increased distance from the crack origin area. Approximately 75% through the sample wall, the fracture surface changed drastically. A high concentration of river markings and hackle marks were present, corresponding to the manual overload of the sample. These features were indicative of rapid and unstable crack growth.

**Fig. 10 - Electron image illustrating the presence of concentric bands of craze remnants on the environmental stress crack fracture surface.**

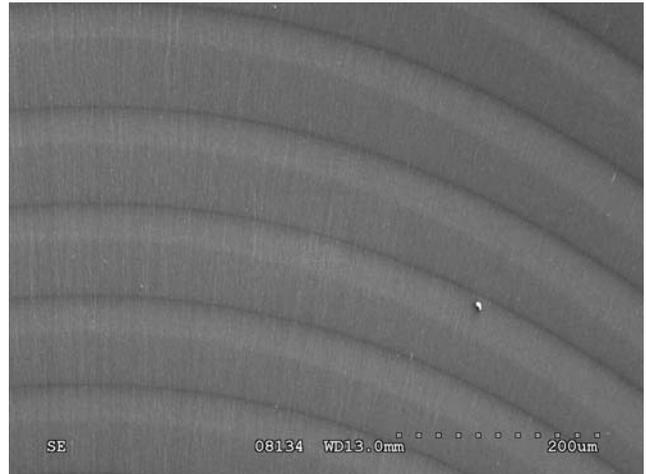
**Fig. 12 - Electron image showing fatigue striations remote to the crack origin location on the fatigue test specimen.**
