The Evaluation of Appliance Hose and Tubing Failures

**Mr. Jeffrey A. Jansen
Polymer Laboratory Manager
Stork Technimet, Inc.
2345 South 170th Street
New Berlin, WI 53151
USA**

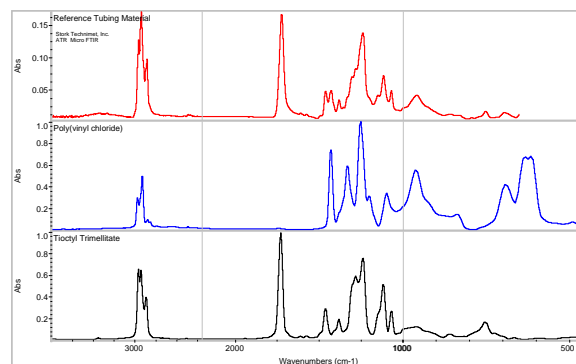
material was characteristic of a PVC resin containing a trimellitate ester plasticizer. This was consistent with the described specified material. The results obtained on the suspect tubing material, however, differed substantially. While the obtained spectrum contained absorption bands characteristic of PVC, the results indicated that the material had been plasticized with an adipate ester material, such as dioctyl adipate.

Figure 2 – The FTIR results obtained on the reference tubing were consistent with a PVC resin plasticized with trioctyl trimellitate.

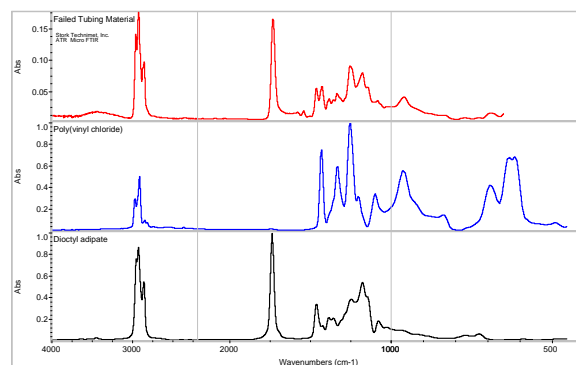
Figure 3 – The FTIR results produced by the failed tubing material differed from those represented by the reference material and were indicative of a PVC resin containing an adipate-based plasticizer.

It was the conclusion of the evaluation that the failed tubing had been produced from a formulation that did not comply with the specified material. The failed tubing material was identified as a PVC resin with an adipate-based plasticizer, not trioctyl trimellitate. The obtained TGA results confirmed that the failed tubing material was not as thermally stable as the reference material because of this

formulation difference. The adipate ester underwent migration and evaporation, rendering the PVC tubing stiffer and relatively embrittled, and that this was responsible for the observed failure. Clearly, the primary factor related to the failure of the PVC tubing was exclusively related to the material.

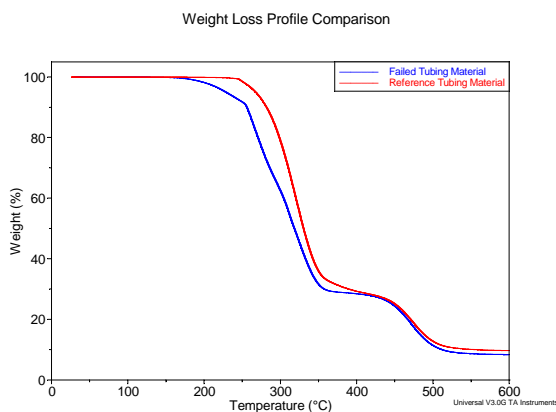
and suspect sample materials showed comparable plasticizer contents of 28% and 25%, respectively. A direct comparison of the weight loss profiles showed that the suspect material, containing the adipate-based plasticizer, underwent initial weight loss at a significantly lower temperature relative to the reference material, formulated with the trimellitate-based plasticizer. The elevated weight loss onset temperature exhibited by the reference tubing material was consistent with the observed performance and greater thermal stability of this tubing material. These results indicated that the reference material exhibited superior thermal resistance compared with the failed material.

Figure 4 – The TGA results showed that the reference tubing material demonstrated greater thermal stability compared with the failed tubing material.

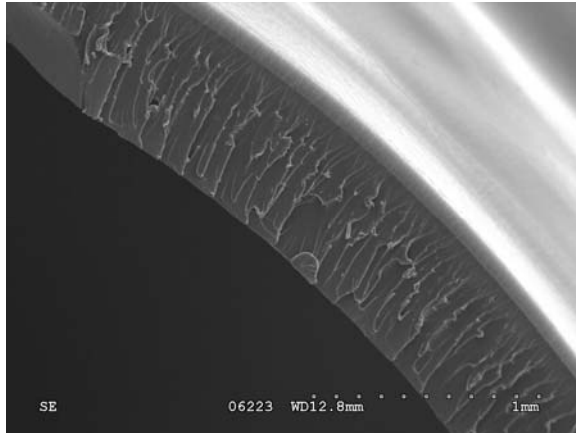
A typical section of the tubing was further examined via scanning electron microscopy (SEM). The tear surface exhibited features associated with overload of a soft polymeric material. A moderate level of micro ductility was apparent in the form of an overlapping morphology. No evidence was found to

Figure 5 – The failed tubing fracture surface exhibited features associated with mechanical overload.

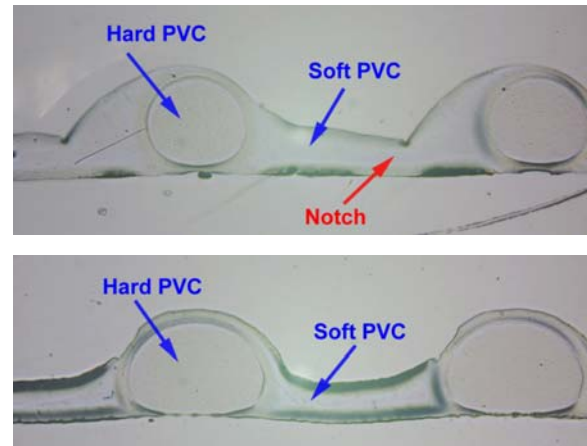
thickness of the soft segment, the size and geometry of the hard segment, and most importantly the angle between the hard and soft segment bands. Specifically, the failed tubing contained a series of sharp corners, absent in the references tubing. These corners acted as notches, producing a point of severe stress concentration.

Figure 6 – Cross section showing that the failed tubing (lower) exhibited a sharp notch between the soft and hard segments. This is significantly different that the design of the reference tubing (upper).

It was the conclusion of the evaluation that the failed tubing had been designed in such a way as to impart severe stress concentration within the soft segment. The stresses placed on the tubing section during installation exceeded the strength of the notched material. As such, the fundamental design differences between the two types of draw tubing were responsible for the observed variation in performance. Analysis of the hard and soft segment material produced very consistent results across the two types of tubing. The outcome of the testing showed that design of the draw tube was the leading factor in the failures.

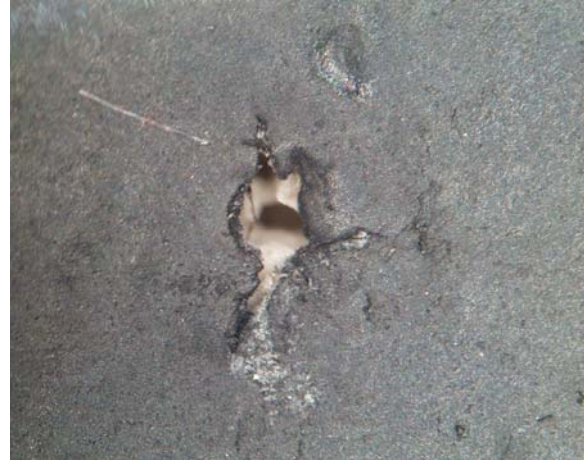
Examination of the hose sections confirmed the presence of included white contaminant material in both the inner tube and cover layers in different samples. Typical contamination samples were excised from the hoses and analyzed. Both contaminant materials were white in color and exhibited a powdery texture. Analysis of the contamination present within the inner tube layer via micro-FTIR produced results characteristic of a silicate-based mineral. The white contaminant was further evaluated using energy dispersive X-ray spectroscopy (EDS). The resulting elemental profile included relatively high concentrations of silicon, calcium and oxygen, consistent with calcium silicate.

Figure 7 – White included contaminant material was present within the hose cover layer.

The results obtained during the analysis indicated that different included contaminant materials were present within the hose inner tube and cover layers. The inclusion within the inner tube was identified as calcium silicate, a mineral filler commonly used in the formulation of rubber compounds and a major constituent of the chloroprene rubber compound. The included material from the cover layer was determined to be calcium carbonate. Calcium carbonate was the primary filler material used in the chlorobutyl rubber hose cover layer formulation. Given the appearance and composition of the included contaminants, both sets of defects were likely the result of

incomplete dispersion of the filler materials within the respective rubber compounds, making this principally a processing related failure. Such inclusions can occur if the rubber mixing process does not impart proper shear with the rubber, or if hard particle agglomerates are present within the fillers.

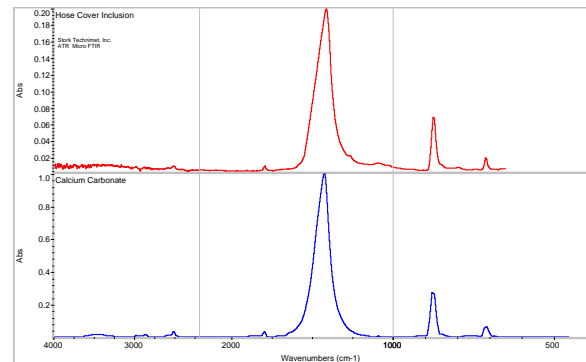
The contaminant material removed from the hose cover layer was also analyzed using micro-FTIR. The resulting spectrum exhibited absorption bands characteristic of calcium carbonate.

Figure 8 – The included material from the hose cover produced an FTIR spectrum characteristic of calcium carbonate.

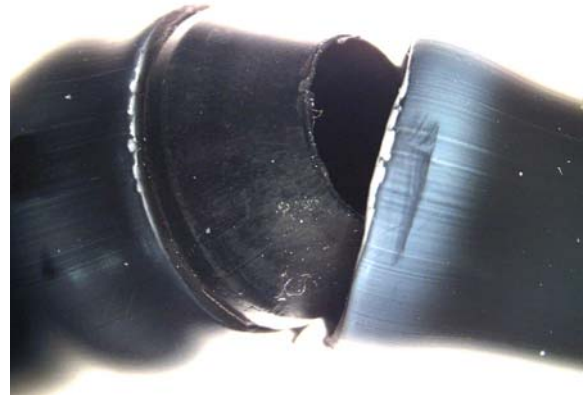
A visual examination of the assembly revealed a circumferential crack within the tube. The crack extended approximately 270 degrees around the tube. The tubing exhibited a substantial level of stress whitening, which was particularly evident on the outside diameter, adjacent to the crack. Areas of tubing that were remote to the crack also demonstrated a high level of ductility in the form of stretching and deformation. The examination showed that while the tip of the nozzle fitting was tapered, the base was sharply angled.

Figure 9 – The tube assembly exhibited significant macro ductility adjacent to the failure.

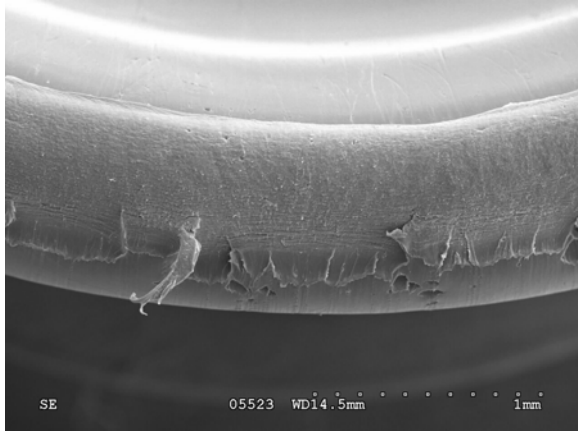
relatively smooth morphology, and the observed features were generally consistent with brittle fracture. Within the crack origin region, additional features indicative of pre-crack initiation sites were also evident. These features also exhibited a morphology associated with brittle cracking. The form of pre-cracks was generally consistent with the crack origins, except that they had not extended significantly into the tubing wall. Increased ductility was apparent within the mid-wall fracture region. This ductility was apparent in the presence of formed fibrils and stretching. The crack surface morphology adjacent to the inner diameter included a smooth texture, indicative of brittle fracture during the final mechanical overload of the tubing wall. Throughout the SEM examination no evidence was found to indicate defects, such as voids or inclusions, within the tubing wall. Further, no signs of molecular degradation, such as chemical attack or thermal deterioration were evident.

Figure 10 – Multiple apparent crack origins were present along the outer diameter of the tubing.

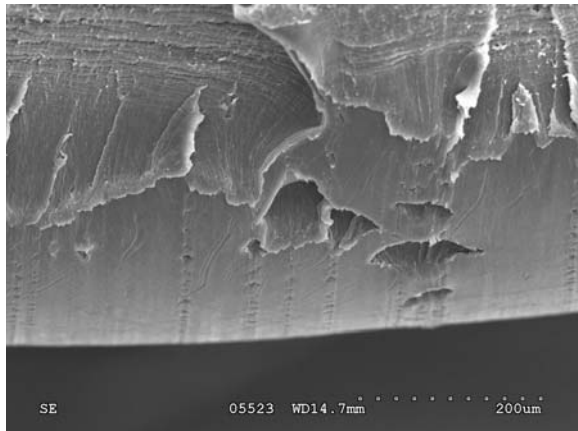
Further SEM evaluation was conducted on the outer diameter of the tubing, adjacent to the apparent crack origins. The inspection revealed multiple linear indications, which were characteristic of extrusion damage, on the outer diameter surface. The examination showed that these indications directly corresponded to the crack and pre-crack initiation sites observed on the fracture surface.

Figure 11 – The outer diameter surface of the tubing exhibited indications that corresponded to the crack origins.

It was the conclusion of the evaluation that the nylon tubing failed through mechanical overload. The fracture surface exhibited multiple crack origin sites along the outer diameter of the tubing. The crack origins and observed pre-crack features corresponded to linear indications present on the outer diameter surface of the tubing. These indications were likely produced during the extrusion process and represented surface defects and points of severe stress concentration. The driving stress responsible for the failure is likely associated with the natural bending of the tubing as it is configured in the appliance. It appears likely that the design of the nozzle fitting was also a factor in the failure because of the relatively sharp corners and the corresponding stress imparted onto the tubing. Once initiated, the cracking extended through the tubing wall and subsequently circumferentially around the tubing. Given the outcome of the investigation, the tube assembly failure was related to processing problems. However design considerations regarding the fitting are thought to be a contributing factor.

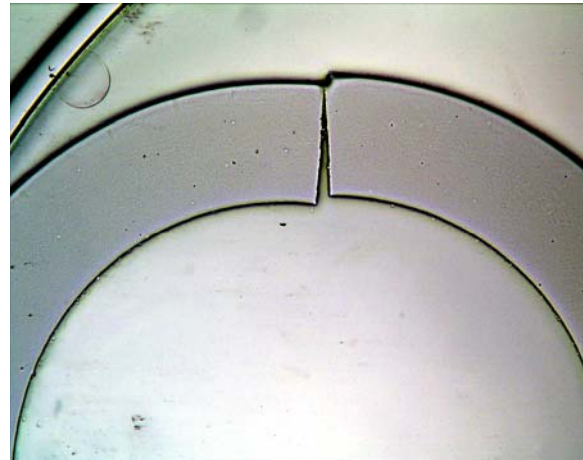
A visual examination of the failed samples revealed relatively long longitudinal slits extending through the tubing wall. The tubing samples were sectioned and further examined with the aid of an optical stereomicroscope. The microscopic inspection of the fracture surfaces revealed little evidence of macro ductility, as would be apparent in the form stress whitening or permanent deformation. Conversely, the fracture surface exhibited features indicative of brittle cracking. The observed features suggested that the cracking had initiated within the mid-wall of the tubing. The examination of several reference tubing samples that had deformed, but not ruptured, during the evaluation showed significant ductility in the form of stress whitening and deformation.

Figure 12 – The cracking within the tube exhibited no signs of macro ductility.

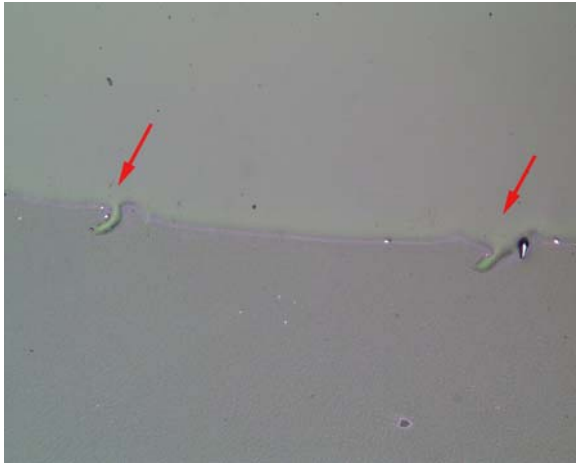
In order to further assess the failed tubing, several samples were evaluated via cross sectional examination. The randomly selected cross sections did not reveal any of the included material suggested through the SEM evaluation. However, several of samples exhibited discontinuities along the inner diameter

wall. The discontinuities appeared as cut defects. Such defects would substantially reduce the tubing strength and lead to premature brittle failure. The cuts were likely produced during the extrusion process, possible through non-uniform operation.

Figure 13 – Discontinuities were apparent along the inner diameter of the failed tubing.

diameter is not apparent, but these may act as notches to reduce the ductility of the formed tubing. Processing, related to both the presence of the included contamination and the inner surface discontinuities, was the principal factor in the failures.

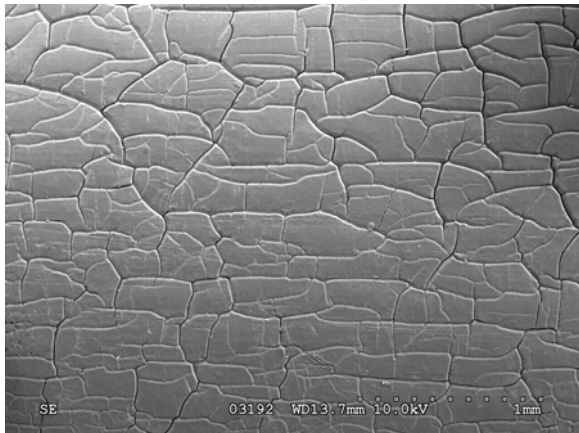
The tubing section was further inspected via scanning electron microscopy. Examination of the outer diameter surface showed the presence of a series of cracks characteristic of severe molecular degradation. The mudcracked morphology included a network of perpendicular cracks that covered the entire surface of the tubing that had been exposed while in service. Such degradation can be the result of chemical attack, thermal deterioration, or ultraviolet (UV) degradation.

Figure 14 – The outer diameter surface exhibited mudcracking characteristic of molecular degradation.

It was the conclusion of the analysis that the fuel line tubing had undergone severe molecular degradation of the outer diameter surface. The location and form of the degradation was indicative of ultraviolet (UV) exposure associated with weathering. While the degradation was most apparent on the outer diameter surface, materials that are transparent can also be degraded at otherwise hidden, isolated areas, such as the inner diameter surface.³ The appearance of the primary, deeply penetrating cracks, which extended from the inner diameter surface, was suggestive of chemical interaction with the tubing material. This was supported by the relatively low concentration of cracks. This interaction is distinct from chemical attack and the corresponding molecular degradation. Instead, the features were suggestive of a failure mode typified by partial dissolution of the crack tip by chemical agents. In this failure mechanism chemical agents dissolve the material at the crack tip, resulting in acceleration of crack

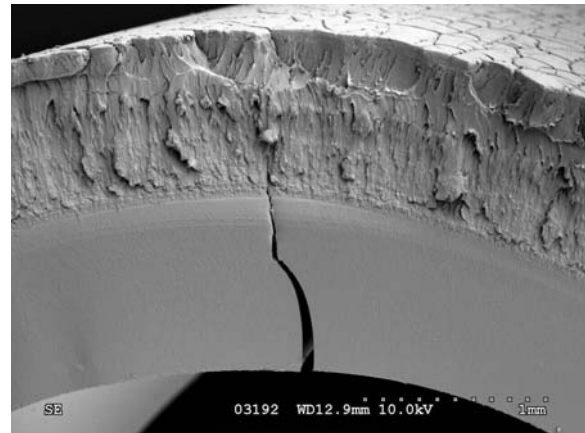
Examination of the inner diameter surface revealed cracks that deeply penetrated the tubing wall, oriented at 90-degree angles. The overall appearance of the surface was suggestive of chemical interaction, but not molecular degradation associated with direct chemical attack. Examination of the fracture surface of a typical crack indicated that the initial

cracking extended through approximately one-half of the tubing wall. The observed features confirmed that the cracking initiated along the inner diameter. Secondary cracking, suggestive of chemical interaction with the tubing material, was also evident. Examination of the crack surface toward the outer diameter revealed that the mudcracking did not extend significantly into the tubing wall. The fracture surface along the outer diameter exhibited features characteristic of final overload, associated with the exertion of stress beyond the strength of the tubing in a state of reduced wall thickness.

Figure 15 – The cracking extended from the inner diameter outward approximately one-half through the wall prior to final overload.

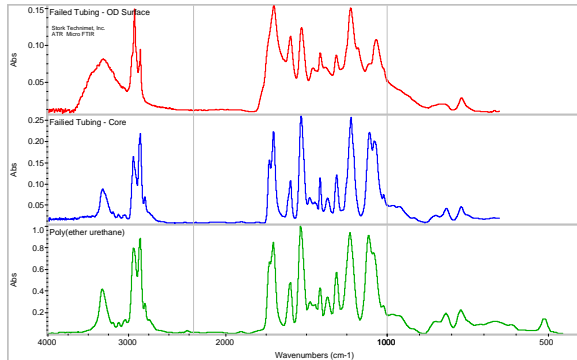
The tubing material was analyzed using FTIR. Analysis of a core specimen of the tubing remote to the apparent cracking produced results characteristic of poly(ether urethane). Analysis of the outer diameter surface, however, resulted in a spectrum that differed substantially. The outer diameter results exhibited absorption bands indicative of severe oxidation of the polymer. Conversely, analysis of the inner diameter surface produced results that closely matched those obtained on the core material. As such, the FTIR analysis generated a good

correlation with the SEM results, indicating gross molecular oxidation of the outer diameter surface, without severe degradation of the inner diameter surface material.

Figure 16 – The FTIR spectrum obtained on the tubing outer diameter surface showed evidence of oxidative degradation of the poly(ether urethane) resin.
