# A Study of the Freezing Phenomena in PVC and CPVC Pipe Systems

*Javier Cruz, Bruce Davis, Paul Gramann, Antoine Rios*  
*The Madison Group*  
*Madison, WI 53711*

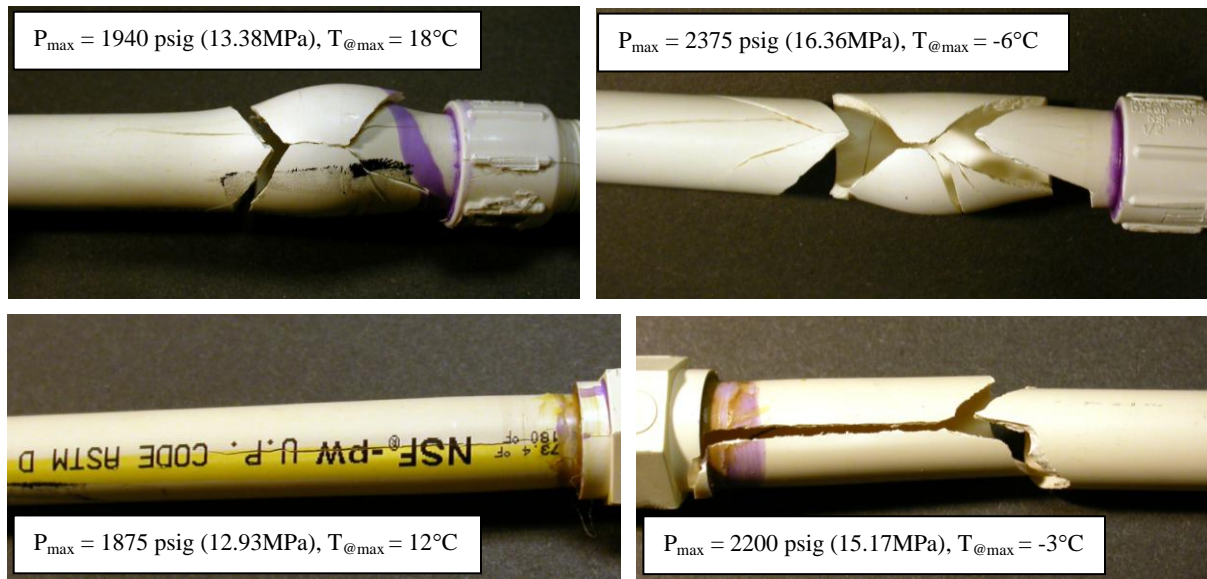
Table 1 shows a summary of results obtained for various trials. As shown, the CPVC undergoes a smaller pressure drop between the maxima and failure. This pressure drop is directly related to the amount of bulging or permanent deformation after yield. Figure 7 shows the fractured PVC and CPVC pipes. The temperature of the plastic pipe when maximum pressure occurred is shown in each image. The PVC pipe showed significant bulging in comparison to the CPVC. As expected, plastic pipes

exposed to lower temperatures showed less ductility and greater stiffness. Consequently, these low temperature failures exhibited higher maximum pressure and the parts showed less bulging with significantly more crack propagations.

Figure 7: View of freezing failures for PVC and CPVC pipe sections (top: PVC, bottom: CPVC, left: pipes exposed to room temperature, right: pipes exposed to subfreezing temperature).

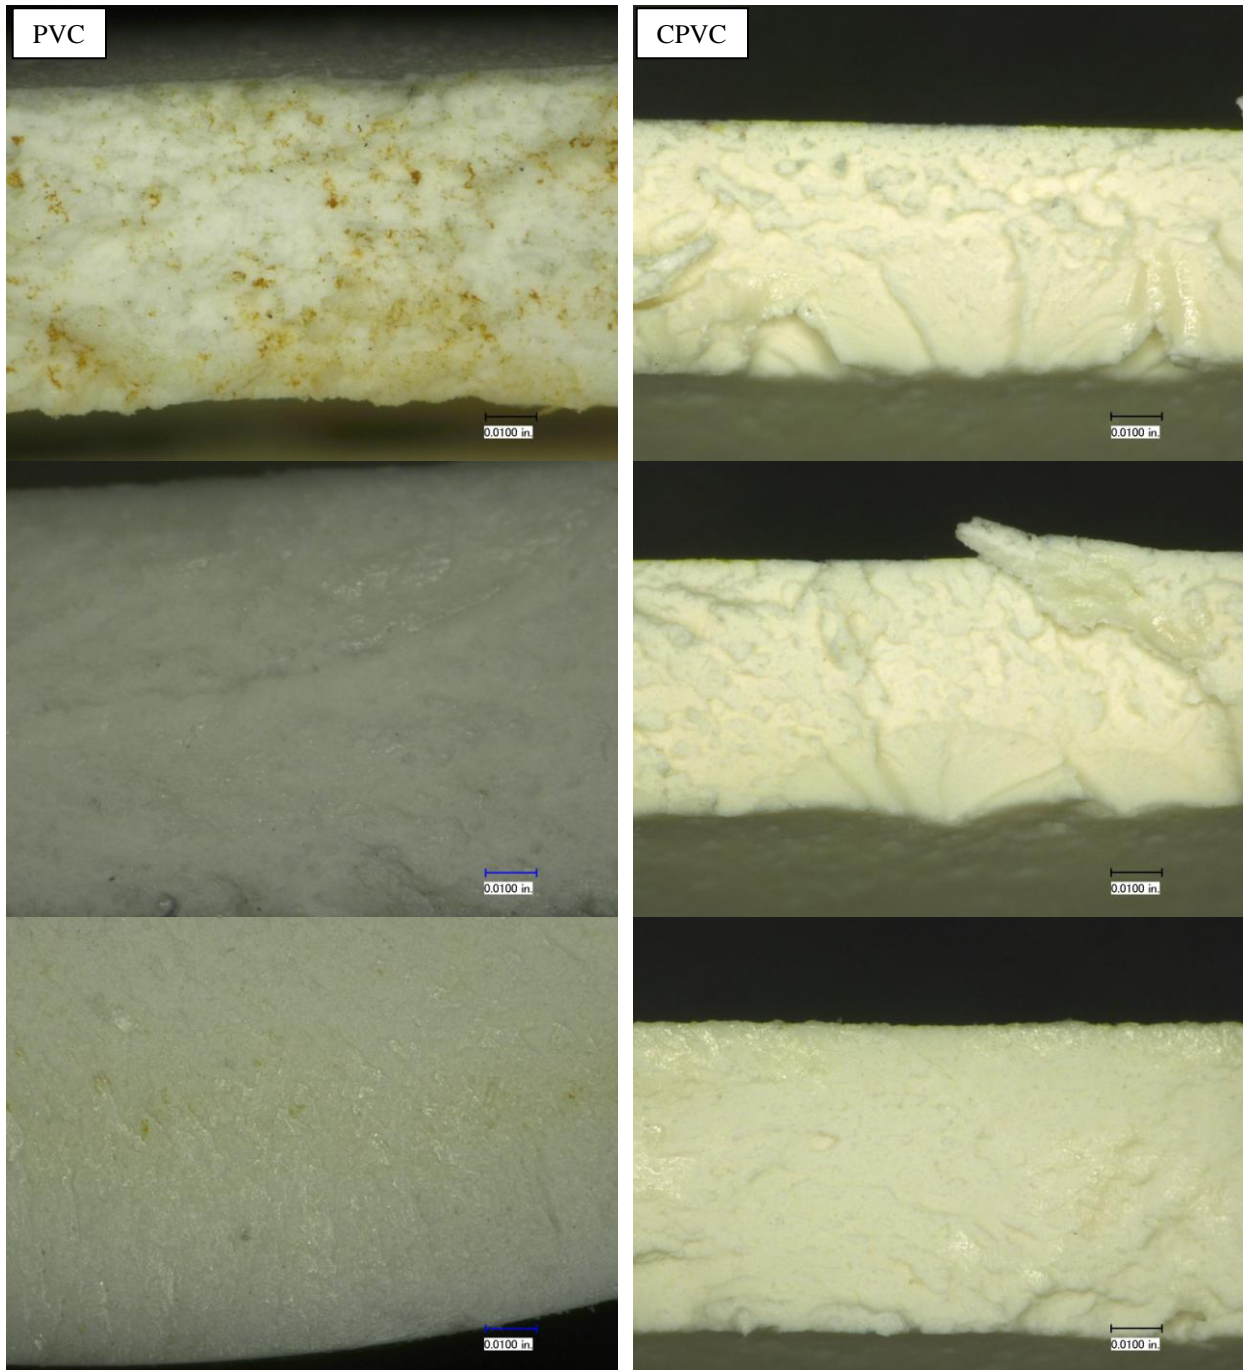
Figure 8 shows micrographs of the fracture surfaces. All fractures showed similar features to those observed in Figure 8. The initiation region of PVC shows a very rough surface that becomes smoother as the energy is released and the crack expands around the circumference. Crack bifurcations also show signs of high energy release and indications of rapid axial crack expansion. CPVC pipe had multiple initiation sites on the interior diameter and a rougher and jagged crack behavior on the interior wall.

Figure 8: Micrographs of fracture surfaces for PVC and CPVC pipes.

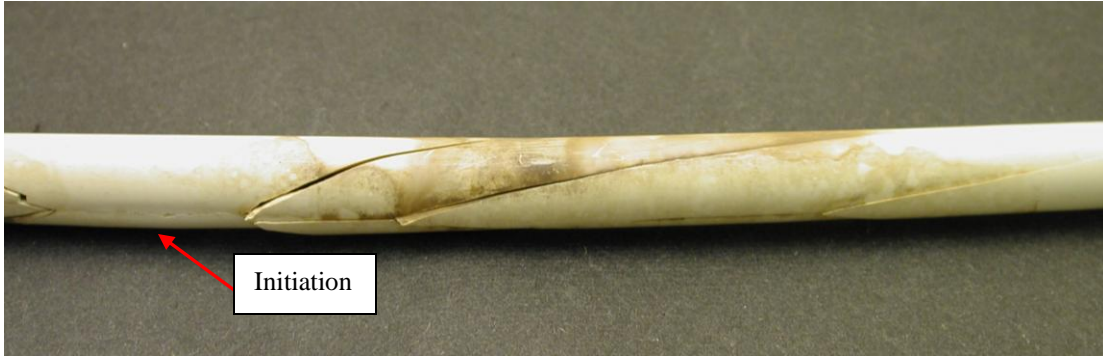
The mode of failure of the pipes presented in this report was compared to pipes that failed in residential settings. The pipes that failed in residential settings show significantly larger crack propagations, more bifurcations, and less pipe bulging. Figure 9 shows an image of a freeze failure for a CPVC pipe in a residential setting. This pipe has significantly larger cracks and numerous bifurcations. In the laboratory setup, a similar fracture behavior was obtained on the PVC pipe manufactured in 2006, Figure 10. This fracture mode occurred only when the plastic pipe was also exposed to subfreezing temperature. The fracture shows no significant bulging and large crack expansions. In this case, the temperature of the pipe was sub-freezing and resulted in a higher material stiffness. However, the PVC pipe manufactured in 2009 did not show this fracture behavior when tested under the same subfreezing condition (refer to Figure 7, PVC subfreezing temperature burst). The 2009 pipe showed a bulging behavior at subfreezing temperatures comparable to what was observed for both pipes near room temperature.

Figure 9: View of a freezing failure of a CPVC pipe in a residential setting.

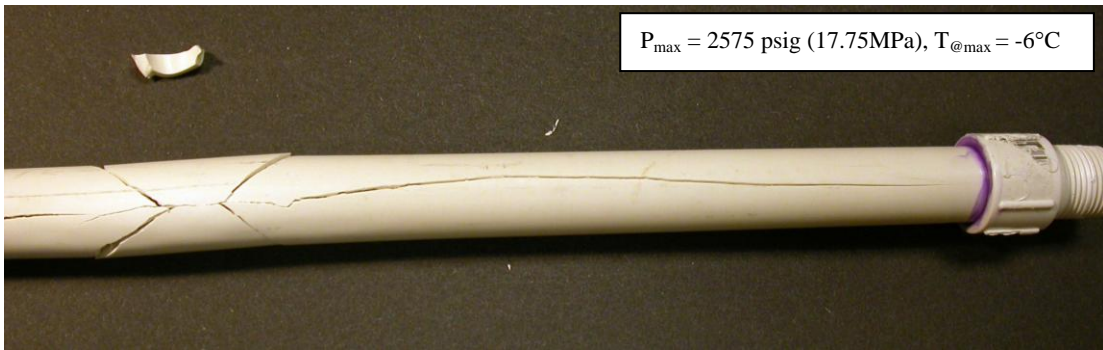
Figure 10: View of a freezing failure for a 1/2 inch (12.5mm) PVC pipe manufactured in 2006 exposed to subfreezing temperature.
