From the TMG Solutions Archives:

Knitline Failure Analysis

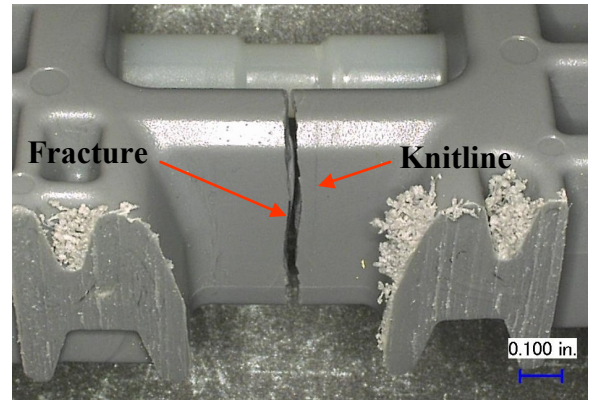
A microscopic examination of the fracture site in the failed component revealed that the crack was parallel to, but slightly offset from the visible knitline on the outer surface of the part, Figure 1. Inspection of the fracture surface showed the presence of a large internal void running through the mid-wall of the knitline region, Figure 2. Multiple crack initiation sites were observed extending from the edges of the void. The initiation sites showed features representative of a brittle, slow crack growth failure mechanism over time that was consistent with creep rupture. Thus, the crack developed within the part and propagated outward during use.

Figure 1: View of the fracture location in the part produced from a gray masterbatch resin.

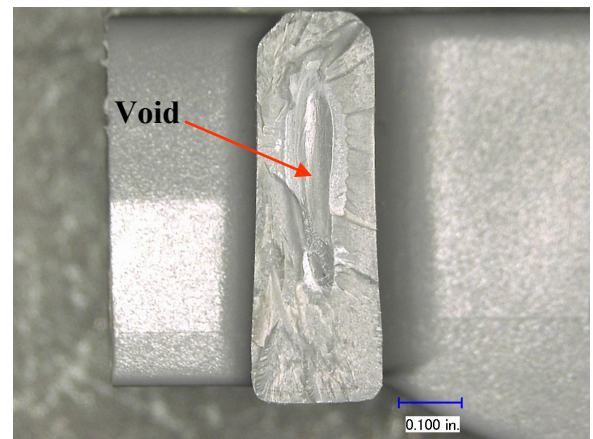
It was the conclusion of the evaluation that the conveyor component failed as a result of voids within a poorly fused knitline. Inadequate mixing of the masterbatch resin during molding created differing flow and shrinkage properties in the masterbatch resin, which created the weak knitline when processed in a similar manner to the pre-compounded resin.

Figure 2: Micrograph view of the fracture surface of the failed part showing the presence of a large internal void at the approximate knitline location

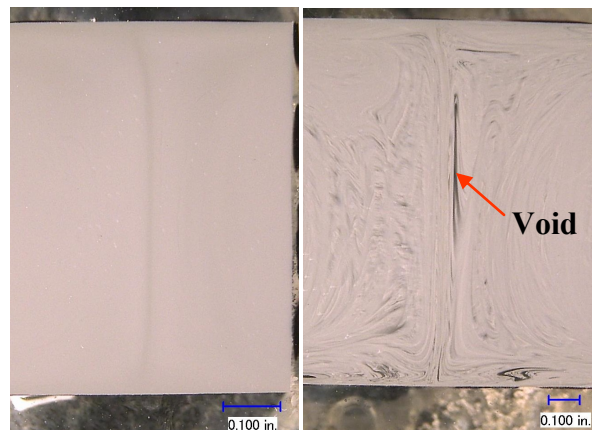
Polished cross-sections were prepared through the knitline regions of reference parts produced using the pre-compounded gray resin and the masterbatch gray resin, as shown in Figure 3. The distribution/mixing of the colorant in the pre-compounded resin component was excellent, while pigment streaking was readily apparent in the masterbatch resin component. Additionally, excellent knitline fusion was visible in the pre-compounded resin component, while the masterbatch resin component displayed a similar internal void at the knitline as the failed part.

Figure 4: Micrograph views of polished cross-sections through the knitline regions of a part produced from a pre-compounded gray resin (left) and a masterbatch gray resin (right) showing poor mixing and an internal void at the knitline of the masterbatch gray part.
