From the TMG Solutions Archives:

Fuel Filter Filling Analysis

Keywords - Moldflow, Nylon, Knit line, Weld line, Air trapping

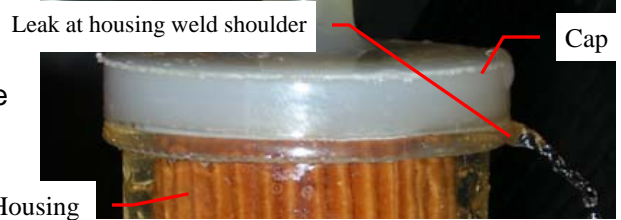
Pressure testing of the fuel filter revealed failure occurred near the housing shoulder weld. Visual and microscopic examination of the fuel filter revealed no evidence of cracking or deformation at the failure location. A leakage flow path was apparent near the housing-to-cap weld. This leak path occurred coincident with a knit line and air trapping in the housing weld shoulder. The leakage path appears to be the result of a no-fill condition from molding. Fourier transform infrared spectroscopy (FTIR) was used to identify the filter housing material and injection molding simulation (Moldflow®) was performed to replicate knit line and air trap formation. FTIR analysis identified the material as nylon. The transparent material property indicates that the nylon structure was amorphous.

Figure 1: Pressure testing revealing the leak location and view of the failure location.

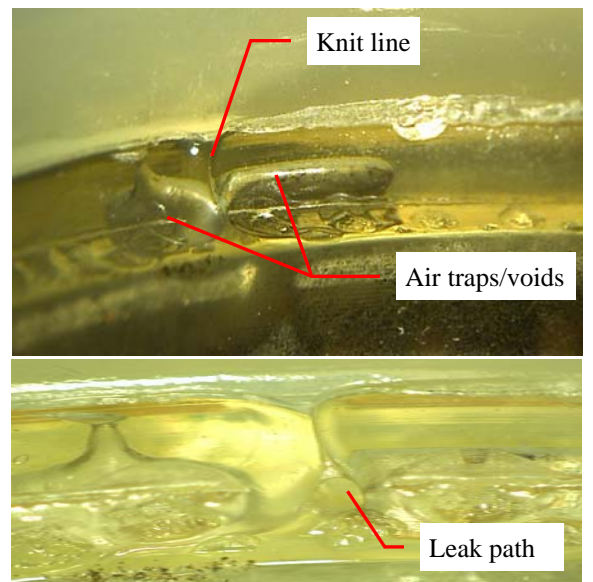
It was the conclusion of the evaluation that leakage occurred from air trapping at a knit line in the housing weld shoulder. Proper venting and localized thickness changes could alleviate these issues in the molding process. The use of injection molding simulation software suggested ways to improve the fill pattern by eliminating knit line formation and reduce air trapping.

Figure 2: Micrographs of the leak location showing air traps/voids and a leak path at the cap-to-housing welded joint.

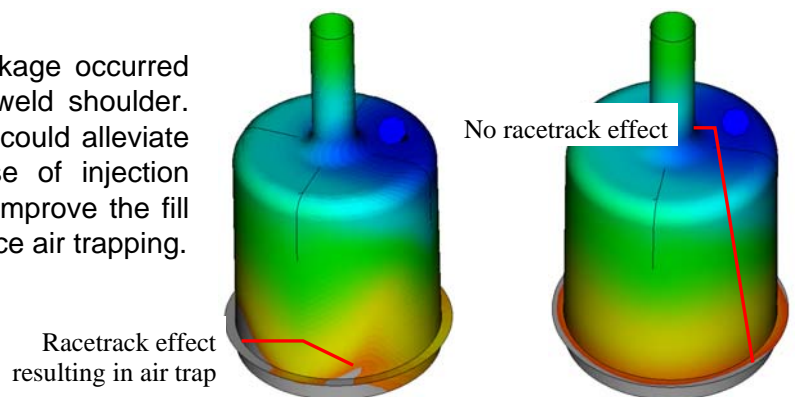
Moldflow® simulation of the fuel filter showed a racetrack effect in the housing weld shoulder. The racetrack effect occurs when plastic flows into thick regions of a cavity more easily than thin regions. In the fuel filter, the racetrack effect leads to a knit line and air trapping tendencies in the weld shoulder. Proper venting at the knit line location and localized thickness changes could reduce the racetrack effect and improve knit line strength. Additional Moldflow® simulation was performed to reduce the racetrack effect, eliminate the knit line, and reduce air trapping in the housing.

Figure 3: Moldflow® fill pattern plots showing the racetrack and air trapping issues (left) and an optimized fill process that eliminates racetracking and minimizes air trapping (right).
