From the TMG Solutions Archives:

Actuating Lever Failure

Keywords - Failure, Environmental Stress Cracking

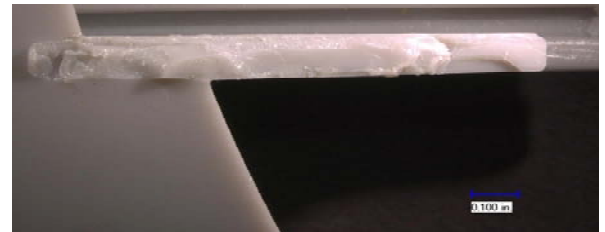
Visual and microscopic examinations of the failed levers revealed features associated with brittle fracture, without signs of macro or micro ductility. The observed irregular, but continuous, fracture pattern indicated the initiation of multiple cracks that subsequently coalesced as they propagated through the wall of the lever. The fracture surfaces presented relatively smooth, sharp features, with signs of slow crack initiation and growth throughout the cracking. The observed features were characteristic of failure through environmental stress cracking (ESC), a failure mechanism whereby a plastic material cracks due to the contact with an incompatible chemical agent while under tensile stress.

View of the fracture surface of a typical failed actuating lever. Multiple individual cracks are evident. The fracture surface shows no signs of ductility.

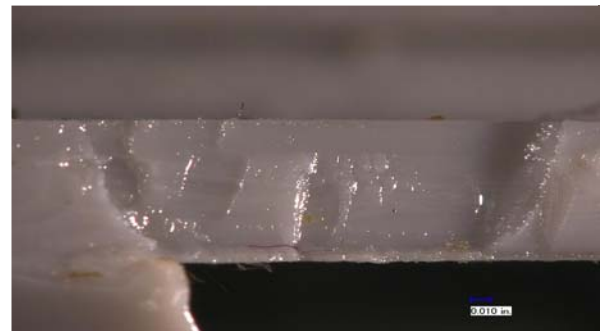
An area of crack initiation is shown. The features are characteristic of brittle fracture via a slow crack growth mechanism.

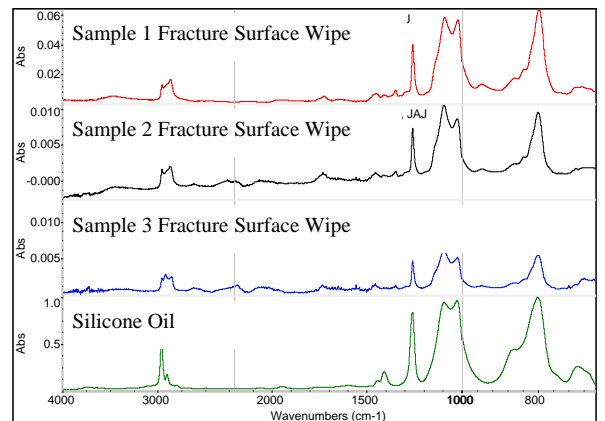
Analysis of the fracture surface revealed the presence of a silicone-based chemical. Silicones are known to act as ESC agents in conjunction with ABS resins. The source of the silicone was thought to be a minor ingredient in one of the sanitizing agents used on the medical device. Environmental stress crack testing of the ABS resin with the sanitizing agent demonstrated incompatibility, with cracking in a short time period, even under conditions of moderate stress.

Analysis of the fracture surfaces showed a silicone-based chemical.

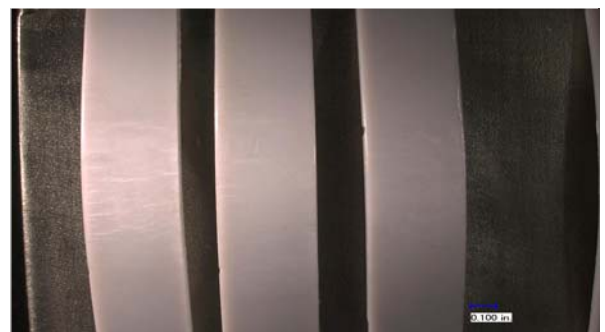
It was the conclusion of the evaluation that the medical device actuating levers failed through environmental stress cracking (ESC). Failures occurred within devices at a limited number of installations because of the unique usage of a sanitizing agent that contained an incompatible silicone-based chemical. It was recommended that either the lever material be changed or that a list of compatible cleaning agents be determined.

ESC testing showed cracking in the lever material when in contact with the sanitizing agent while under stress.
