From the TMG Solutions Archives:

Snap Fit Failure

Keywords - Failure, Snap Fit, Contamination, FTIR

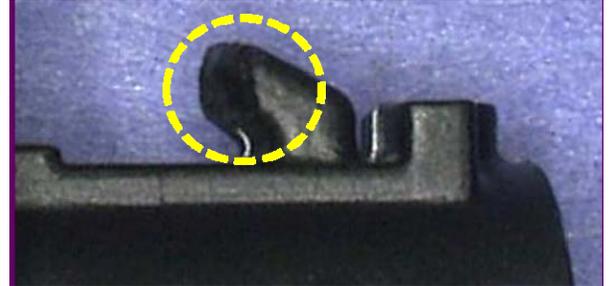
An injection-molded poly(acrylonitrile:butadiene:styrene) (ABS) component experienced cracking within the retaining arm during a snap fit installation with the mating part. Failure was limited to approximately 1% within a single production lot.

Figure 1: Cracking occurred with the retaining arm during a snap fit installation.

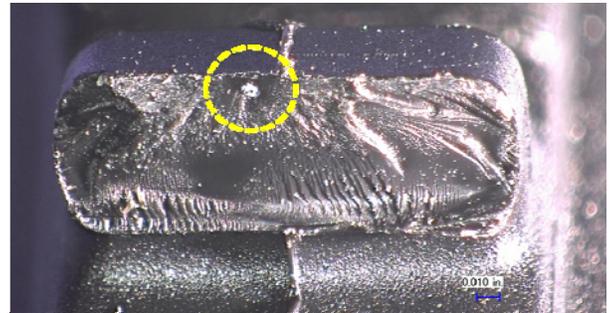
Microscopic examination of the failed parts showed consistency in regards to failure location and appearance of the fracture surface. The parts exhibited a single crack origin within the retaining arm at a location under anticipated tensile stress during the snap fit installation. The fracture presented brittle fracture features indicative of rapid crack extension through overload.

Figure 2: The fracture surface showed features associated with rapid brittle cracking, and a single crack origin.

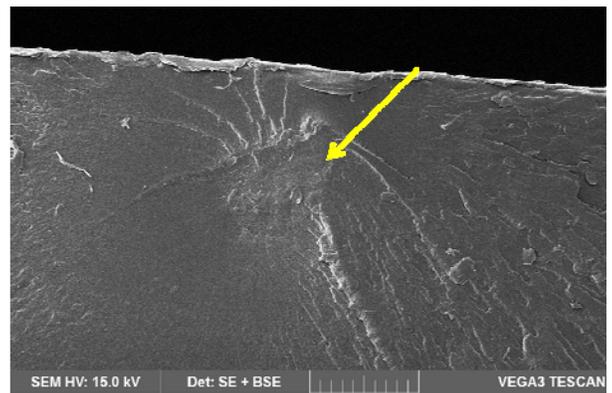
Scanning electron microscopy (SEM) revealed the presence of an inclusion at the crack origin. The inclusion was a discontinuity within the material and acted as a point of severe stress concentration. Energy dispersive X-ray spectroscopy (EDS) revealed that the inclusion had a relatively high sulfur content compared with the surrounding base resin. Further testing through Fourier transform infrared spectroscopy (FTIR) showed the inclusion to be poly(phenylene sulfide) (PPS).

Figure 3: The SEM examination showed the cracking initiated at an inclusion within the material.

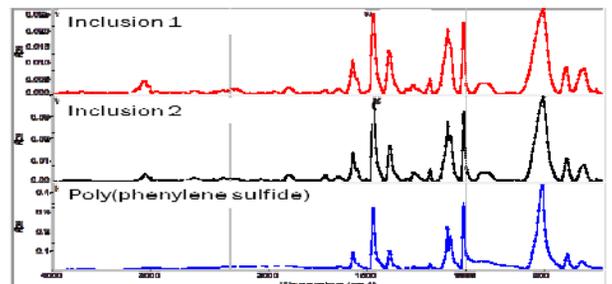
Figure 4: FTIR testing showed the inclusion to be PPS in the ABS molded part.
