# Water Tubing Failure

**Keywords - Failure, Tubing, Degradation, UV**

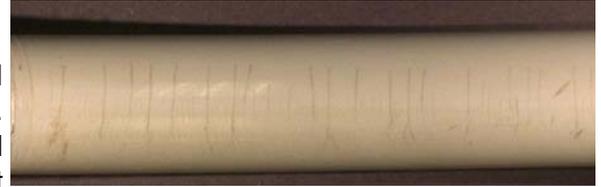
The cracking was present on the end of the tubing that had been connected to the brass fitting associated with the water meter connection. A series of transverse parallel cracks, displaying brittle fracture features, was located exclusively on the exterior surface within the inner diameter of the tubing as it was coiled. At higher magnification an intersecting crack network was apparent. Distinct discoloration was exclusively evident within the general area of cracking.

It was concluded that the tubing failed via brittle fracture through significant molecular degradation of the exterior surface of the tubing. The degradation was the result of ultraviolet (UV) radiation through exposure to sunlight. The mechanical stresses responsible for the cracking are thought to be associated with tensile loads created during bending of the tubing against the coiled direction. Significant improvement in performance could be achieved by the use of a resin with an alternate stabilizer package.

Figure 1: The failed tubing exhibited a series of parallel transverse cracks on the exterior surface within the inner diameter of the coil.

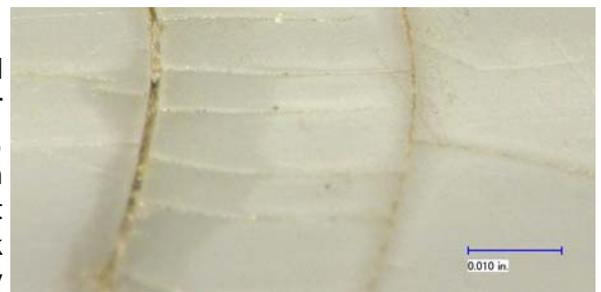
Figure 2: At higher magnification an intersecting network of cracks was apparent, characteristic of molecular degradation.

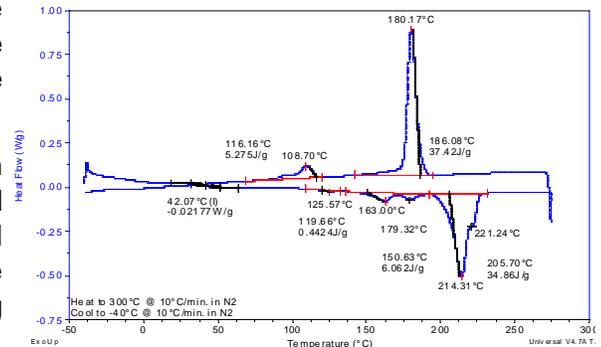
Compositional analysis, including FTIR, DSC, and melt flow rate testing produced results indicative of a blend of poly(butylene terephthalate) (PBT) and a polyether block amide. No evidence was found to suggest contamination or bulk degradation of the failed tubing material.

Figure 3: DSC test produced results characteristic of a PBT resin modified with polyether block amide.

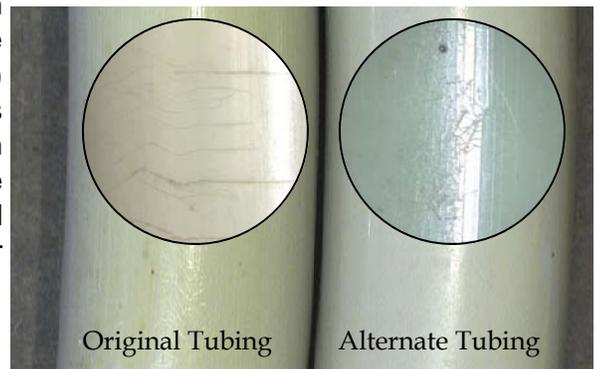
Ultraviolet (UV) exposure per ASTM G154 was performed on the original tubing as well as an alternate resin with an improved stabilizer package. Through UV exposure the original material exhibited significant yellowing and cracking. The alternate material showed no signs of material alteration, including discoloration or cracking.

Figure 4: UV exposure testing showed significant performance differences between the original and alternate tubing materials.
