# When acrylic aquariums fail

*Article appeared in Plastics Today July 13, 2018*

Paul J. Gramann, PhD, PE, The Madison Group

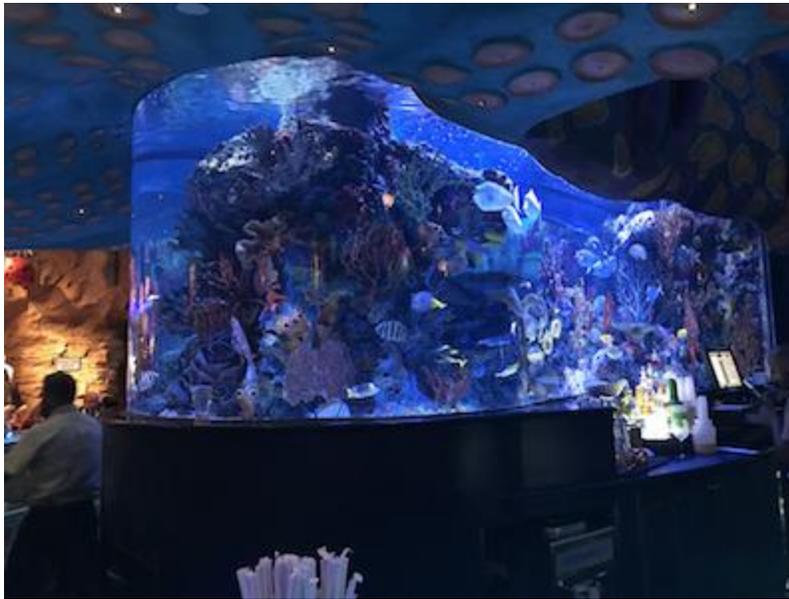
*The aquarium at the T-Rex restaurant at Walt Disney World in Orlando, FL, failed in 2014, when a vertical bonded seam opened instantaneously. Image courtesy Paul J. Gramann.*

**T-Rex, Walt Disney World, Orlando, FL:** On March 17, 2014, just as dinner was being served at the T-Rex restaurant at Walt Disney World, a vertical bonded seam opened instantaneously in a large cylindrical aquarium. The aquarium was located adjacent to dining tables resulting in a number of people becoming drenched. The opening was approximately three feet long, giving employees time to transfer fish to other aquariums located on the grounds.

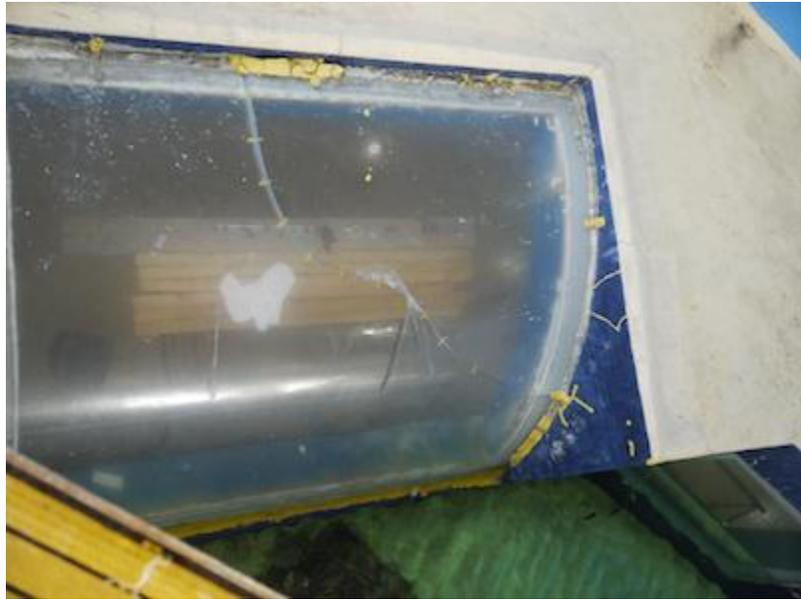
*A large crack formed instantaneously in a 3-in.-thick curved overhead viewing panel at the Mazatlan, Mexico, aquarium last year. Image courtesy Paul J. Gramann.*

**Mazatlan, Mexico:** A large crack formed instantaneously in a 3-in.-thick curved overhead viewing panel on Feb. 3, 2017, shortly after the aquarium had closed for the day. The 1.2-million-gallon aquarium housed 13 large sharks at the time of the failure. The crack released over three quarters of the water in the aquarium, allowing for the safe removal of the sharks. This crack initiated at a large gouge mark at the exterior of the tank.
