Rubber Gasket Failure

Paul J. Gramann, Ph.D., The Madison Group

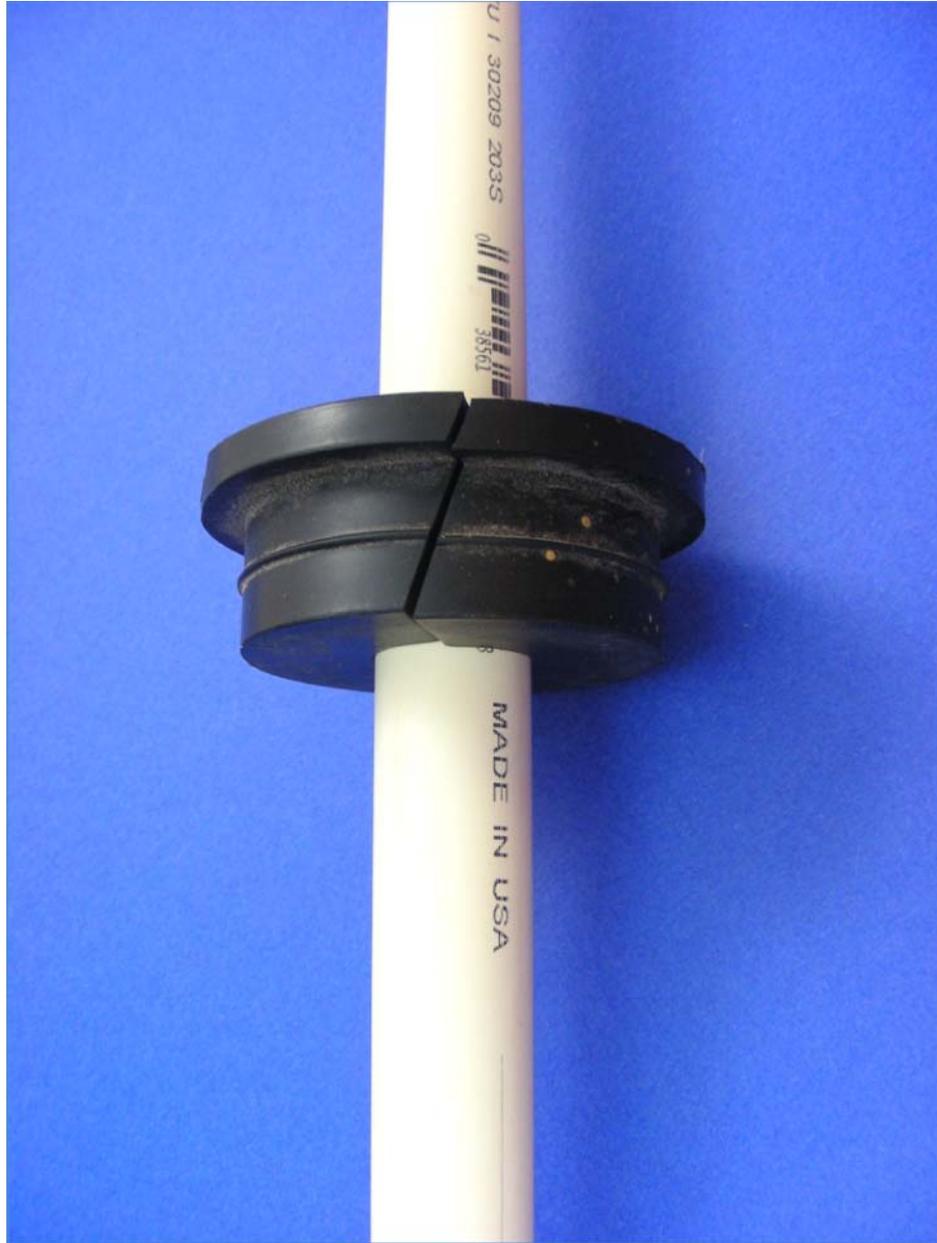
There has been a rash of failures involving chlorinated poly(vinyl chloride)(PVC) pipes that were used with black rubber gasket plugs (Such as those made by ProSet Systems, Inc.), Figure 1. The gasket is typically used as a firestop plug and/or horizontal support as pipe travels vertical from one floor to the next. Failures have been observed occurring anywhere from several months to years after installation. Once a failure has occurred at a location, numerous failures have followed. At the location of failure, the CPVC pipe has been observed swelling with a rubbery feel at the location of failure, Figure 2.

Figure 1 – Rubber gasket on a CPVC pipe.

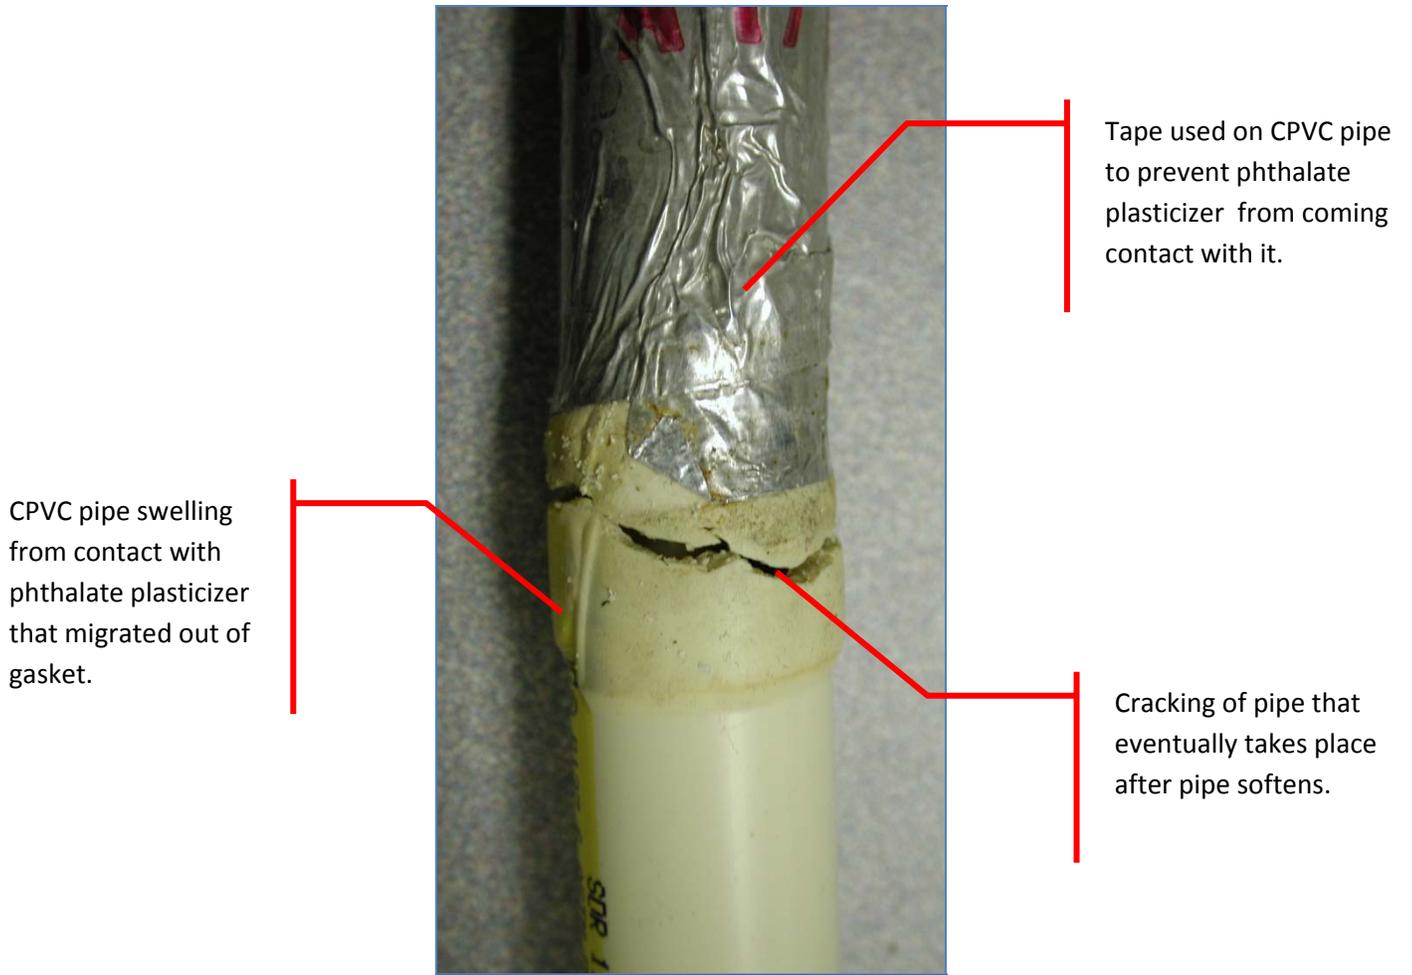
In this case the phthalate-based plasticizer separates from the rubber as described above. If allowed to come in contact with the chlorinated-polyvinylchloride (CPVC) pipe it will be absorbed by the CPVC and in the process cause environmental stress cracking to take place. Phthalate-based plasticizers are known to be detrimental to CPVC pipe materials. The temperature the product is exposed to can accelerate the separation and migration of the phthalate plasticizer from the gasket. For this reason, one should expect migration of the plasticizer to occur faster with the hot water supply. Once in contact with the CPVC pipe the plasticizer will migrate into the pipe causing it to swell. The pipe will soften, becoming leathery at this location. In the softened state a crack can form. Cracking in a pressurized pipe (e.g. water supply) is more likely because of the extra stress (recall ESC requires stress and will take place faster at higher stress levels). However, one should expect cracking to take place in an unpressurized pipe as well since these pipes will have stress from other sources.

Figure 2 – Swelling of the CPVC pipe from absorption of phthalate that migrated out of gasket.

This application is an example of a product that was not fully tested prior to being released into the market. Unfortunately, if the plasticizer in the gasket comes in contact with the CPVC pipe, failure will more than likely take place. This will require massive repairs since the pipes and gasket are located behind the wall. The fix that was proposed to the plumbers, prior to installation, appears to have only prolonged the inevitable – complete replacement of the piping system.

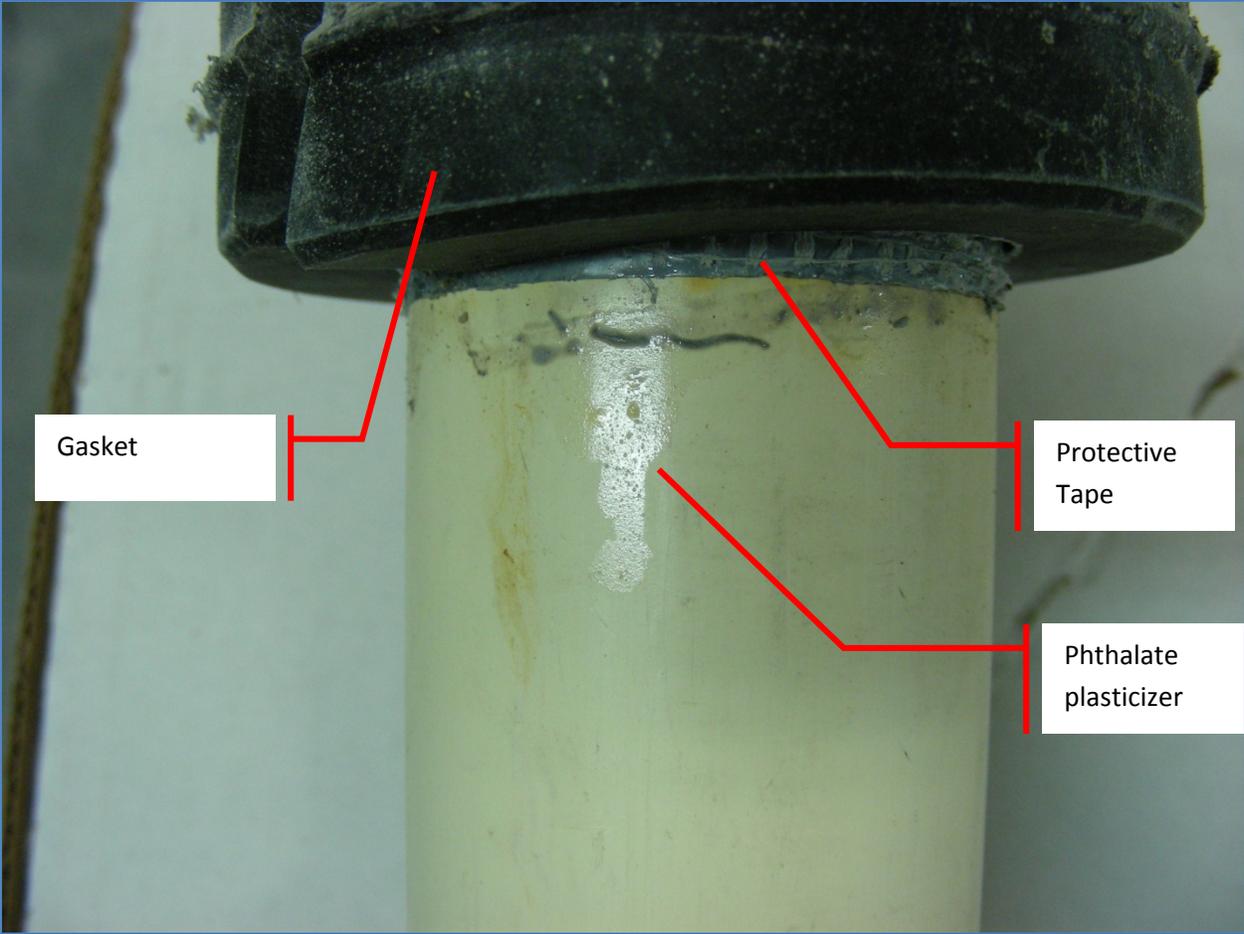
A fix recommended and issued by one manufacturer had the plumber apply tape to the CPVC pipe underneath the rubber gasket with the goal of preventing the plasticizer from coming in contact with the pipe. However, the tape has proven to only prolong failure from taking place in some cases. The plasticizer has been observed running down the tape and eventually coming in contact with the pipe, Figure 3. The plasticizer can also migrate through seams or tears in the tape.

Figure 3 - Phthalate running down side of tape and pipe after migrating out of gasket.
