ENVIRONMENTAL STRESS CRACKING – EXAMPLES FROM THE AUTOMOTIVE INDUSTRY

Jeffrey A. Jansen, Stork Technimet

Abstract

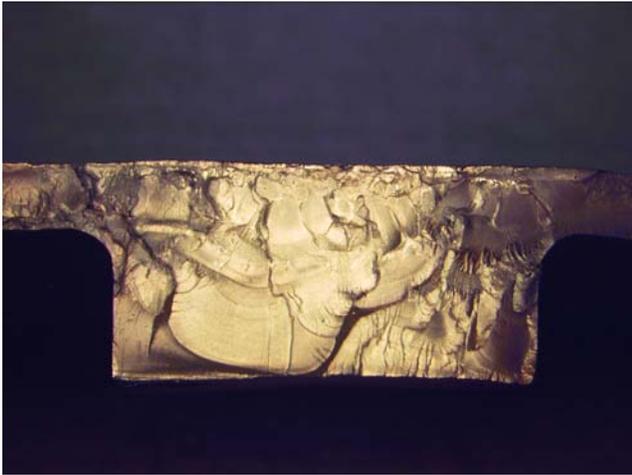
Representative fracture surfaces were examined via SEM, and the observed features confirmed that multiple individual cracks had initiated along the exterior edge of the mirror housing wall. The morphology within the crack origin zone was relatively, smooth, indicating slow crack initiation. Outside of the origin zone, the fracture surface exhibited signs of moderate micro ductility in the form of stretched flaps. Additionally, the surface outside of the crack origin area displayed a series of radiating features. At high magnification these features were present as bands of opened craze remnants. The fracture surface along the interior housing wall, remote to the area of crack initiation, showed contrasting features. The morphology within this area included a high concentration of stretched fibrils, characteristic of ductile cracking, associated with mechanical overload.

Fig. 1 - A typical fracture surface from the mirror housing is shown exhibiting features characteristic of ESC.

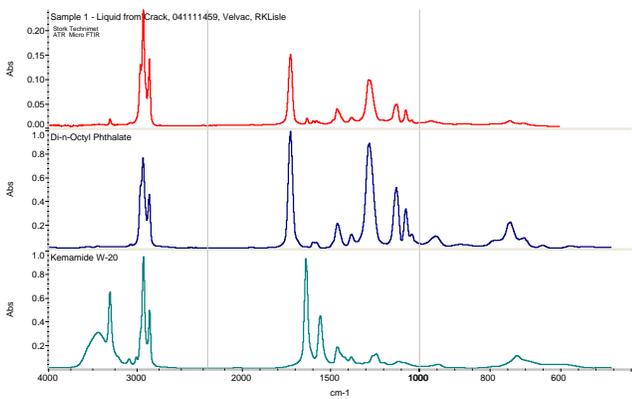
The oily residue present on the fracture surfaces was analyzed using FTIR. The obtained results were denotative of a phthalate-based ester, such as dioctyl phthalate, as presented in Figure 2. The coating covering the steel clamp was also analyzed and the results represented a poly(vinyl chloride) (PVC) resin containing a significant level of a phthalate ester, which closely matched the results obtained on the fracture surface residue.

It was the conclusion of the investigation that the mirror housings failed through ESC. The ESC agent in this case was the phthalate-based ester plasticizer present in the PVC coating on the steel clamp used to secure the housing to the mating pole. The plasticizer likely migrated from the coating under the conditions of the engineering testing, including exposure to elevated temperature and the compressive loading inherent to the design. Phthalate esters are known to be aggressive ESC agent in concert with ABS resins. The obvious mechanical stress driving the failures was the interference loading between the mirror housing and the clamp. The failure was identified as ESC through the visual, microscopic, and SEM evaluations. The designative features included multiple crack initiation sites that subsequently coalesced into a unified fracture. Additional features were found within the mid-fracture zone, including a series of radiating markings corresponding to opened craze remnants. Such features are consistent with the ESC failure mechanism in which the crack front alternately forms crazes leading to cracking, followed by arrest. Once the crack progressed to a critical size, final overload occurred. The primary factor in the

Fig. 2 - The FTIR spectrum obtained on the residue from the fracture contained absorption bands indicative of a phthalate based ester.

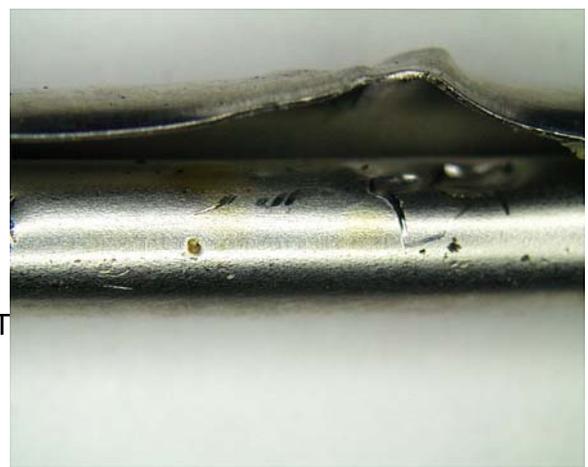
Visual and microscopic examinations of the failed parts revealed significant cracking, which was consistent across all of the handles. The cracks were present within the molded boss that secured the roll pin. When the parts were disassembled, numerous additional, non-catastrophic cracks were apparent at similar locations around the boss hole. The crack surfaces, as represented in Figure 5, exhibited features characteristic of brittle fracture, and the crack origins were primarily located adjacent to the inner diameter. An oily residue was evident on and adjacent to the fracture surfaces, and on the mating roll pin, as shown in Figure 6.

Analysis of the oily residue found on the fracture surface using FTIR produced results indicative of a hydrocarbon oil containing an ester-based additive. The residual oil within the roll pins was also analyzed and the obtained results produced an excellent match with spectra representing the fracture surface residue. Spectral library searching generated very good matches with commercial fluids for metal processing.

The conclusion of the failure analysis was that the latch handles failed via ESC. The chemical agent responsible for the failure was identified as the fluid used in the forming and processing of the metal roll pin, a hydrocarbon oil containing an organic ester-based additive. Ester-based materials are known to be active ESC agents for both ABS and PC resins. The oil had not been properly cleaned from the roll pin, as mandated by the handle manufacturer. This inadequate cleaning is the main factor in the failure of the latch handles. The requisite stress involved in the failure apparently came from the interference fit between the roll pin and the handle boss. The failure was identified as ESC by the visual, microscopic, and SEM examinations. The telltale features included the irregular, but continuous crack pattern, the presence of multiple individual crack initiation sites, the generally brittle fracture surface morphology, and the micro-craze remnants within the crack origin locations.

Fig. 6 - A high concentration of oil was present on the

hinge roll pin.

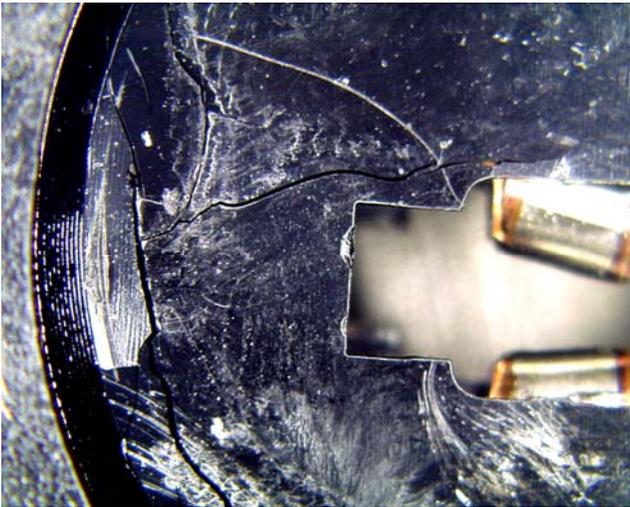
The failed parts were visually and microscopically examined. Cracking was observed surrounding the area of contact with the metal cylinder housing. The surface of the black base modules also exhibited a series of gray streaks, commonly known as splay. A typical surface of a base is shown in Figure 7. Additionally, an oily film was found covering the bulk of the plastic modules. No signs of macro

Fig. 7 - A substantial level of crack was apparent on the ignition switch base. Silver streaking associated with splay was also evident.

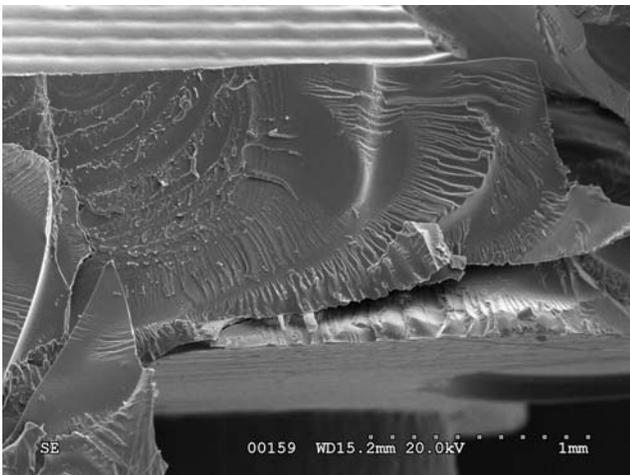
Several fracture surfaces were evaluated through SEM inspection, with consistent observations. Multiple apparent crack origins were evident along the surface that had been in contact with the mating metal housing. The crack origins showed a pattern of radiating bands interspersed with zones of extremely smooth morphology, as illustrated in Figure 8. At high magnification, the bands were revealed to consist of craze remnants. Surrounding the crack origins, the fracture surface displayed classic brittle fracture features, including hackle marks and river markings.

The conclusion of the failure analysis was that the ignition base modules failed via ESC. The stresses driving the failures likely originated from the interference with the mating metal cylinder housing. This included both the assembly snap fit force and the static stress. The chemical agent responsible for the failure was thought to be the aliphatic hydrocarbon oil found covering the surface of the base modules. This oil was present as residual fluid from the production of the mating metallic components. While such fluids do not normally effect polycarbonate resins, the material was severely compromised by the substantial level of molecular degradation. Thus the degradation was primary factor responsible for the failures. This degradation was evident through the reduced glass transition and softening temperatures, as well as the elevated melt flow

Fig. 8 - Scanning electron micrograph showing the ignition base fracture surface features characteristic of ESC. (SEM 40X)
