# FAILURE ANALYSIS OF AUTOMOTIVE AIR CONDITIONING CONNECTORS

*Jeffrey A. Jansen, The Madison Group, Madison, Wisconsin*

Failures occurred within automotive air conditioning system connectors. The cracking was observed within connectors that had been installed in automobiles, which were part of a durability testing program. The focus of this investigation was a determination of the nature and cause of the failures. The results obtained during the evaluation of the cracked connectors indicated that the failures occurred through a brittle fracture, slow crack initiation creep rupture mechanism of the material. However, the cause of the failure was severe molecular degradation as a result of the durability test program conditions. This paper will review the testing performed to characterize the failure mode and identify the cause of the cracking, while demonstrating the analytical procedures used in the investigation.

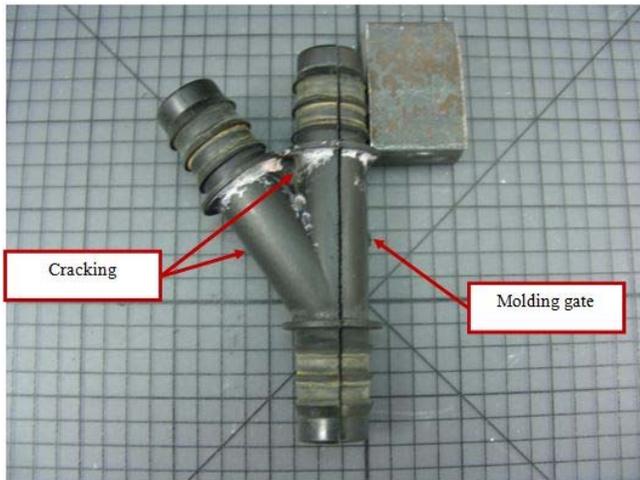
Examination of the connectors confirmed the presence of cracking within the parts. The cracking within the failed parts was oriented longitudinally, consistent with hoop stress within the connector. A likely source of the hoop stress was internal pressure associated with operation of the refrigeration system. The cracking was present within both legs of the connector Y geometry, positioned approximately 180 degrees around the part from the injection molding gate (Figure 1).

the cracking exhibited features characteristic of brittle fracture. The cracking location likely represented a knit line, an area of union between the two resin flow fronts during the molding process.

Figure 1. Close-up view showing one of the failed connectors in the as-received condition. The cracking was positioned approximately 180 degrees around the part from the injection molding gate.

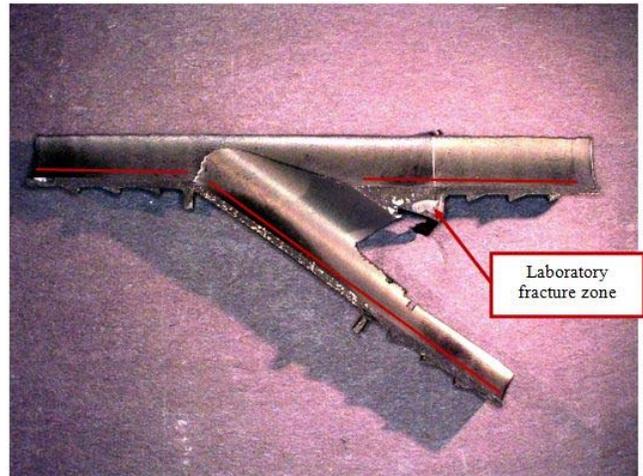
The cracks within the connectors were completed in the laboratory to allow further inspection. The fracture surfaces of the various parts were very consistent, displaying similar features. The fracture surfaces showed no signs of macro ductility, and were indicative of a brittle fracture mechanism (Figures 2 and 3). The appearance of the fracture surfaces was consistent with crack initiation along the inner diameter walls of the connectors. During the examination, it was noted that the fracture surfaces showed the presence of glass reinforcing fibers oriented almost exclusively parallel to the cracking direction (Figure 3). This was likely the result of oriented flow of the resin into the molding tool within this location. Isolated areas on the fracture surface created during completion in the laboratory exhibited stress whitening. The presence of the stress whitening within the lab fracture zones was significant as it indicated that the material had some inherent ductility (Figure 2).

Figure 2. Photomicrograph showing the fracture surface after completion in the laboratory. The failure fracture surfaces are indicated by the red lines.

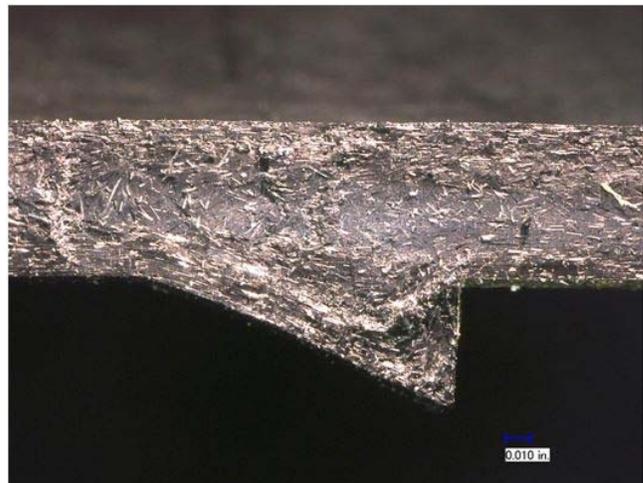
Figure 3. Photomicrograph showing a typical area on the failed connector fracture surface.

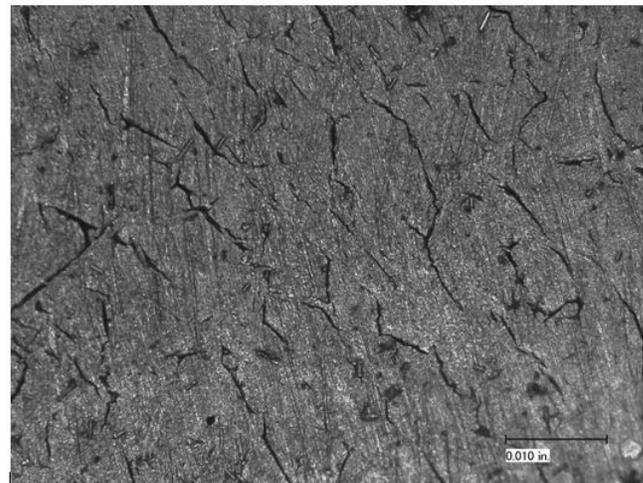
Microscopic examination of the interior surface of the connectors showed the presence of a network of micro cracks, commonly associated with molecular degradation (Figure 4). Additionally, during handling of the samples and subsequent sample preparation it was noted that the failed connector material cracked with very little applied stress or deformation, indicating that the connector material was in a compromised state.

Figure 4. Photomicrograph showing a network of small micro cracks present on the inner diameter surface of the failed connector.

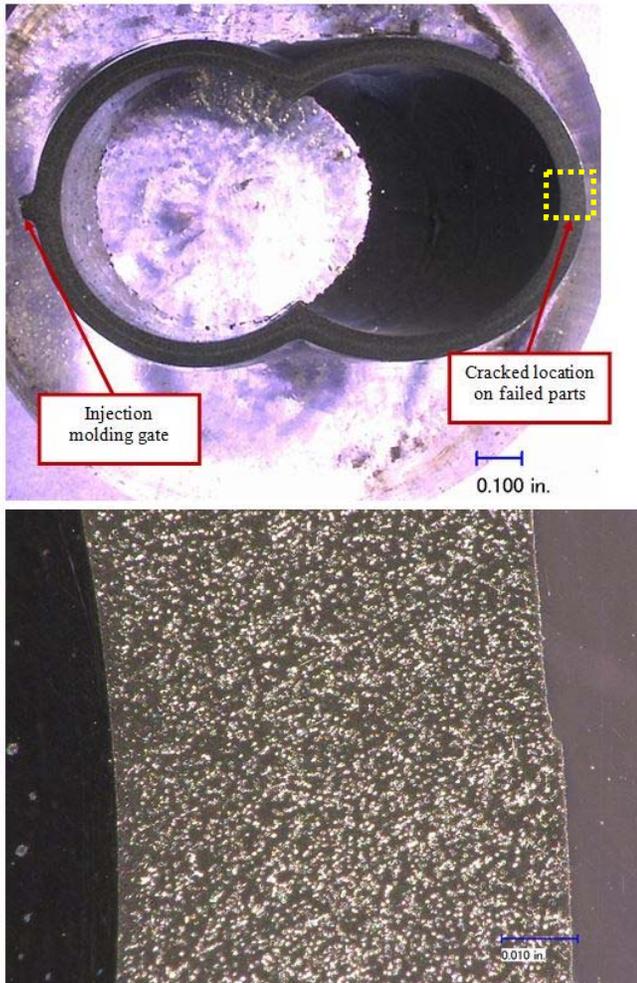
A cross-section was prepared through a supplied as-molded reference part at a location planar with the injection molding gate. Microscopic examination of the cross-section showed flow emanating from the injection molding gate. Inspection of the location corresponding to the cracking on the failed parts, approximately 180 degrees from the molding gate, did not show the presence of a poorly fused knit line. It was observed, however, that the glass fiber reinforcement within this area was oriented almost exclusively parallel to the crack direction (Figure 5). This glass fiber orientation was primarily longitudinal to the primary axis of the connector. Thus, the orientation of the glass fibers would not produce reinforcement against the hoop stress produced from internal pressurization.

Figure 5. – Photomicrographs showing a cross-section prepared through an unused reference part. The area corresponding to the cracking within the submitted failed parts does not show fiber orientation to reinforce against hoop stresses. Clear markings indicating a poorly fused knit line are not evident.

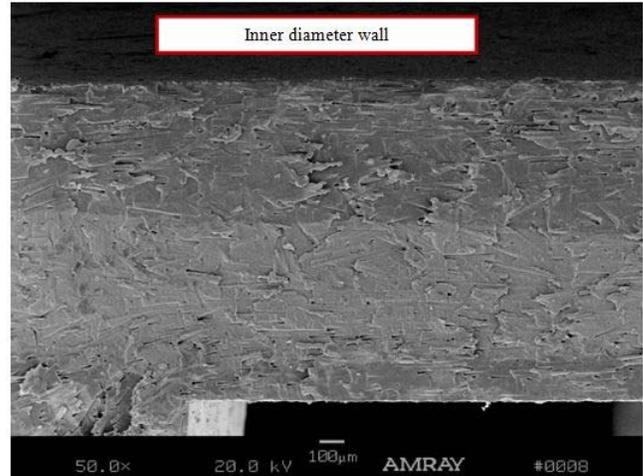
extension. Examination of the fracture surface showed features indicative of crack initiation along the inner diameter surface of the connector wall (Figures 6 and 7).

Figure 6. – Scanning electron micrograph showing a typical area on the failed connector fracture surface.

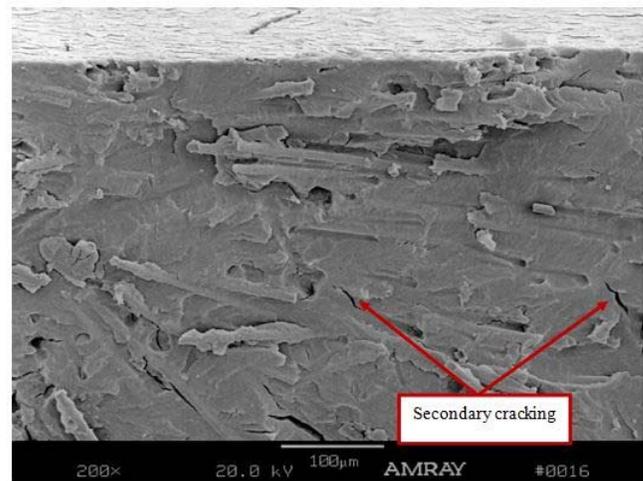
Figure 7. – Scanning electron micrograph showing a typical area on the surface adjacent to the inner diameter. Characteristics associated with crack initiation are present. Brittle fracture features are evident. The presence of secondary cracking is also apparent.

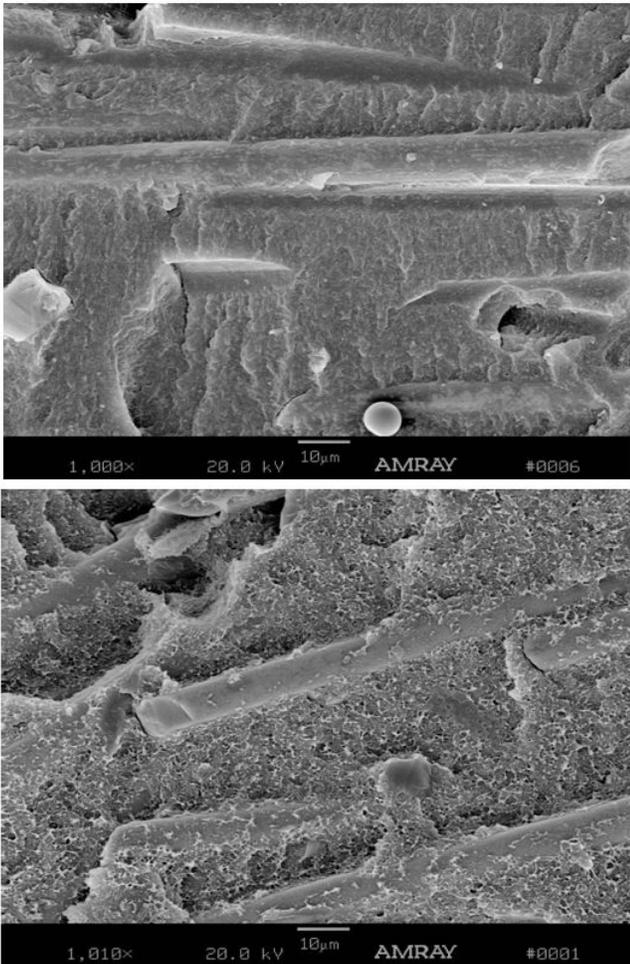
A distinct morphological difference was observed between the area adjacent to the wall inner diameter and mid-wall (Figure 8). The morphology along the inner diameter wall was relatively smooth and exhibited features characteristic of brittle fracture. No evidence was found of substantial micro ductility, as would be indicated by the presence of stretched fibril formation. An area within the mid-wall of the connector displayed a sharp contrast in features. The mid-wall locations showed the presence of fibril formation at high magnification.

Figure 8. – Scanning electron micrographs showing the difference in morphology between locations adjacent to the inner diameter wall (upper) and the mid-wall (lower).

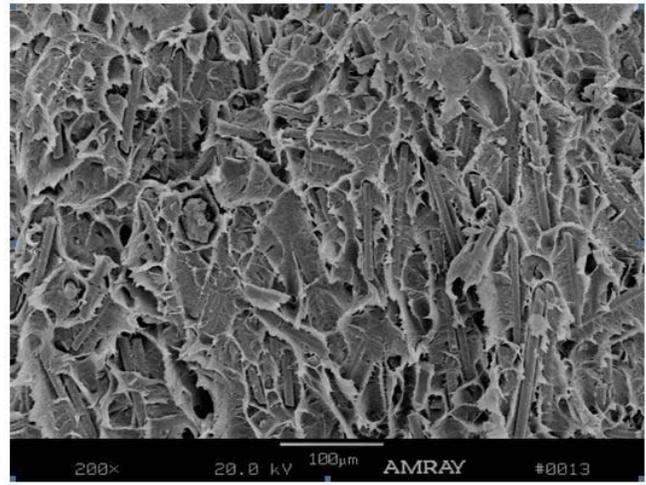
Examination of the laboratory fracture showed a high level of micro ductility, as indicated by the presence of stretched flaps and fibrils (Figure 9). This laboratory fracture zone was created through rapid mechanical overload, and the features were in sharp contrast to those present on the failure fracture surface. The SEM examination showed moderate bonding of the glass fibers to the surrounding polymer matrix.

Figure 9. – Scanning electron micrograph showing stretched fibril formation indicative of a high level of micro-ductility.

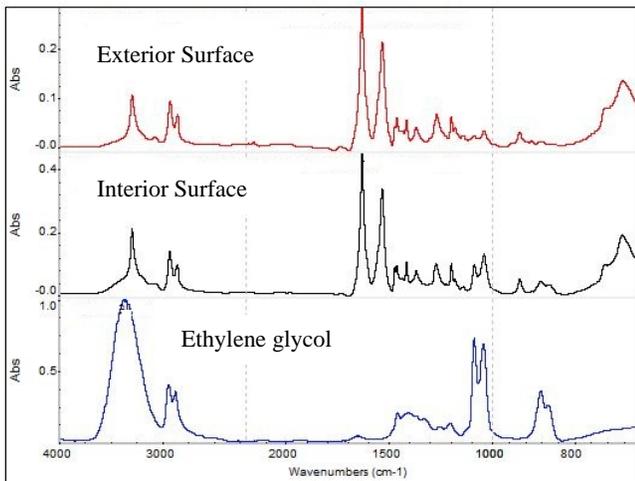
Compositional analysis of the sample materials was performed using Fourier transform infrared spectroscopy (FTIR). Analysis of specimens representing the exterior and interior surfaces of one of the failed connectors showed that the two results were generally consistent, but exhibited subtle yet distinct differences in the spectra. Specifically, the spectrum representing the interior surface exhibited additional absorption bands relative to the results obtained on the exterior surface. Subsequent interpretation of the results obtained on the exterior surface indicated that the spectrum contained absorption bands characteristic of a nylon resin. Spectral subtraction showed that the additional absorption bands present in the interior surface spectrum corresponded to the presence of a glycol-based chemical. These results indicated that the connector material had

absorbed a significant level of the glycol-based cooling agent (Figure 10).

Figure 10. – The FTIR spectrum obtained on the interior surface of the failed connector exhibited absorption bands characteristic of a nylon resin, as well as the presence of a glycol-based chemical

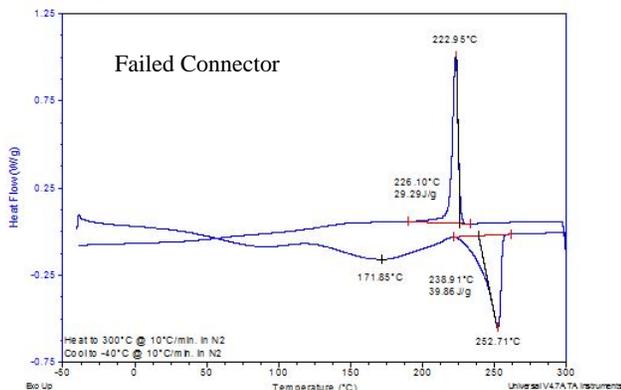
Differential scanning calorimetry (DSC) of the failed connector material produced results that indicated that the connector material underwent a primary endothermic transition centered at 253 °C during the first heating run (Figure 11). These results were consistent with the melting point of the material. Generally, nylon 6/6 resins exhibit a melting point of approximately 263 °C. Correspondingly, the recrystallization of the polymer also occurred at a temperature somewhat lower than expected for a nylon 6/6 resin. A weaker endotherm was also evident in the first heating run results, centered at 172 °C. The relatively broad nature of the transition was indicative of evaporation or volatilization, not melting. Based upon the FTIR results and the determination of the presence of a glycol-based chemical, this transition was thought to represent the volatilization of the glycol-based coolant.

Figure 11. – The DSC thermogram obtained on the failed connector material.

The results obtained during the second heating run showed a bimodal endothermic transition with a primary maximum at 251 °C and a secondary maximum at 240 °C. The bimodal nature of the endotherm during the second heating run was in agreement with the expected results for a nylon 6/6 resin. The absence of the weaker endothermic transition observed during the first heating run was consistent with volatilization of the chemical from the plastic resin. The relatively low melting point determined during the first and second heating runs was indicative of significant molecular degradation of the nylon 6/6 resin.

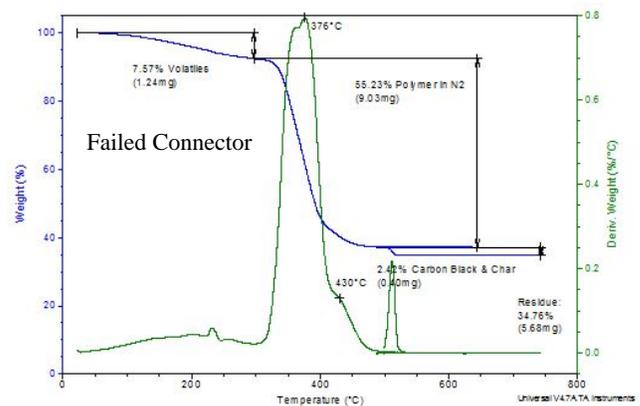
Thermogravimetric analysis (TGA) of the resin and housing components was performed to further evaluate the compositions of the material. The thermogram representing the failed connector materials presented an initial weight loss of approximately 7.6% while heating under a dynamic nitrogen purge through 300 °C (Figure 12). This transition was associated with the presence of volatile materials, likely including water and the glycol-based coolant. Continued heating resulted in a weight loss of 55.2% centered at 376 °C, associated with the initial thermal decomposition of the nylon 6/6 polymer. The temperature of the weight loss was somewhat lower than expected, and was a further indication of degradation of the base polymer. Continued heating of the sample under an air atmosphere resulted in a weight loss of 2.4%, corresponding to carbonaceous char formed during the initial thermal decomposition of the polymer and carbon black pigment. Upon completion of the analysis a non-combusted residue content of 34.8% remained. Visual inspection of the residue revealed primarily short glass fibers. Both the amount and appearance of the residue were consistent with the stated description of the material as a nominal 35% glass fiber reinforced resin.

Figure 12. – The TGA thermogram obtained on the failed connector material.

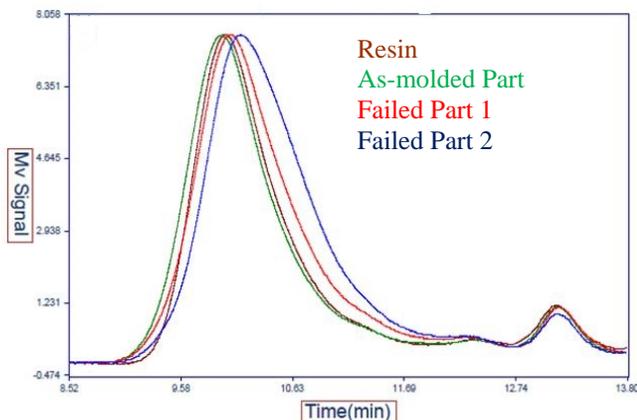
A review of the results showed two distinct molecular weight phenomena (Figure 13). A definite increase in the molecular weight was noted in the as-molded connector material relative to the molding resin. While it is possible that this difference in molecular weight resulted from materials with inherently different molecular weight profiles, the results were interpreted to indicate that a cross-linking mechanism takes place within the material during processing. All three tested molded connector samples exhibited a relative increase in the concentration of high molecular weight species compared with the molding resin. It is thought that a cross-linking reaction takes place, possibly through chain extension associated with the hydrolysis-resistant additive formulated into the resin. Such cross-linking could be expected to improve the mechanical and chemical resistance of the resin. The cross-linking was most evident upon direct comparison of the results obtained on the molding resin and the connector in the as-molded condition.

The results also indicated that the failed connectors had undergone significant molecular degradation, as indicated by a relative reduction in the molecular weight distribution of these samples. Such molecular degradation would be expected to reduce the mechanical integrity of the material and further reduce the chemical resistance. Given the overall results, the molecular degradation exhibited by the failed connectors occurred during field service, not the molding process.

Figure 13. – The molecular weight profiles obtained on the connector materials.
