Keywords - Failure, Environmental Stress Cracking

Problem

The actuating levers on a high number of medical components cracked after a relatively short time in service, resulting in the failure of the devices. The levers were injection molded from a poly (acrylonitrile:butadiene:styrene) (ABS) resin. The failures were isolated to a few installation locations.

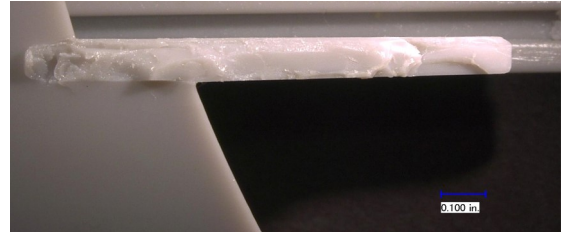
Visual and microscopic examinations of the failed levers revealed features associated with brittle fracture, without signs of macro or micro ductility. The observed irregular, but continuous, fracture pattern indicated the initiation of multiple cracks that subsequently coalesced as they propagated through the wall of the lever. The fracture surfaces presented relatively smooth, sharp features, with signs of slow crack initiation and growth throughout the cracking. The observed features were characteristic of failure through environmental stress cracking (ESC), a failure mechanism whereby a plastic material cracks due to the contact with an incompatible chemical agent while under tensile stress.

View of the fracture surface of a typical failed actuating lever. Multiple individual cracks are evident. The fracture surface shows no signs of ductility.

It was the conclusion of the evaluation that the medical device actuating levers failed through environmental stress cracking (ESC). Failures occurred within devices at a limited number of installations because of the unique usage of a sanitizing agent that contained an incompatible silicone-based chemical. It was recommended that either the lever material be changed or that a list of compatible cleaning agents be determined.

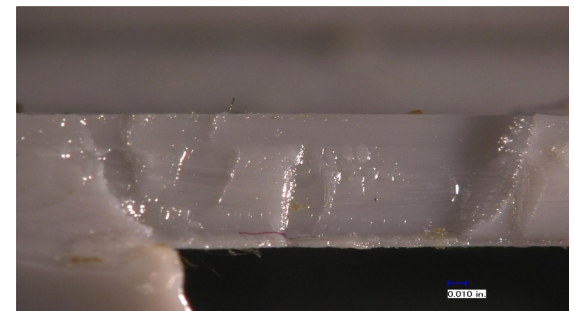
An area of crack initiation is shown. The features are characteristic of brittle fracture via a slow crack growth mechanism.

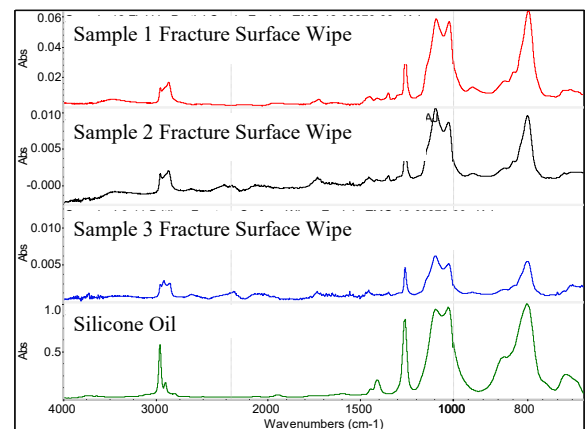
Analysis of the fracture surface revealed the presence of a silicone-based chemical. Silicones are known to act as ESC agents in conjunction with ABS resins. The source of the silicone was thought to be a minor ingredient in one of the sanitizing agents used on the medical device. Environmental stress crack testing of the ABS resin with the sanitizing agent demonstrated incompatibility, with cracking in a short time period, even under conditions of moderate

Analysis of the fracture surfaces showed a silicone-based chemical.

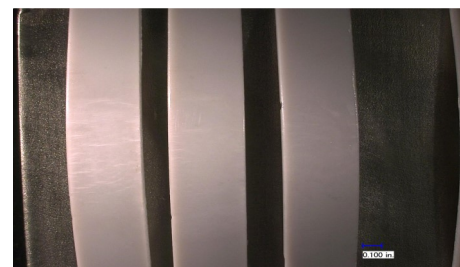
ESC testing showed cracking in the lever material when in contact with the sanitizing agent while under stress.
