Effects of Glycerin Antifreeze on CPVC

*Paul J. Gramann, Ph.D., and Javier C. Cruz, Ph.D., The Madison Group
David Grewell, Ph.D, Melissa Montablo-Lomboy, Ph.D, Tong Wang, Ph.D., Iowa State University*

Failure of a CPVC Fire Suppression System

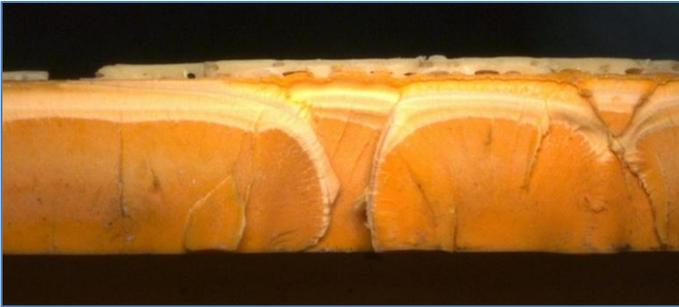
When using CPVC pipe for fire suppression systems that are susceptible to freezing, a solution of water and antifreeze must be used to ensure freezing does not take place [1]. A solution containing propylene glycol is a common option for metal piping systems. However, environmental stress cracking (ESC) [2] issues with this antifreeze have been found when used with CPVC. Figure 1 shows an example of cracking that initiated at the inside surface of a CPVC pipe that was used for a fire suppression system that contained propylene glycol. The individual cracks propagated outward from the initiation sites in a thumbnail pattern, in the process coalescing with other cracks. The CPVC fails in a brittle manner as the crack travels through the thickness, driven by the synergistic effect of the propylene glycol and stress. In this case, it is clear that the CPVC material showed high affinity to the propylene glycol allowing the solution to be locally absorbed and affect the plastic resulting in slow-crack growth and failure. For this reason, alternative antifreeze agents need to be considered for CPVC piping systems.

Figure 1 – Cracking through the thickness of a CPVC pipe that contained propylene glycol.

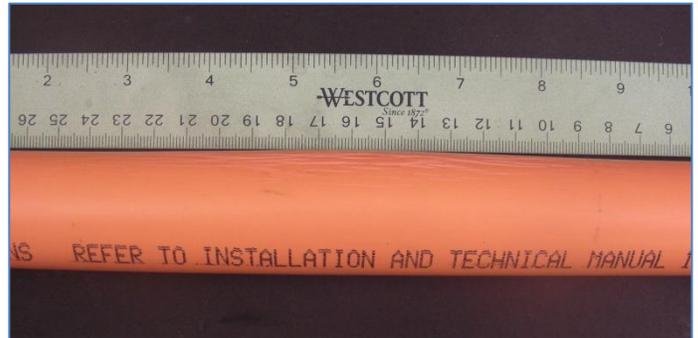
The homeowners described the leaking pipes as having striated areas of softness with regions of bulging and sagging between supports. Figure 4 shows a bulged section of pipe. Figure 5 shows striations in one of the failed pipes. The striations were evident as a lighter orange color that ran axially along the pipe. The striations were much softer than the non-striated regions of the pipe to the degree that one could press a fingernail into CPVC in these regions. During inspection of the piping system in an attic area, significant sagging of a pipe between supports was observed, see Figure 6. The pipe, which should have had maximum sag of less than 1 inch, was found to be sagging over four inches. The sagging is an indication of softening and creep of the pipe under the force of gravity.

Figure 4 – Bulging of a failed CPVC pipe exposed to a mixture of water and bio-glycerin.

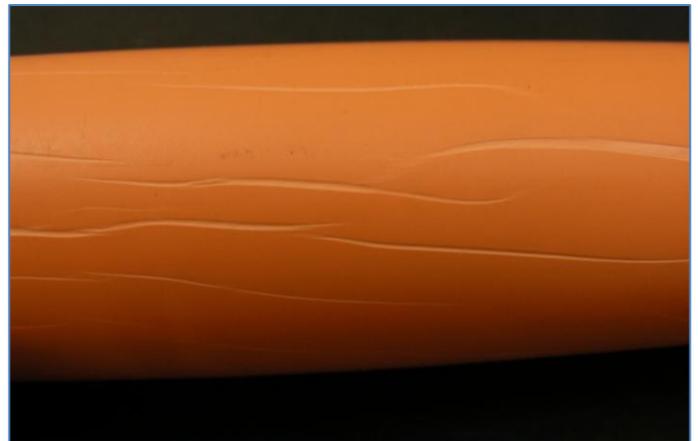
Figure 5 – Axial striations on the outside a failed CPVC pipe exposed to a mixture of water and bio-glycerin.

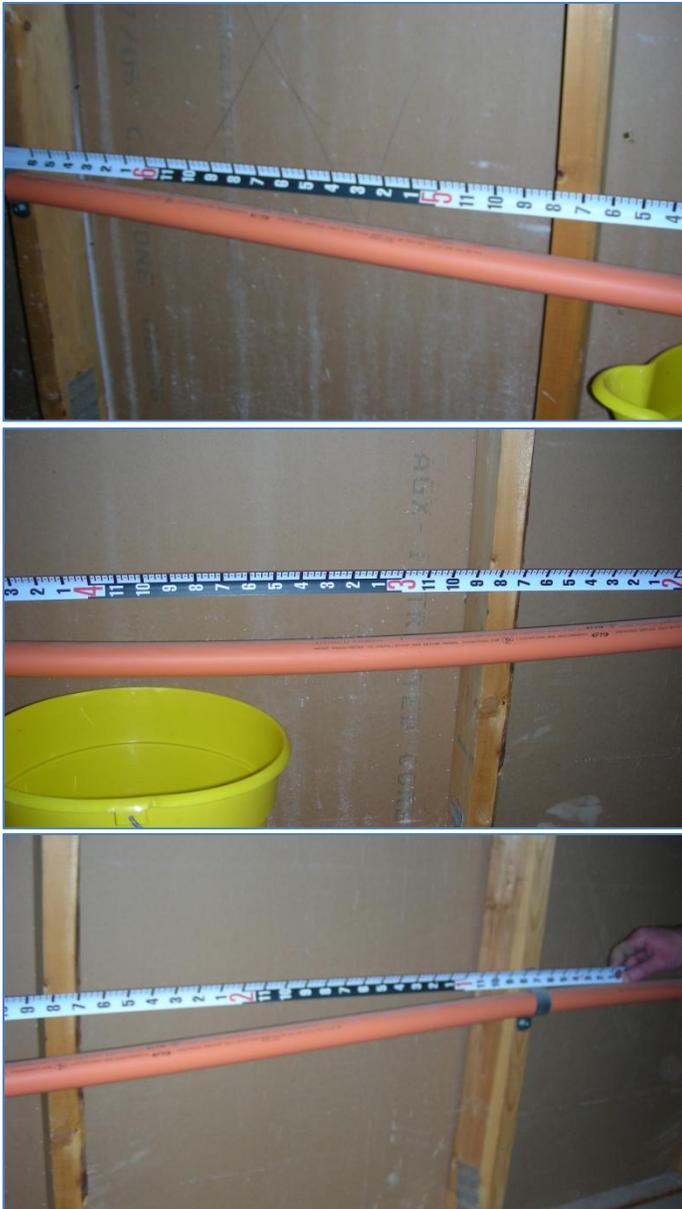
Figure 6 – Sagging of an installed CPVC pipe exposed to a mixture of water and bio-glycerin.

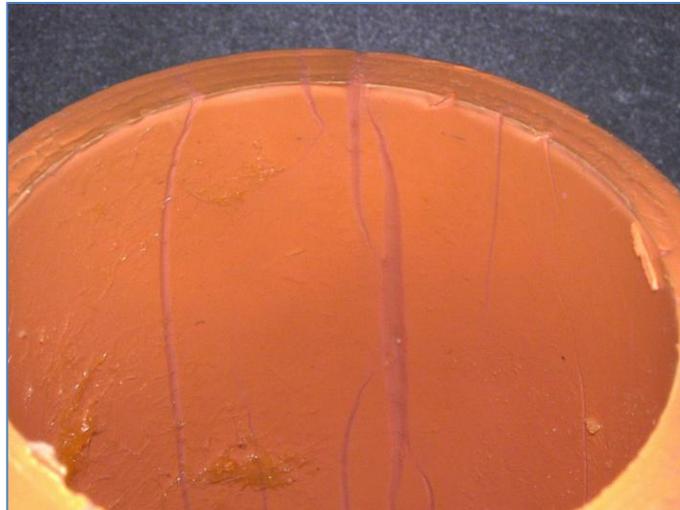
One of the failed pipes was cross-sectioned through a region that contained striations. Figure 7 shows the striations at the inside of the pipe and Figure 8 shows the striations through the cross-section. It was clear from Figure 8 that the striations had originated at the inner surface of the pipe and propagated outward. That is to say, there are limited evidence of striations on the outer wall while there are numerous striations on the inner wall.

Figure 7 – Striations evident at the inside of a failed CPVC pipe exposed to a mixture of water and bio-glycerin.

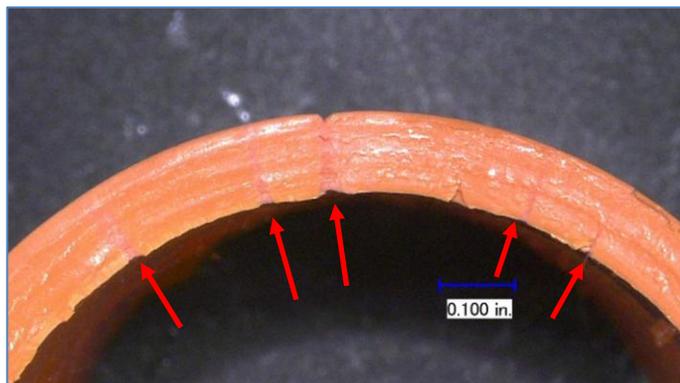
Figure 8 – Striations initiating at the inner diameter of the CPVC pipe exposed to a mixture of water and bio-glycerin.

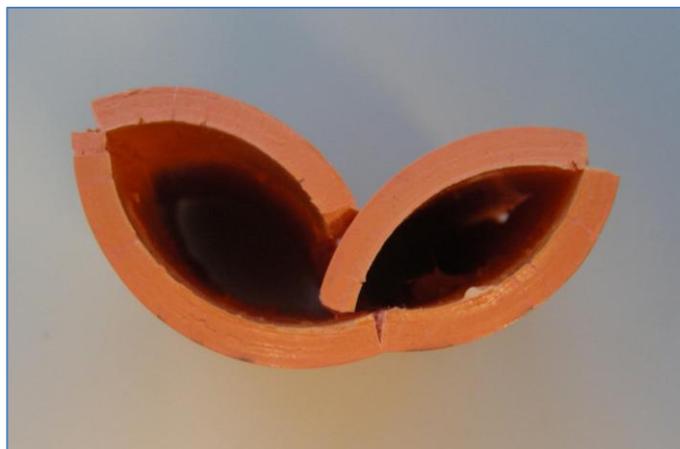
Two-inch sections were removed from failed pipes to perform flattening tests following ASTM D 442 [10], Section 8.6 to determine if the pipe had been structurally compromised. In this test, the pipe is flattened to 40% of its original diameter over a specified time period. During and after the test, the section was examined for any cracks at the outside and inside surfaces. As defined by the standard, the section passes the test if no cracking is observed. In this case, all sections that were tested cracked catastrophically at four locations approximately 90 degrees apart, see Figure 9. One of the cracks was opened and examined using a Keyence digital microscope, see Figure 10. The fracture surface showed a smooth surface immediately adjacent to the inner diameter of the pipe. The majority of the fracture surface appeared to be softened with long ductile flaps. The CPVC at the fracture was soft and material was easily displaced. It was clear that the material had been solvated, which reduced the mechanical properties of the pipe.

Figure 9 – Result of flattening test [8] of a CPVC section that was exposed to a mixture of water and bio-glycerin.

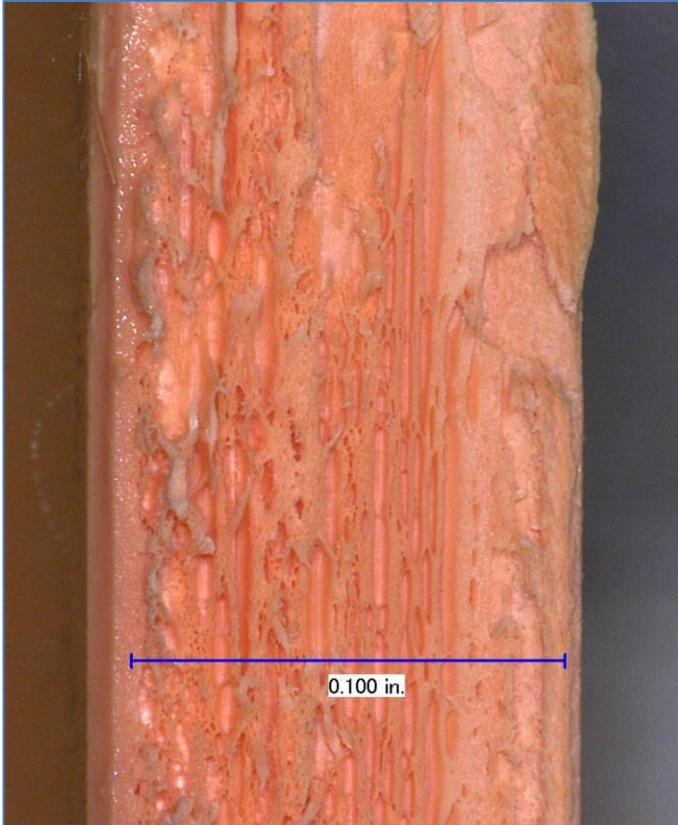
Figure 10 – A fracture surface of the pipe section shown in Figure 9.

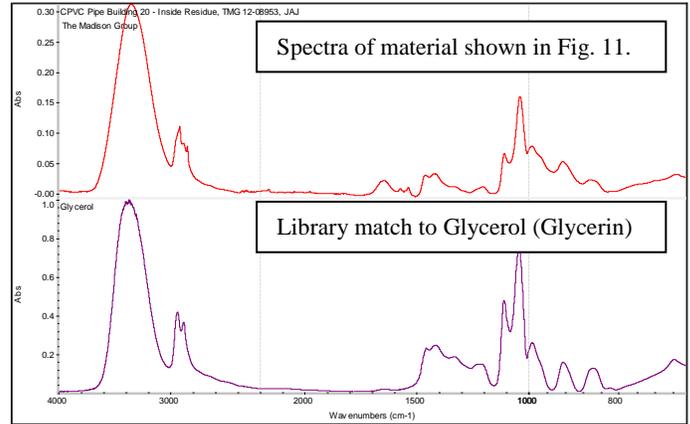
It was seen that a significant foreign mass was present at the inner surfaces of some of the pipes examined, see Figure 11. This material was greenish and had the consistency of petroleum jelly. This material was foreign to the system and could pose a problem by clogging the sprinkler head in the event of a fire. The chemical structure of this material was examined using FTIR in attenuated total reflectance (ATR) mode. A small amount of the substance was placed on the ATR unit giving the spectra shown in Figure 12. The closest library match for this material was glycerol, or glycerin (also presented

in Figure 12). Furthermore, ester functionality was observed in the spectra at approximately 1700 cm^{-1} . It should be noted that the library match shown is for pure glycerin.

Figure 12 – FTIR spectra of material shown in Figure 11.

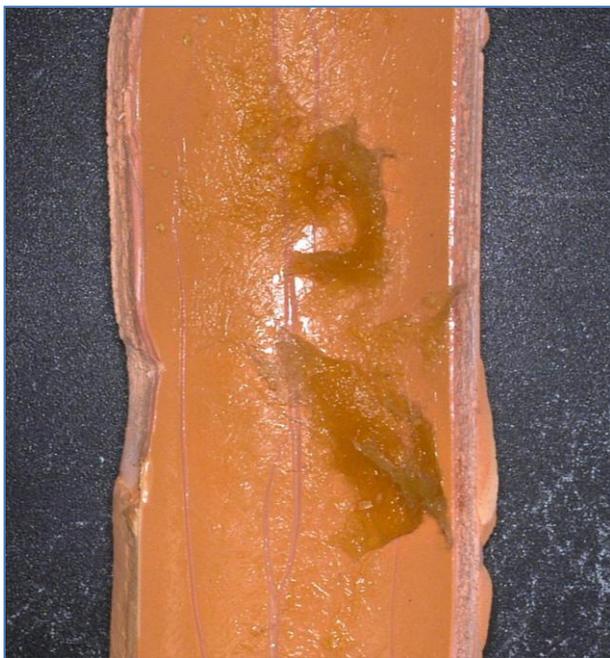
Figure 11 – Material observed at inner surface of failed CPVC pipe exposed to a mixture of water and bio-glycerin.
