Identifying Failures and Ensuring Quality of Plastic Materials

Increasing the confidence in the plastic parts designers and manufacturers depend on.

by **jeff jansen**
and **mike garry**

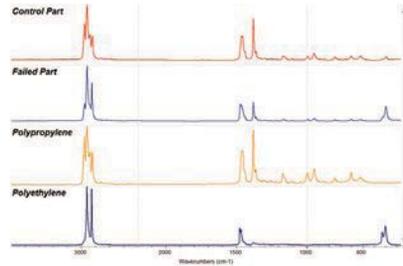
The parts are injection molded from polypropylene copolymer resin. Known good control parts from previous production runs were available for comparison. A quick infrared scan of the failed and control parts using the diamond ATR yielded the top two spectra in **Figure 3**. Observation of these spectra compared to the reference spectra of polypropylene and polyethylene at the bottom of the figure confirms that both the failed and control parts are copolymers of these two materials.

Figure 3: Spectra of control and failed parts along with reference spectra of pure polyethylene and polypropylene. Source: Thermo Fisher

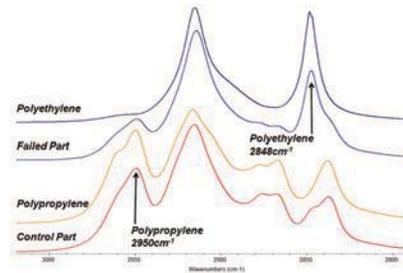
However, closer examination of the expanded hydrocarbon stretching region of the failed and control parts tells a more complete story as shown in **Figure 4**. The spectra reveal that the ratio of the polyethylene to polypropylene in the failed part is significantly higher than in the control part. The higher relative amount of polyethylene created a part that was not as stiff as intended, making it more prone to deformation and cracking under long-term stress. This situation could have been prevented using a quality control verification of the incoming polymer beads prior to molding. FT-IR

Figure 4: Expanded hydrocarbon stretching showing stronger polyethylene characteristics in the failed part. Source: Thermo Fisher

using a diamond ATR provides a rapid and simple method for performing copolymer blend ratio analysis on polymer beads and plastic parts. The cost of the failure, in terms of resolution and potential product recalls could easily offset the investment in running this routine QC test.

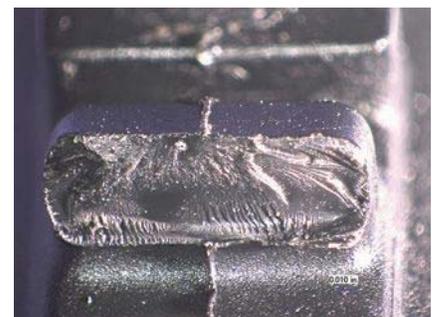
Microscopic examination of the valve fracture surfaces showed generally similar features, characteristic of brittle fracture, across all of the failed parts. The failures

exhibited crack initiation at an inclusion present within the molded retention arm, as illustrated in **Figure 5**.

The valve samples were directly analyzed using FT-IR with a diamond ATR. Analysis of a sample of the base material produced a spectrum characteristic of thermoplastic polyester, such as PBT. The fracture surface inclusion was excised and subsequently analyzed via FTIR. A direct comparison of the results with those obtained on the base material showed the presence of additional absorption bands, as illustrated in **Figure 6**. A spectral subtraction was performed removing the bands associated with the PBT base material. The resulting spectrum exhibited absorption bands characteristic of poly (phenylene sulfide) (PPS), as shown in **Figure 7**. PPS has a melting temperature approximately 285 °C, and as such, consistent with its presence as a non-dispersed particle within the significantly lower melting PBT resin. The presence of the included contaminant acted as a point of severe stress concentration, focusing and multiplying the stress applied through the snap installation.

Figure 5: The fracture surface is shown with crack initiation at an inclusion. Source: Thermo Fisher

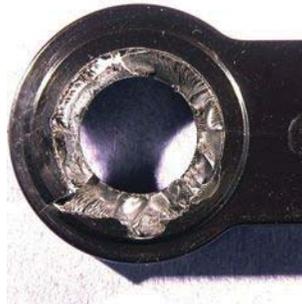
The brackets were examined microscopically, identifying catastrophic transverse cracking at the base of the cylindrical boss, consistent with tensile or bending stresses. Inspection of the fracture surfaces presented characteristics of brittle fracture, with multiple apparent crack origins along the inner diameter of the boss wall, as illustrated in **Figure 8**. The observed features were indicative of a slow crack initiation and growth mechanism, transitioning into more rapid crack extension. Overall, the observed features were indicative of environmental stress cracking (ESC), a failure mechanism whereby a plastic material cracks due to the contact with an incompatible chemical agent while under tensile stress. Several of the cracks exhibited a liquid residue emanating from the fractures.

Melt flow rate testing was used in the investigation to determine that the part material had undergone substantial molecular degradation associated with the injection molding process. This degradation rendered the parts susceptible to premature failure and environmental stress cracking.

Figure 8: The failed bracket fracture surfaces exhibited features characteristic of environmental stress cracking (ESC). Source: Thermo Fisher

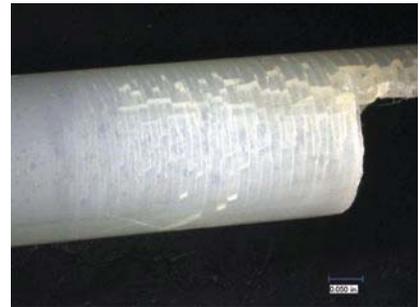
The tubing was examined and found to exhibit a single through-crack and multiple partial cracks oriented transversely. The cracks, shown in **Figure 11**, exhibited features characteristic of brittle fracture, and indicated crack initiation along the inner diameter wall of the tubing. Some discoloration was also present localized to the area of cracking. The observed features were indicative of a slow crack growth mechanism associated with localized bending loads and the internal pressure within the system.

were characteristic of a polyethylene resin. Analysis of the inner diameter surface adjacent to the primary through-crack also produced results characteristic of polyethylene. However, additional absorption bands indicative of carbonyl functionality were also present. Specifically distinct bands at 1715 cm^{-1} and 1740 cm^{-1} were present associated with carboxylic acids and esters. These results are presented in **Figure 12**. Such materials are commonly formed as by-products of oxidation of polyolefin resins, such as polyethylene. Polyethylene can undergo oxidation through contact with chlorinated municipal water. The molecular degradation caused by the oxidation resulted in a marked reduction in mechanical integrity of the tubing material, and together with the nominal internal pressure, produced cracking within the tubing.

Figure 11: The tubing showed a series of parallel transverse cracks with brittle fracture features. Source: Thermo Fisher
