FRACTOGRAPHIC CHARACTERIZATION OF PIPE AND TUBING FAILURES

Jeffrey A. Jansen, The Madison Group
Thomas G. Loken, The Madison Group

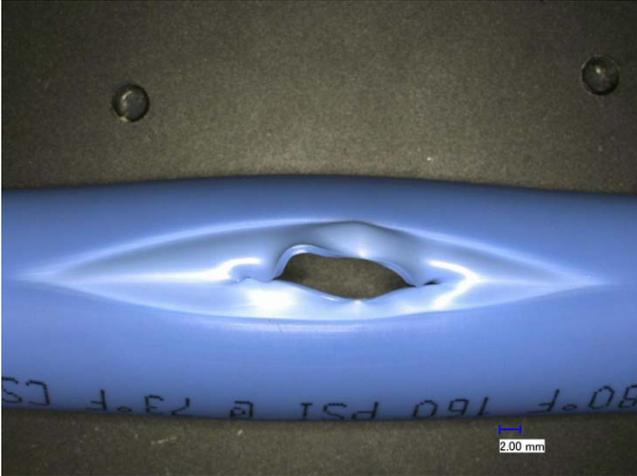
An examination of the specimen showed a single longitudinal crack on the pipe sample. Significant macroductility in the form of stress whitening and permanent deformation, as illustrated in Figure 4, was evident. While the level of apparent ductility was significant, measurements showed that the level of elongation was well below the elongation at break expected from a standard tensile test. The reduction in elongation is the result of the rapid overload mechanism. Examination of the fracture surface showed that the crack initiated at an included

Fig. 4 - Photomicrograph showing the deformation on the PEX pipe sample.

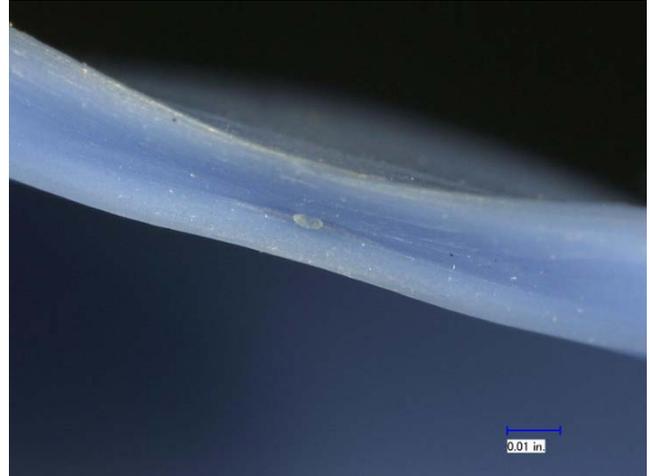
discontinuity, likely present as a gel particle. The morphology at the crack origin was relatively smooth, as presented in Figure 5. Fracture surface locations remote to the origin also showed smooth surface features, as represented in Figure 6. The lack of apparent microductility is further evidence of the brittle fracture mechanism.

Fig. 5 - Photomicrograph showing the crack origin at a discontinuity.

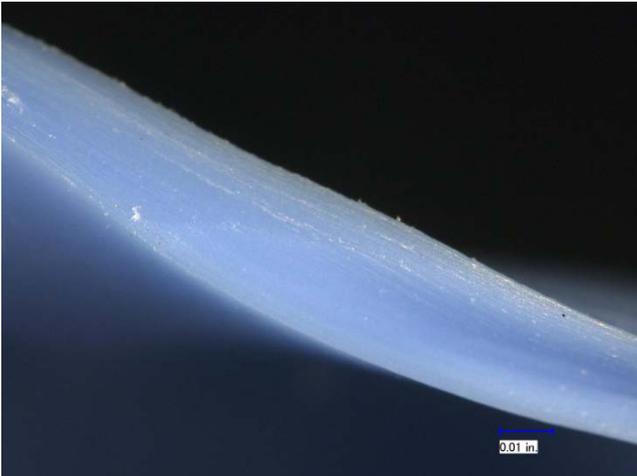
Fig. 6 - Photomicrograph showing a typical area on the fracture surface remote to the origin.

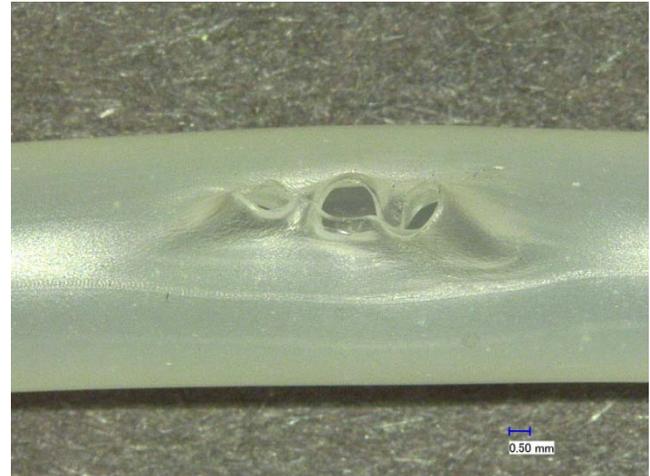
Inspection of the failed tubing samples showed longitudinal cracking, which exhibited a significant level of macroductility, as illustrated in Figure 7. The overall appearance of the cracking was generally similar to that produced within the PEX pipes. Further examination of the fracture surface revealed a lack of microductility, showing an absence of stretch flaps or fibrils. A typical surface of the fracture is included in Figure 8.

Fig. 7 - Photomicrograph showing the PE tubing deformation.

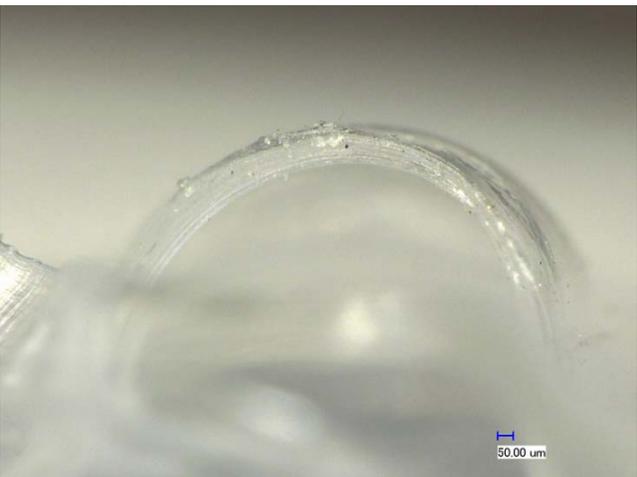
Fig. 8 - Photomicrograph showing a typical area on the PE tubing fracture surface.

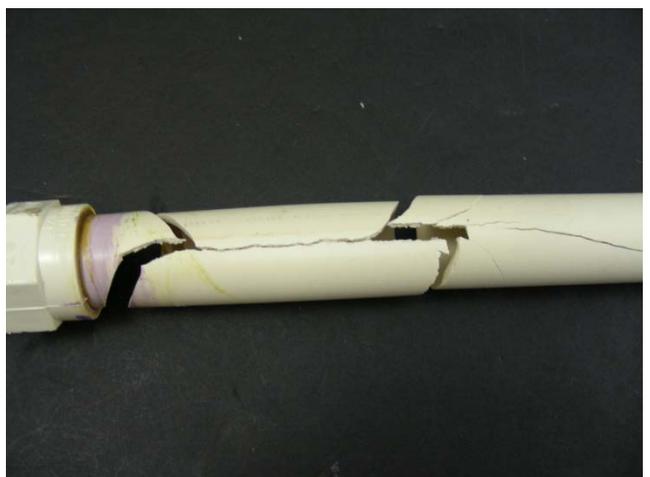
Examination of a failed test specimen showed multiple cracks and a significant crack bifurcation pattern, as illustrated in Figure 9. The cracking was generally oriented

longitudinally. This fracture pattern is consistent with rapid crack propagation and indicated that the fracture was traveling rapidly in order to dissipate a significant level of energy. Multiple apparent crack origins were noted within the straight sections of the crack, with subsequent extension resulting in bifurcation. No signs of macro-ductility were apparent, with the features being characteristic of brittle fracture.

Fig. 9 - Close-up view showing the crack pattern on the CPVC pipe.

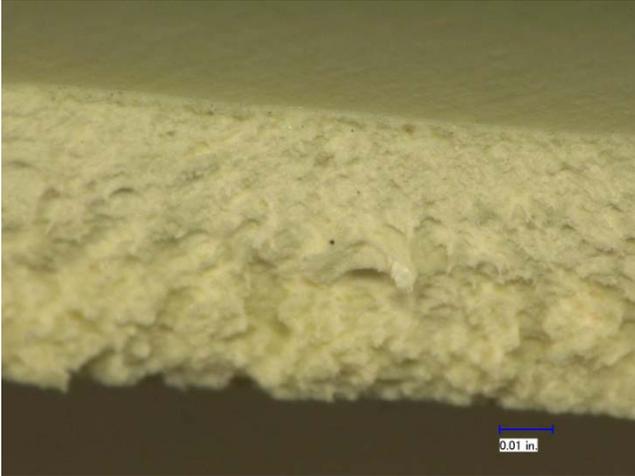
Crack origins were observed along the fracture surface at both the inner diameter and outer diameter walls, with a typical origin area shown in Figure 10. The morphology within the origin area was coarse and generally consistent with a moderate level of micro-ductility for CPVC. Conversely, areas remote to the crack origins displayed a relatively smooth morphology showing sharp, distinct crack directionality features. These features, as presented in Figure 11, are consistent with brittle cracking.

Fig. 10 - Photomicrograph showing an apparent crack origin on the CPVC fracture surface.

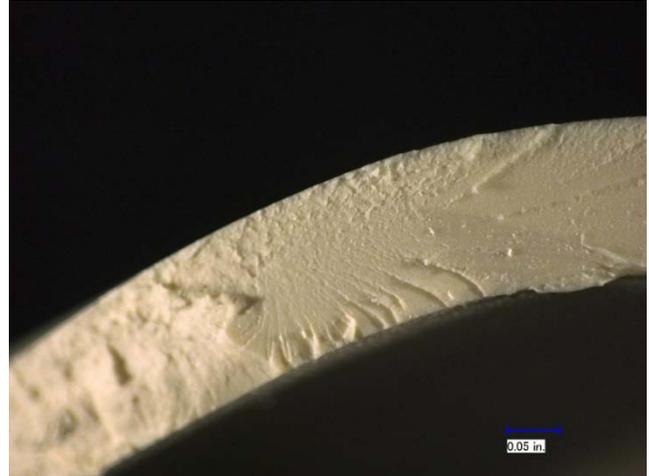
Fig. 11 - Photomicrograph showing an area remote to crack origins on the CPVC pipe.

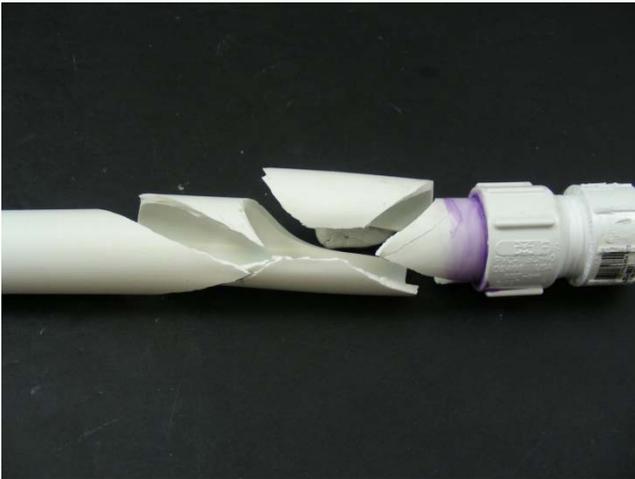
An examination of the failed test specimen showed an overall appearance that closely matched that of the CPVC specimen, as illustrated in Figure 12. The specimen exhibited multiple cracks and a distinct and widespread crack bifurcation pattern. The cracking was oriented longitudinally and the pattern was characteristic of rapid crack propagation. Similar to the features on the CPVC pipe, the pattern indicated that the fracture was traveling rapidly in an attempt to dissipate a significant level of energy. Multiple crack origins were found within the straight sections of the crack, with subsequent extension resulting in bifurcation. No signs of macro-ductility were apparent, with the features being characteristic of brittle fracture.

Fig. 12 - Close-up view showing the crack pattern on the PVC pipe.

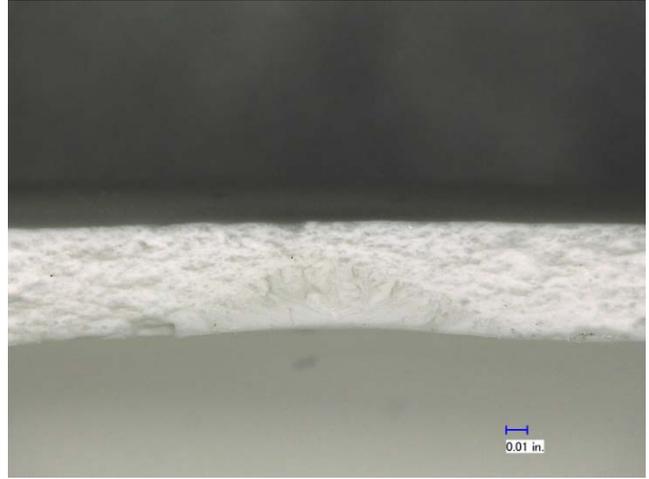
Multiple crack origins were observed along the PVC fracture surface. The crack origins were present at both the inner diameter and outer diameter walls, and a typical origin area is shown in Figure 13. The morphology within the origin area was generally coarse, indicative of a moderate level of micro-ductility for PVC. The morphology at locations remote to the crack origins displayed a contrasting smooth morphology, which included sharp and distinct

Fig. 13 - Photomicrograph showing an apparent crack origin on the PVC fracture surface.

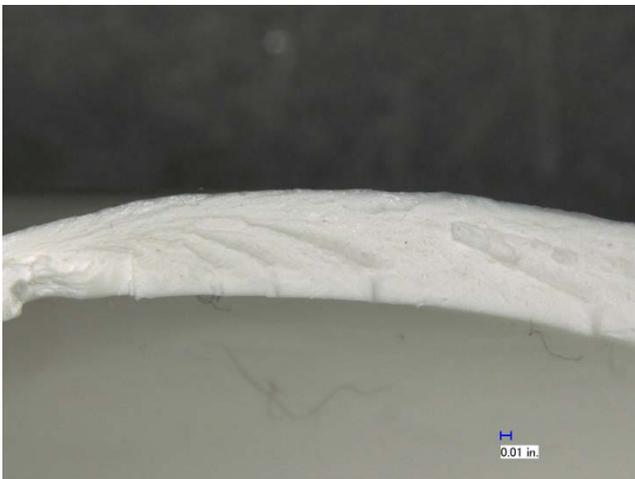
crack directionality features. These features, as represented in Figure 13, were consistent with brittle cracking.

Fig. 14 - Photomicrograph showing the fracture surface remote to crack origins on the PVC fracture surface.
