Environmental Stress Cracking – THE PLASTIC KILLER

Jeffrey A. Jansen
Stork Technimet
New Berlin, Wisconsin

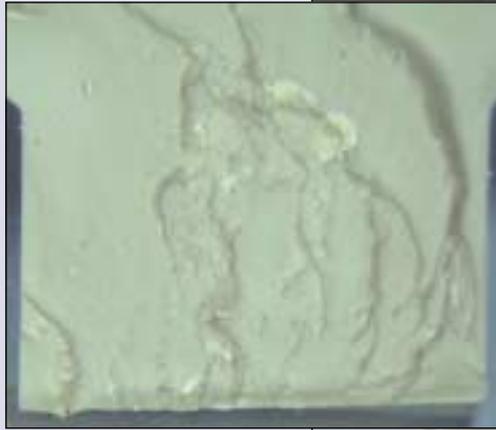
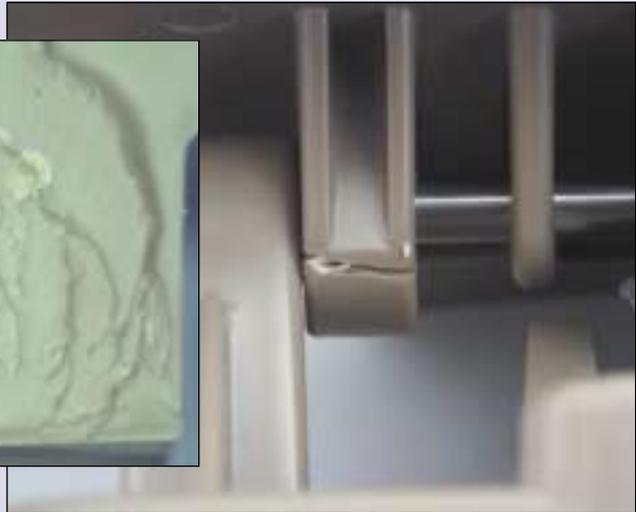
A visual inspection of the failed parts showed significant cracking, consistent across all of the failed parts. The cracks were present within the molded boss that secured the roll pin, and had a shape that was irregular but continuous. Upon disassembly of the units, additional non-catastrophic cracks were apparent within similar locations around the boss hole. **The fracture surface displayed features characteristic of brittle fracture, with many crack origins adjacent to the inner diameter surface.** A typical crack is shown in Fig. 3. An oily residue was readily apparent on and adjacent to the fracture surface.

Fig. 3—Photomicrographs show the crack location within the hinge and the fracture surface.

The oil residue found on the inner diameter surfaces of the failed handles was analyzed by FTIR and the results were characteristic of a hydrocarbon-based oil containing an ester-based additive. The oil present within the formed roll pins was also analyzed, and a direct spectral comparison yielded an excellent match with the results obtained on the part residue. Spectral library searching produced good matches with commercial fluids for metal processing.

The investigators concluded that the enclosure handles failed via ESC. The chemical agent responsible for the failure was identified as the fluid used in the forming and processing of the metal roll pin, a hydrocarbon-based oil containing an organic ester additive. This material had not been properly cleaned from the roll pin, and chemicals of this type are known to produce ESC in ABS resins and corresponding blends. The stress appeared to come from the interference fit between the roll pin and the handle boss.

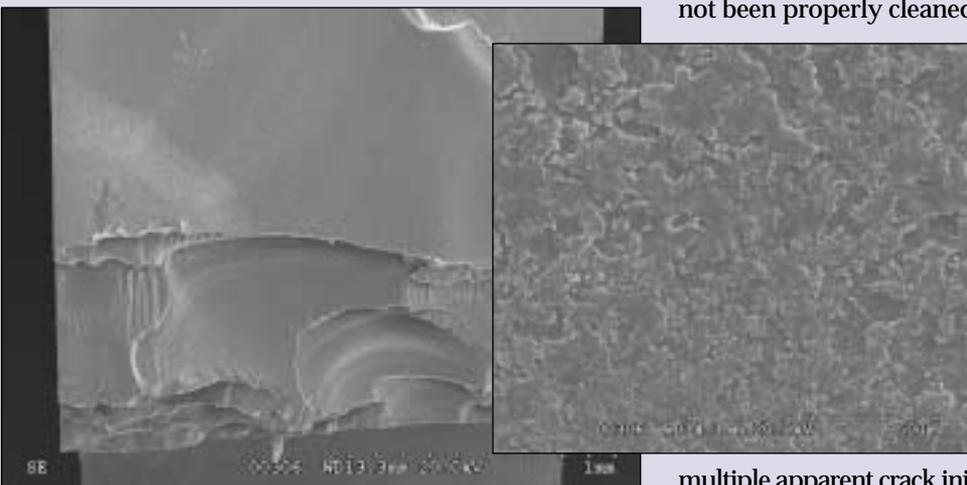
Typical fracture surfaces were further examined via scanning electron microscopy (SEM). The SEM inspection of the fracture surface confirmed the presence of multiple apparent crack origins along the inner diameter of the molded boss in an area that had been in direct contact with the roll pin. Locations within the crack origins showed evidence of craze remnants, as shown in Fig. 4. This suggested the formation of micro-crazes as part of the crack initiation. Locations adjacent to the apparent crack origins revealed features indicative of brittle fracture, and secondary cracking was also apparent. Examination of the final fracture zone showed continued evidence of brittle fracture, as indicated by the presence of hackle marks.

The failure mode was identified as ESC by the characteristic features observed during the visual, microscopic, and SEM examinations. These included the irregular but continuous crack formation, the presence of

multiple apparent crack initiation sites, the generally brittle fracture features, and micro-craze remnants within the crack origin location.

Fig. 4—Scanning electron images show a typical hinge fracture surface. The failure mode was identified as ESC.

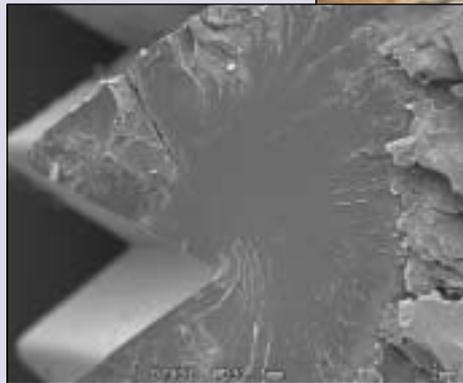
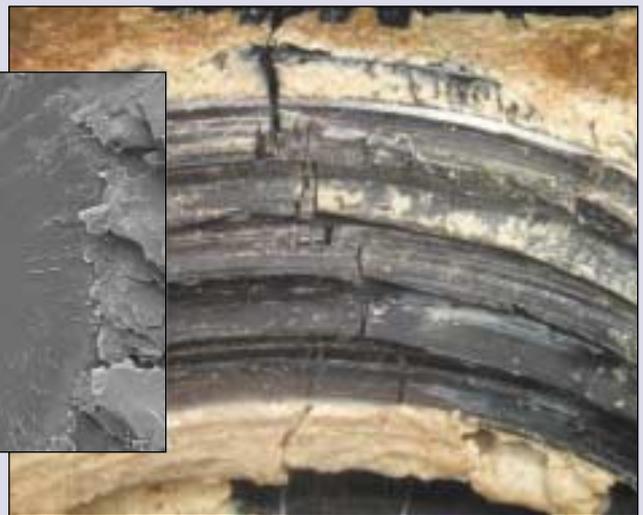
Visual examination of the failed housings confirmed a high concentration of cracks on each of the parts. The observed fractures extended longitudinally down the housing, predominantly through the threaded region along the inner diameter, as shown in Fig. 5.

The cracks were generally oriented in a parallel pattern, and several cracks had progressed through the entire housing wall to the outer diameter. The macro features, especially the high concentration of parallel cracks, were characteristic of ESC failure. The housings were covered with dirt and debris from the agricultural application, as well as a soft, gummy material with the consistency of putty.

Microscopic examination of the fracture surfaces revealed multiple individual crack origins, with the apparent initiation sites located within the thread roots. The fracture surfaces presented a relatively coarse texture, with the overall appearance consistent with brittle fracture, in contrast to the normally ductile behavior exhibited by ABS resins.

Fig. 5—Images illustrate the cracking in the sprinkler housings.

It was the conclusion of the investigation that the sprinkler housings failed via brittle fracture associated with ESC. The tensile stresses driving the cracking originated from the interference between the housing threads and the mating metal plumbing fixture. These stresses were likely severely concentrated by the relatively small radius at the thread root. The requisite chemical agent responsible for the failure was identified as an ester-based oil with a commercial pipe dope sealant. Ester-based oils are known to produce ESC failure within ABS resins, and pipe dope sealants have been widely recognized as deleterious to ABS pipe and fittings.

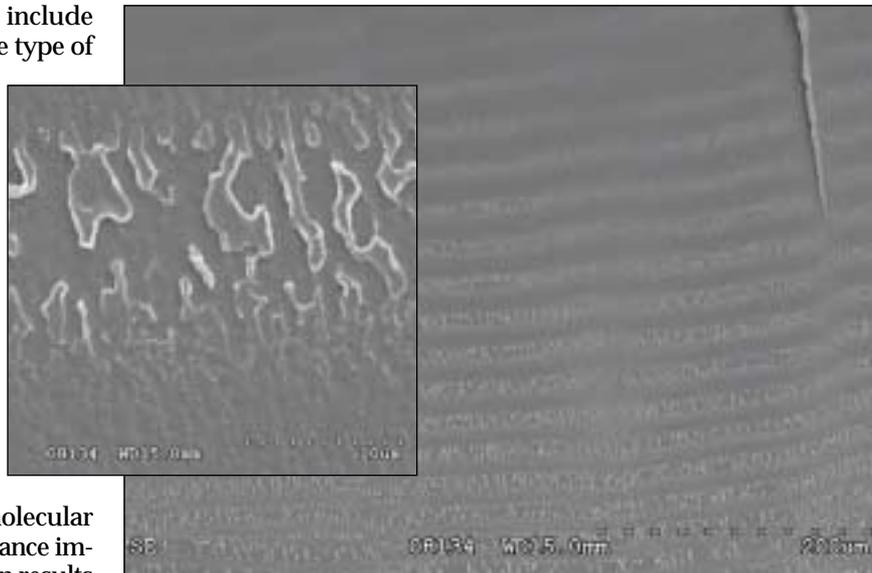
- *Alternating bands:* Recent experimentation has shown that ESC commonly develops by a progressive crack-extension mechanism. Examination of fracture surfaces created under laboratory conditions reveals a series of alternating bands corresponding to crack extension cycles, as illustrated in Fig. 1. The observed bands are thought to represent repeated cycles of crazing, followed by crack extension via brittle fracture, consistent with the steps involved in creep and ESC failure mechanisms. This is illustrated in the diagram shown in Fig. 2.

Fig. 1 –Scanning electron images show the progressive nature of ESC failure within a polycarbonate laboratory fracture.
