Keywords - Failure, Creep, FEA, Design Evaluation

A plastic rain barrel was cracking at the bottom of a stiffening rib after approximately two weeks in service, which resulted in leakage of water. The rain barrel was injection molded from a high-density polyethylene material.

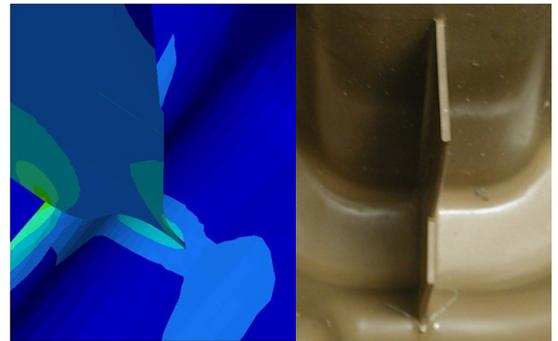
A visual examination of the failure revealed a smooth fracture surface that initiated at the base of the rib. The fracture surface was characteristic of a brittle fracture mechanism known as creep. Creep is a material response mechanism, commonly experienced by plastics and composites, in which the molecules of the plastic separate under the influence of a constant stress that is below the yield stress of the material.

The failure location coincided with a high-stress area.

It was the conclusion of the evaluation that the rain barrel failed through a brittle fracture mechanism known as creep. The combination of the rain barrel design and material selected resulted in a stress level that left the rain barrel susceptible to premature failure when filled with water. It was recommended that either the design of the rain barrel be modified or the plastic should be changed to a more creep resistant material.

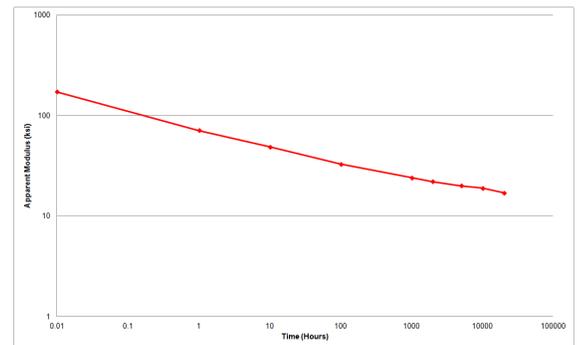
The design integrity of the rain barrel was evaluated by performing a series of material tests and structural finite element analysis (FEA). The material testing used dynamic mechanical analysis (DMA) to characterize the long-term mechanical properties of the resin while under load. The FEA was used to determine the stress distribution in the rain barrel when the barrel was filled with water. The FEA confirmed the area of high stress coincided with the failure location, and the stress remained below the yield point of the plastic material. Combining the results of the material testing and the FEA allowed for a prediction to be made regarding the amount of time until the rain barrel would fail. With the stress levels predicted in the FEA, the rain barrel was predicted to fail after approximately two weeks of service.

Material testing provided a prediction of material response over time.

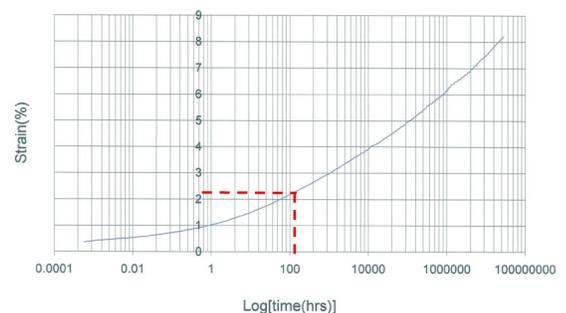
Failure was predicted to occur after two weeks of service.
