From the TMG Solutions Archives:

Rain Barrel Analysis

Keywords - Failure, Creep, FEA, Design Evaluation

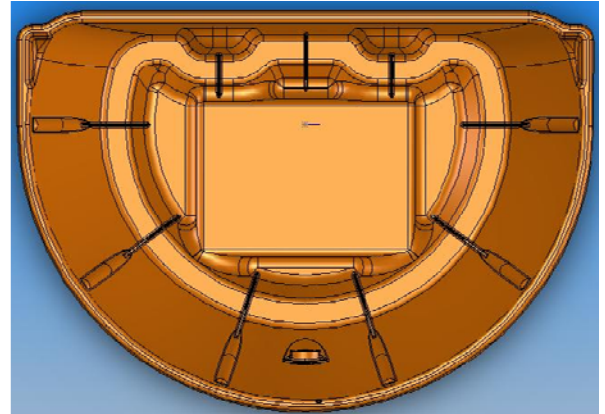
Top view of rain barrel design.

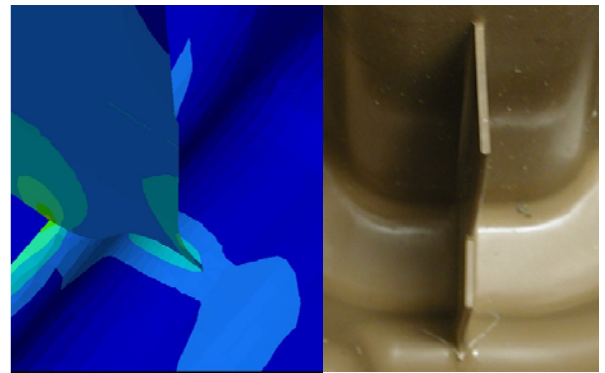
A visual examination of the failure revealed a smooth fracture surface that initiated at the base of the rib. The fracture surface was characteristic of a brittle fracture mechanism known as creep. Creep is a material response mechanism, commonly experienced by plastics and composites, in which the molecules of the plastic separate under the influence of a constant stress that is below the yield stress of the material.

The failure location coincided with high stress area.

It was the conclusion of the evaluation that the rain barrel failed through a brittle fracture mechanism known as creep. The combination of the rain barrel design and material selected resulted in a stress level that left the rain barrel susceptible to premature failure when filled with water. It was recommended that either the design of the rain barrel be modified or the plastic should be changed to a more creep resistant material.

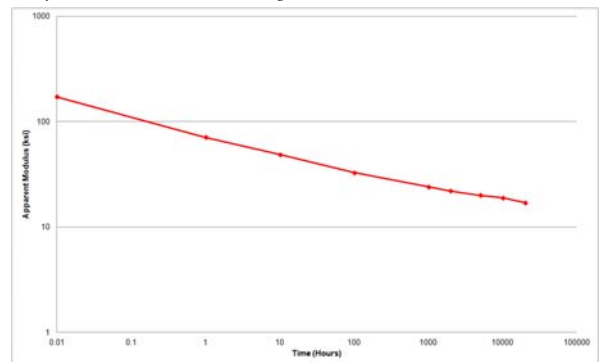
The design integrity of the rain barrel was evaluated by performing a series of material tests and structural finite element analysis (FEA). The material testing used dynamic mechanical analysis (DMA) to characterize the long-term mechanical properties of the resin while under load. The FEA was used to determine the stress distribution in the rain barrel when the barrel was filled with water. The FEA confirmed the area of high stress coincided with the failure location, and the stress remained below the yield point of the plastic material. Combining the results of the material testing and the FEA allowed for a prediction to be made regarding the amount of time until the rain barrel would fail. With the stress levels predicted in the FEA, the rain barrel was predicted to fail after approximately two weeks of service.

Material testing provided a prediction of material response over time.

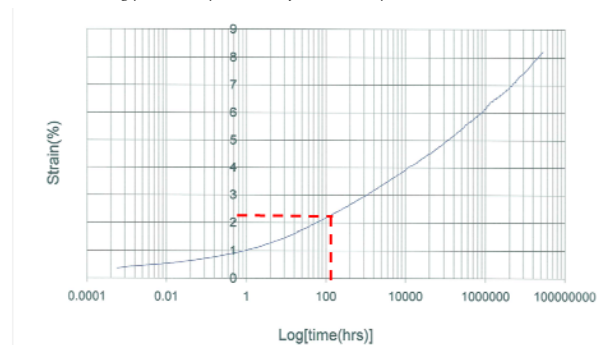
Failure was predicted to occur after two weeks of service.
