Keywords - Failure, Snap Fit, Contamination, FTIR

Problem

An injection-molded poly(acrylonitrile:butadiene:styrene) (ABS) component experienced cracking within the retaining arm during a snap fit installation with the mating part. Failure was limited to approximately 1% within a single production lot.

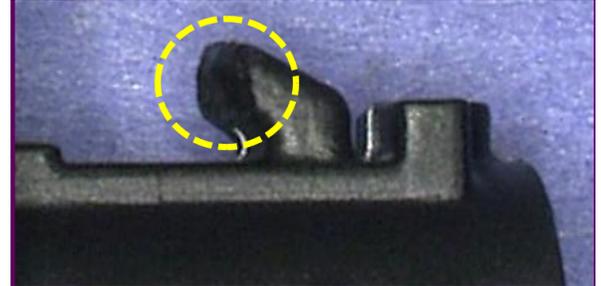
Figure 1: Cracking occurred with the retaining arm during a snap fit installation.

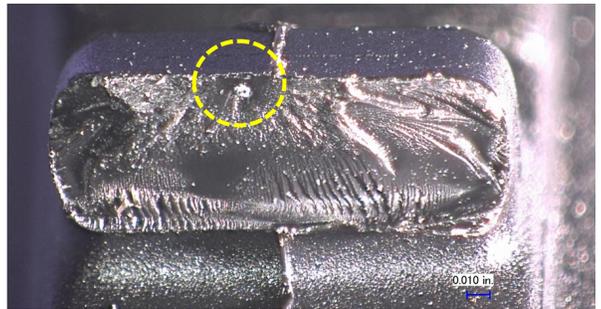
Microscopic examination of the failed parts showed consistency in regards to failure location and appearance of the fracture surface. The parts exhibited a single crack origin within the retaining arm at a location under anticipated tensile stress during the snap fit installation. The fracture presented brittle fracture features indicative of rapid crack extension through overload.

Figure 2: The fracture surface showed features associated with rapid brittle cracking, and a single crack origin.

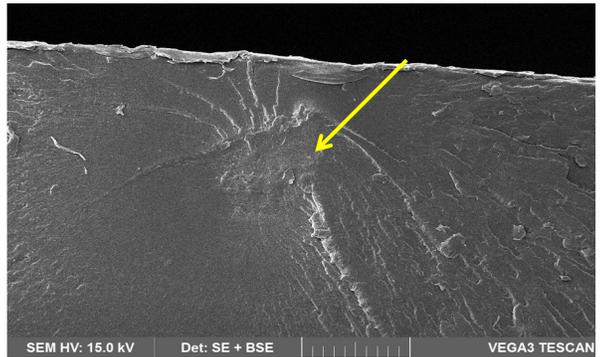
Scanning electron microscopy (SEM) revealed the presence of an inclusion at the crack origin. The inclusion was a discontinuity within the material and acted as a point of severe stress concentration. Energy dispersive X-ray spectroscopy (EDS) revealed that the inclusion had a relatively high sulfur content compared with the surrounding base resin. Further testing through Fourier transform infrared spectroscopy (FTIR) showed the inclusion to be poly(phenylene sulfur) (PPS).

Figure 3: The SEM examination showed the cracking initiated at an inclusion within the material.

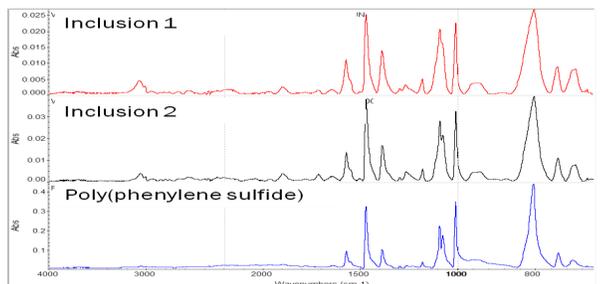
It was the conclusion of the evaluation that the retaining arm failed through overload via rapid brittle fracture. The cracking initiation at included PPS contamination that acted as a severe point of stress concentration. The material was also significantly embrittled because of molecular degradation from the molding process. Failure occurred within the compromised material when the contamination was located at the point of tensile loading associated with the snap fit installation.

Figure 4: FTIR testing showed the inclusion to be PPS in the ABS molded part.
