Using Differential Scanning Calorimetry to Determine the Quality of a PVC Part

*Paul Gramann, Javier Cruz and Brian Ralston
The Madison Group
Madison, WI 53711*

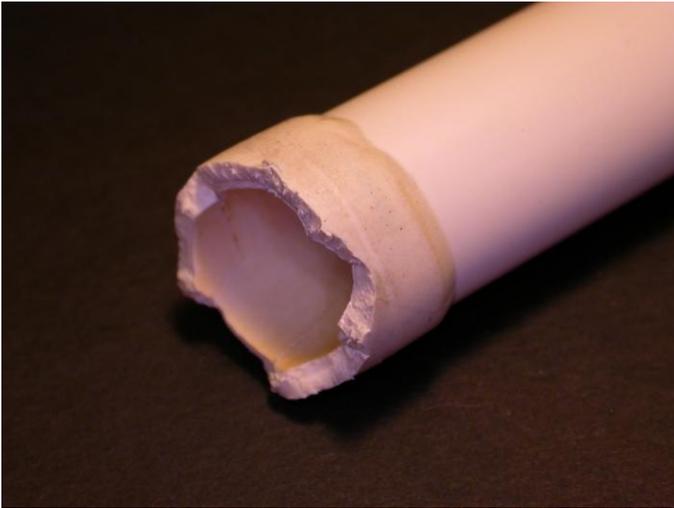
PVC is considered to have relatively good chemical resistance. However, like all plastics it can be attacked by a host of foreign chemicals. Chemicals such as ketones, aromatic and chlorinated hydrocarbons, esters and benzene can be very aggressive to a PVC part. Figure 1 shows a pipe that swelled and cracked as a result of contact with a phthalate ester. Failure as a result of installation can occur for many different reasons including: overbelling of the pipe's bell during insertion of the male, incorrect adhesive, improper joining technique, wrong climate, and inadequate support.

Figure 1 – Chemical attack of a plastic pipe.

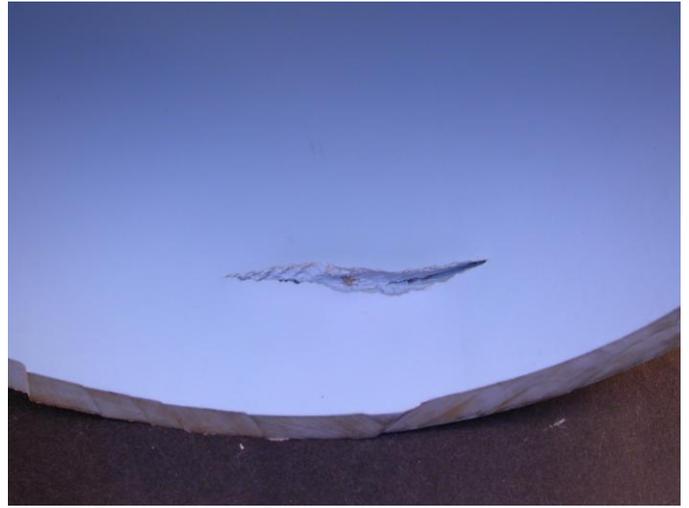
A study of a PVC pipe failure (Pipe #1), which exhibited a circumferential crack on its interior surface (Figure 2), utilized the DCM chemical test, as well as, DSC. Figure 6 shows the coupon after the DCMT. Severe lifting of the PVC is seen. According to the ISO Standard 9852[4] the PVC failed the test and is considered to be inadequately fused. A sample from the same cracked location of the pipe was analyzed using DSC. The sample was heated at a rate of 10°C/min to approximately 230°C. Figure 7 shows the DSC thermogram of this sample with gelled (Area A) and ungelled (Area B) indicated. The T_g was found to be 84.8°C and the processing temperature 177°C. The degree of gelation was calculated to be 55.9%.

Figure 2 – Circumferential crack in PVC pipe prior to installation.

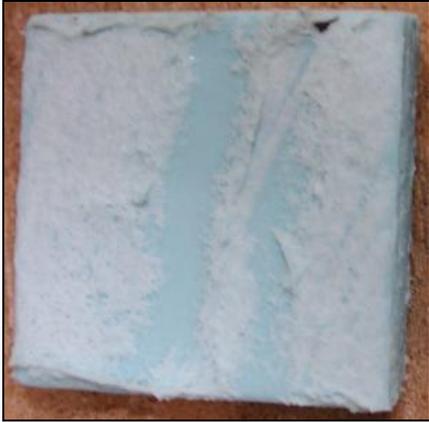
Figure 6 – PVC sample of failed Pipe #1 after immersion in dichloromethane.

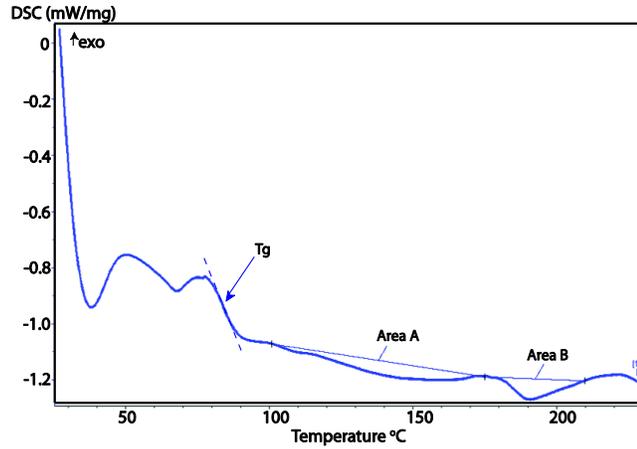
Though this is not an exhaustive study on the comparison of the DCMT and DSC methods, nor the validity of the DSC method, it does show that the cracked pipes have a lower degree of gelation than the uncracked exemplar and

Figure 7 – DSC thermogram of failed Pipe #1.

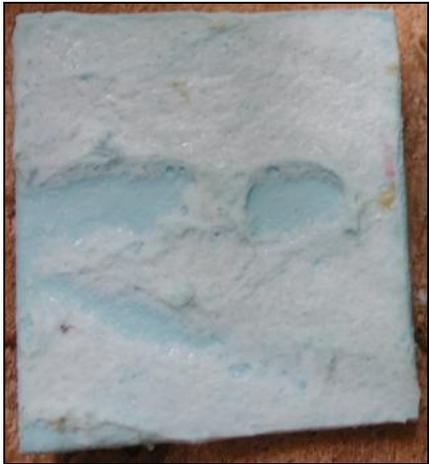
A pipe that cracked axially while in service was also examined (Pipe #2). The sample after the DCM chemical test is shown in Figure 8. Again, severe lifting is observed in this photograph. The DSC thermogram of a sample taken near the crack is shown in Figure 9. The T_g was found to be 84.7°C and the processing temperature 177°C. The degree of gelation was calculated to be 53.9%.

Figure 8 – PVC sample of failed Pipe #2 after immersion in dichloromethane.

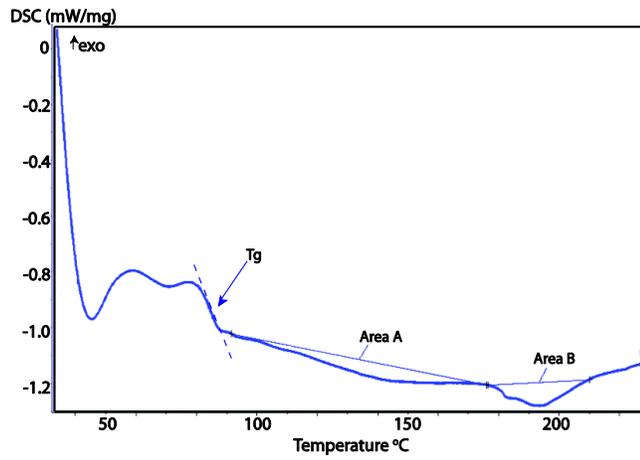
Figure 9 – DSC thermogram of failed Pipe #2.

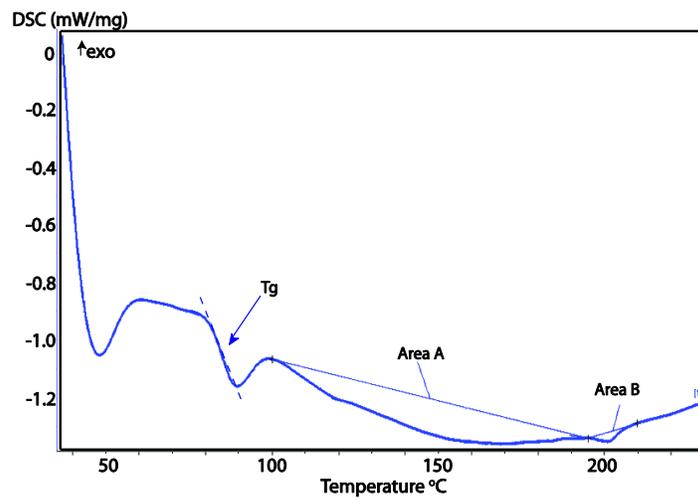
An exemplar (not cracked) PVC pipe¹ (Pipe #3) was also analyzed. No lifting of the PVC was observed during the DCM chemical test. Figure 10 shows the DSC thermogram for this pipe. The T_g was 84.9°C and the processing temperature during manufacturing of the pipe was found to be 195°C. The degree of gelation was calculated to be 97.1%.

Figure 10 – DSC thermogram of Exemplar Pipe #3.
