Keywords - Failure, Tubing, Degradation, UV

Problem

A section of tubing was submitted for evaluation as the material had failed while in service. The sample was identified as ¾ in. coiled tubing, assembled onto a water meter in an uncovered pit. Leaking from the tubing was observed after a relatively short period in service. The tubing was extruded from a poly(butylene terephthalate) (PBT) resin modified with polyether block amide.

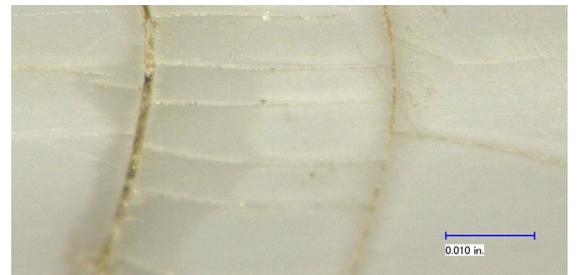
The cracking was present on the end of the tubing that had been connected to the brass fitting associated with the water meter connection. A series of transverse parallel cracks, displaying brittle fracture features, was located exclusively on the exterior surface within the inner diameter of the tubing as it was coiled. At higher magnification an intersecting crack network was apparent. Distinct discoloration was exclusively evident within the general area of cracking.

It was concluded that the tubing failed via brittle fracture through significant molecular degradation of the exterior surface of the tubing. The degradation was the result of ultraviolet (UV) radiation through exposure to sunlight. The mechanical stresses responsible for the cracking are thought to be associated with tensile loads created during bending of the tubing against the coiled direction. Significant improvement in performance could be achieved by the use of a resin with an alternate stabilizer package.

Figure 1: The failed tubing exhibited a series of parallel transverse cracks on the exterior surface within the inner diameter of the coil.
