The Benefits of a Non-Destructive Visual Analysis- Part 2 : A Case Study Jack DeSousa

The Benefits of a Non-Destructive Visual Analysis – Part 2

(This article is a continuation of the article titled “The Benefits of a Non-Destructive Visual Analysis: A Case Study” appearing in the TMG News for June 2017.)

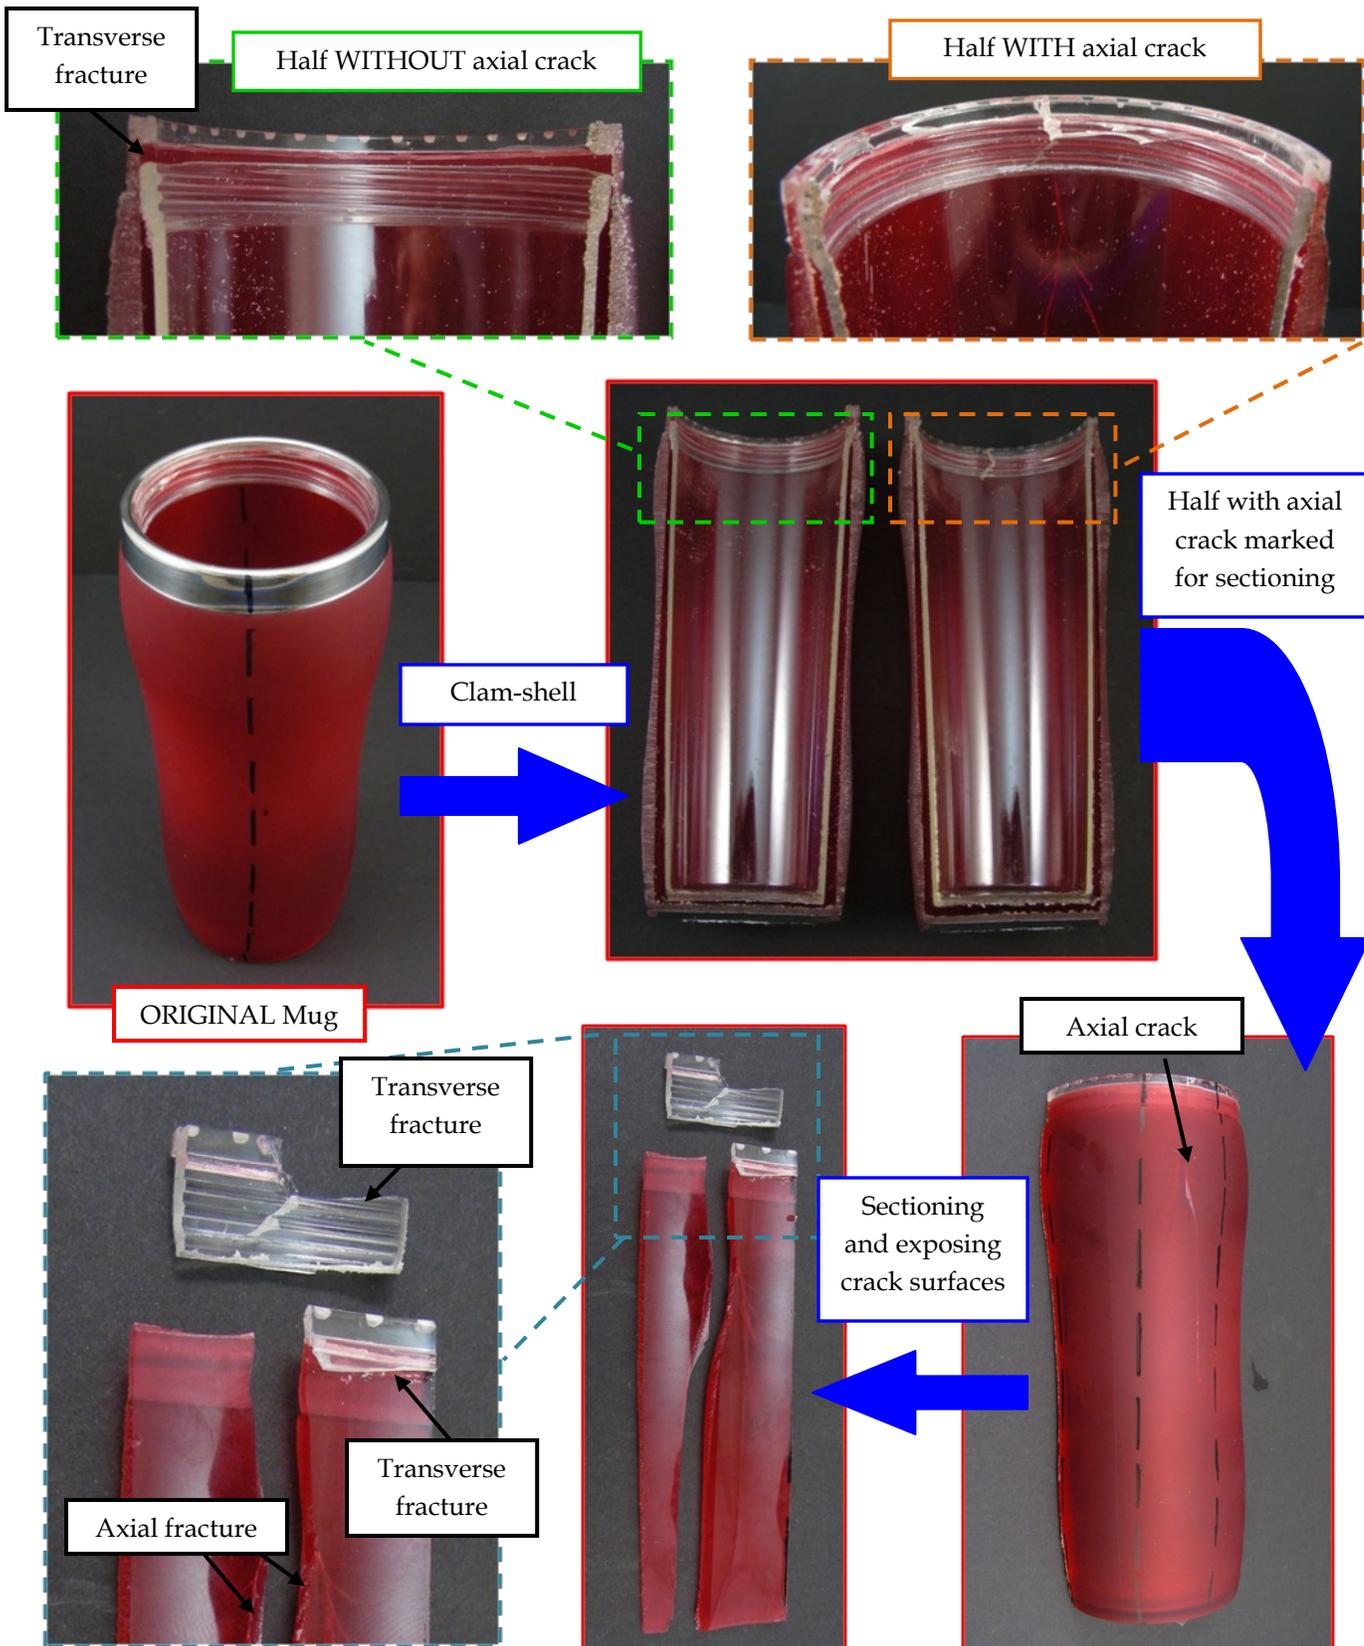
The first goal of destructive testing was to expose both of the cracks in the travel mug (a flowchart is shown in **Figure 1**. The transverse crack and axial crack surfaces were both exposed for visual, microscopic, and SEM analysis. In addition to exposing the fracture surfaces, a section of the mug with an intact weld was longitudinally cross-sectioned and potted in order to view the weld and internal geometries of the travel mug.

Figure 1 - Flowchart of the destructive sectioning for the travel mug.

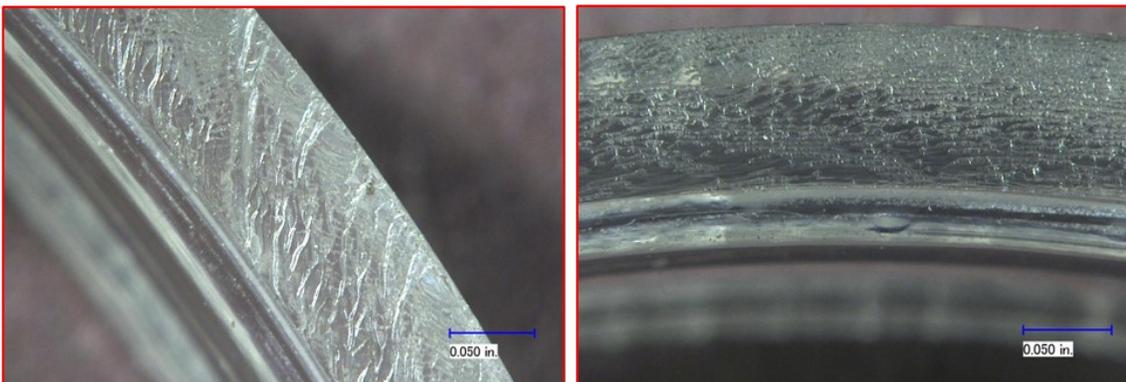
The transverse crack in the clam-shelled half without the axial crack was viewed with a digital microscope (**Figure 2**). There are two distinct sections within the transverse fracture. The sections on the cut ends of the clam-shelled half showed a jagged/sporadic fracture surface, while the middle section was relatively flat and appeared to follow the transition below the weld. The fracture in the cut end sections was evidently brittle in

Figure 2- Micrograph views of a cut end section (left) and the middle section (right).

nature with little ductility. This fracture surface showed some relatively large river and hackle marks, which are indicative of a rapid fracture that has high energy. In the middle section, the fracture surface appeared brittle in nature with light ductility in some fracture features. At first, the features looked similar to banding, which is typically associated with slow crack growth. However, at higher magnifications with the digital microscope, the surface showed numerous fracture planes and rapid fracture features. In contrast, slow crack growth would most likely leave significantly, more smooth and fine features. Therefore, this showed that while the middle section was a rapid fracture, it could have had slightly less energy than in the cut ends of the transverse fracture.

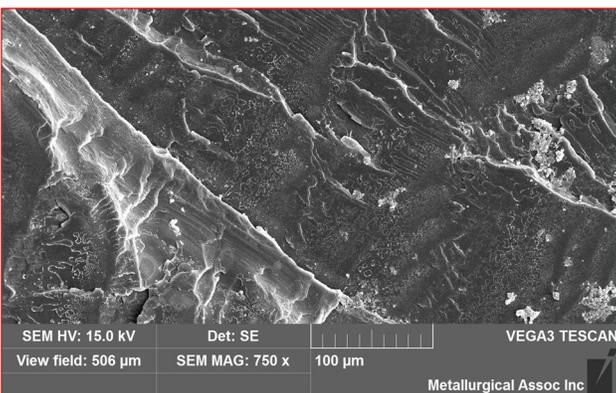
Both distinct sections of the transverse crack were viewed with a scanning electron microscope (SEM). The end sections showed a fracture surface that was characteristic of a rapid and high-energy fracture (**Figure 3**). There were river markings and hackle marks showing the fracture moving from the bottom right to upper left-hand corner of the image. While there was some micro ductility in the crack unions, there were little to no

Figure 3— SEM view of a cut end section of the transverse fracture.

signs of any macro ductile stretching of the polymer during cracking. When viewed with an SEM, the “relatively flat” section of the transverse crack showed a fracture similar to the end sections in the sample. There were slightly larger areas between fracture features, but the features were similar in nature. In both sections, there were no signs of any adverse chemical/environmental effects that had contributed to cracking in the mug. Overall, the transverse crack showed a brittle and high-energy failure with rapid fracture features. This was observed with both the digital microscope and SEM. This confirms the conclusions in the non-destructive analysis regarding the transverse crack. There was nothing observed in the transverse fracture that showed it was not due to a short-term, high-energy event.

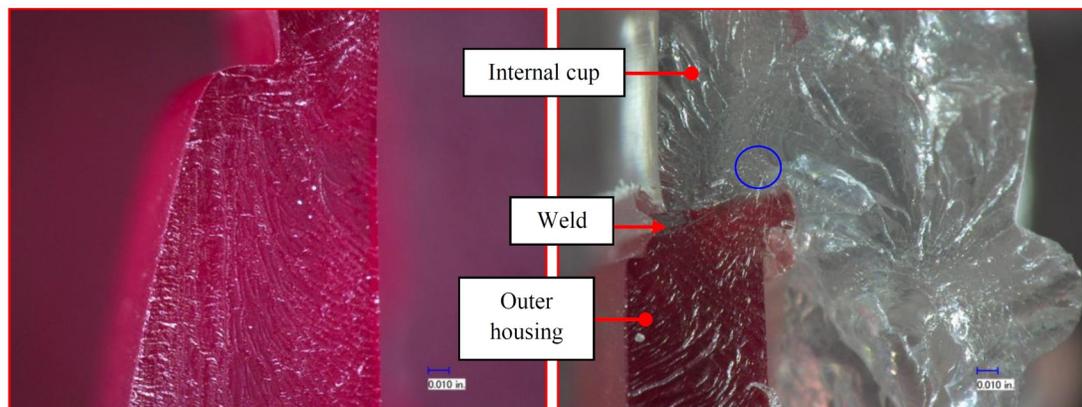
The axial crack surface in the outer housing showed features that were characteristic of a short-term, high-energy failure (**Figure 4**). Much like the transverse crack, the fracture surface appeared to be brittle in nature with rapid fracture features such as hackle marks. The fracture features appeared to propagate from the top of the outer housing

Figure 4- Micrograph views of the axial crack near the weld (left) and in the outer housing (right). The “secondary initiation” point is marked with the blue circle.

of the outer housing down to the bottom of the crack. When viewing the axial crack near the weld with a digital microscope, it appeared that the crack initiated within the internal cup very near to the weld between the two parts. This was observed as the fracture features in the outer housing appeared to extend from a single point right over the weld (this was overturned when viewed with an SEM.) At that point in the analysis, it was thought that the crack was likely initiating from around the weld in the part, but the part was viewed with an SEM to confirm the crack initiation area.

While it appeared that the axial crack initiated at/near the weld with a digital microscope, it was obvious with an SEM that this “secondary initiation” grew out of a fracture propagating from the internal cup. Upon further searching, the approximate area of crack initiation was observed in the internal cup adjacent to the transverse crack (**Figure 5**). From the crack initiation area, the crack propagated up and around the internal cup, crossed through the weld, and propagated down the outer housing. It is pertinent to note that due to the location of the approximate crack initiation area, the sample would have to be further sectioned to directly view that area with higher magnifications.

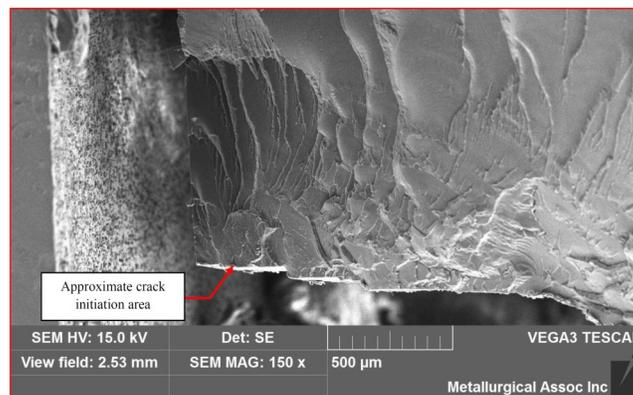
Figure 5 – SEM view of approximate crack initiation area.

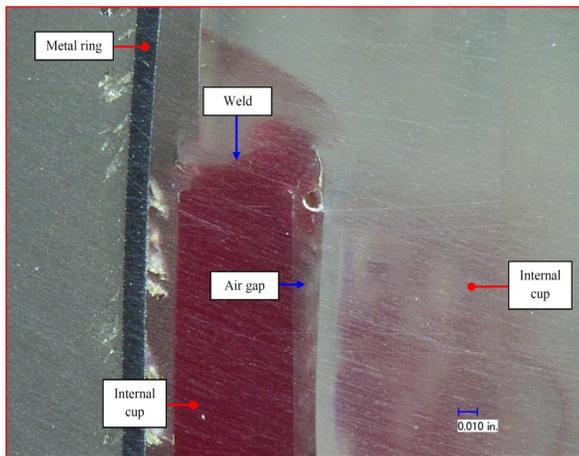
The potted portion of the mug was cross-sectioned and polished in order to view the weld area and threaded section (**Figure 6**). While the weld between the two parts appeared to have decent mixing of the materials, the intentional air gap between the sidewalls of the parts would have likely decreased the overall strength of the weld area. This shows that the travel mug contained a less-than-optimal design near the weld. The transverse crack in the internal cup occurred completely below the weld in the internal cup. It is possible that the weld

geometry decreased the strength of the part. Furthermore, the top of the gap between the parts could have acted as a stress concentration in the part, and increased the local stress in that area.

Figure 6-Micrograph view of the cross-sectioned travel mug.

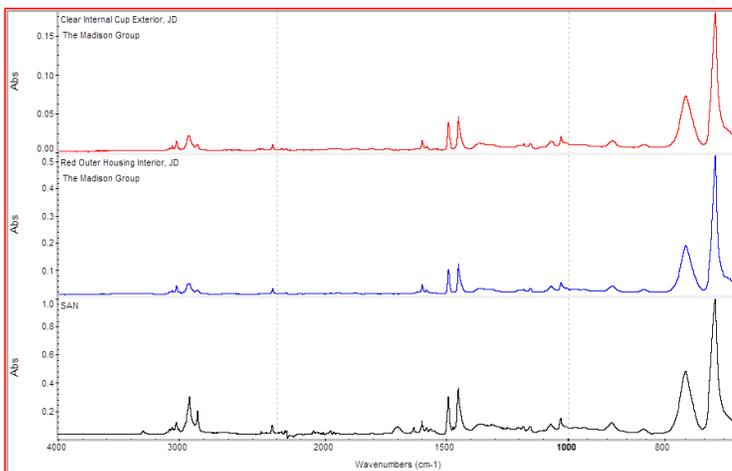
The polymeric material for both the red outer housing and the clear internal cup were subjected to Fourier transform infrared spectroscopy (FTIR). As observed, there is a good match between the spectra for both the outer housing and internal cup (**Figure 7**). The absorption bands are characteristic with those for a styrene/acrylonitrile (SAN) copolymer resin. The soft coating on the exterior of the red outer housing was also tested with FTIR. It showed absorption bands indicative of a thermoplastic elastomer material with ester and acrylic functionality. Overall, the FTIR analysis fits with what has been observed in the other tests. While there was nothing unusual found from the test in this case, FTIR can provide you with helpful information. Knowing what material you are working with can give you a better understanding of where to go with other tests,

Figure 7— View of the spectra for both the internal cup (top), the outer housing (middle) and their shared library match.
