TMG News

The Benefits of a Non-Destructive Visual Analysis: A Case Study

Jack DeSousa

A Non-Destructive Testing Case Study: Travel Mug

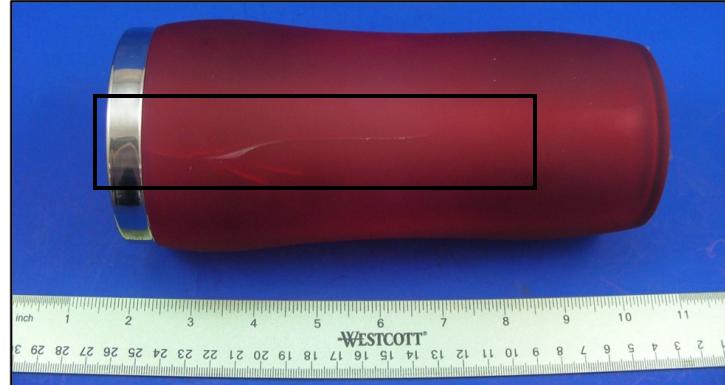
Problem Identification. The only background information I was provided is that the mug failed in the field, and I do not have access to the lid. In this case, the failure is obvious to anyone who would pick up the mug to use it. There is a large longitudinal crack running down from the metal lip at the top of the mug. A quick survey of the interior shows a little less obvious cracking in the threaded section of the travel mug (**Figure 2**).

Figure 2– Overview of the failed travel mug.
(Black box shows axial crack).

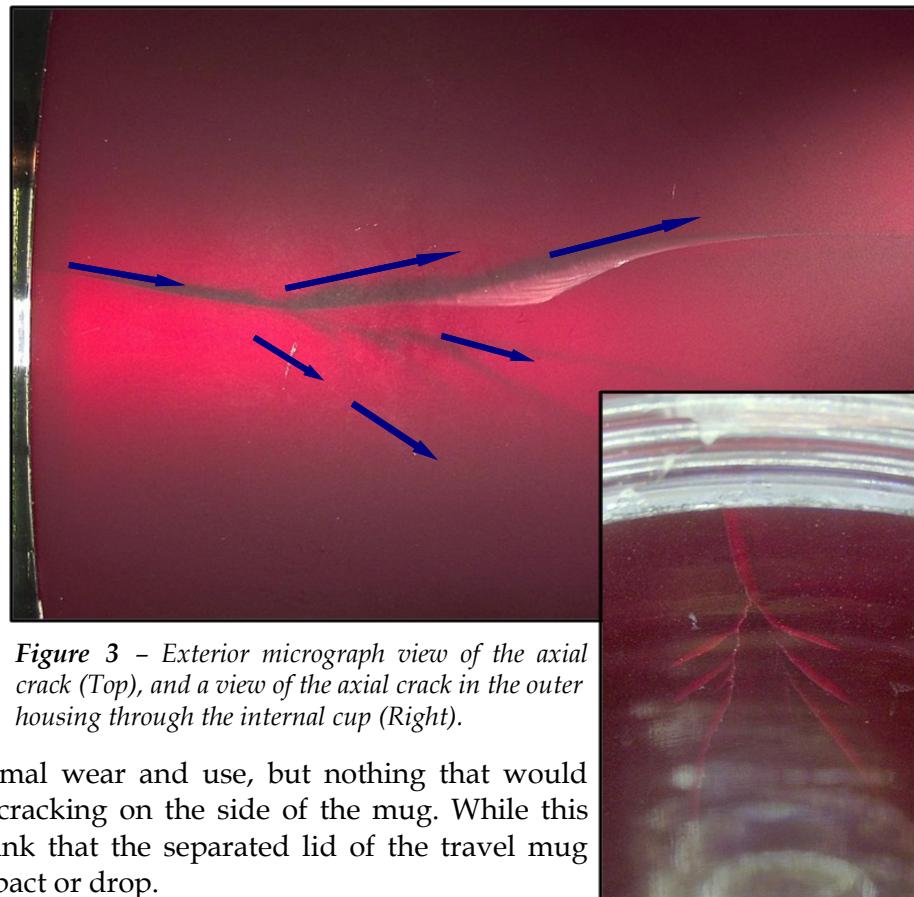
A closer examination of the visible fracture on the side of the mug (**Figure 3**) shows me three things right away: it is *high energy*, it is *rapid*, and it started at the *top*. All three of these characteristics stem from the fact that there are bifurcations in the main crack. When a single crack cannot dissipate energy in a part quickly enough, it will branch into multiple cracks. Because of this, true bifurcations typically occur in rapid fractures. Finally, if you think of the crack as a tree branch, the bifurcations grow out of the main crack; not the other way around. This shows that the crack progressed from the top to the bottom of the mug for the bifurcation to branch off in that way.

Now I have talked about what *is* on the exterior, it is equally important to look at what *is not* on the exterior of the mug. Even though the cracking is rapid and high-energy, there is not much damage on the exterior of the mug. There is some superficial scratching and marks likely from normal wear and use, but nothing that would correlate with the rapid, high-energy cracking on the side of the mug. While this could be due to multiple factors, I think that the separated lid of the travel mug would likely show damage from an impact or drop.

Figure 3 – Exterior micrograph view of the axial crack (Top), and a view of the axial crack in the outer housing through the internal cup (Right).

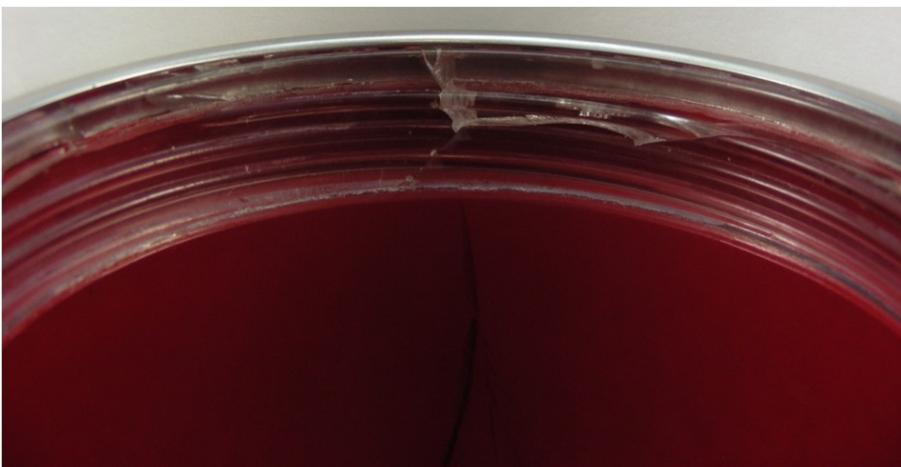
Moving to the interior examination of the mug, I can see cracking that extends around the internal circumference of the threads (**Figure 4**). Although this crack is more difficult to interpret than the one on the exterior, there are some key elements about the crack that can be observed.

First of all, the cracking is *brittle* in nature. Plastics are visco-elastic materials that can sometimes behave in a ductile manner and sometimes behave in a brittle manner. Typically, brittle cracking in plastics occur when the crack is moving either very quickly in the part or very slowly over a long period of time. In this case, the cracking occurred without stretching or deforming the material, thus, it is *brittle*.

Figure 4 – View of the cracking in the threaded section of the travel mug.

The other observations show that the crack was *rapid* and *high-energy*. The crack does not coincide with abrupt transitions in the threaded section. When it was propagating around the threaded section, it jumped between two different thread roots, and did not follow the root of the threads where the stress concentration would have been the sharpest. This shows me that the crack had energy behind it, and quickly propagated through the part to release energy in the path of least resistance.

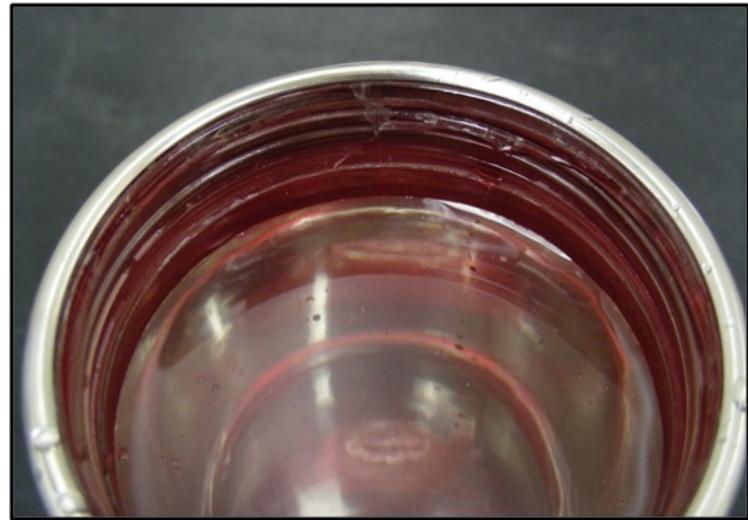
I want to do the same thing for the interior of the mug and look for what *is not* there. First, I was surprised to find that the interior of the travel mug does not have any cracking below the threaded section. In order to confirm, I filled the internal cup with water and did not find any cracks or leaking up to the threads (Figure 5). If the heat from a hot liquid had caused or contributed to failure, I would expect cracking to occur in the internal cup since this would be nearest to the heat source. Therefore, this can eliminate thermal influences from a liquid placed in the travel mug. Furthermore, if frozen water had expanded in the mug to crack the threads and outer housing, the internal cup would definitely be cracked as well. The other major thing I do not see on the interior of the mug is adverse chemical or environmental effects. This would typically result in much more pervasive and global cracking on the interior of the travel mug.

Figure 5 – View of the water placed in the travel mug.

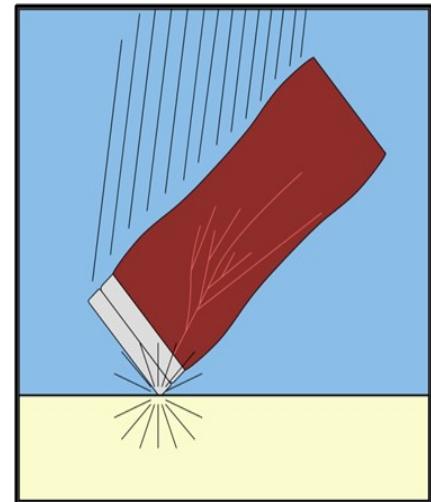
From our non-destructive, visual analysis, we can conclude the following: **failure was due to a high-energy event, which caused rapid and brittle cracking in the travel mug.** This conclusion is within a reasonable degree of engineering certainty. Even though this technically answers our first question, I think we can use critical thinking and logic to figure out what *more-likely-than-not* caused the short-term, high-energy event driving failure.

While there are other more extreme situations that could place high amounts of stress on the mug, I think that these are fairly typical stresses that a travel mug would see in its lifetime. First of all, since we know that failure was due to a short-term, high-energy event, the weight of a liquid in the mug and the tightening of the lid would not fit this situation. Also, we already eliminated cross-threading of the lid, differing thermal expansion, and freezing a liquid inside the mug during the interior analysis. It is possible that residual stresses or stresses from assembly could cause this failure. However, this mug did not fail directly after manufacturing. We know that this mug failed in the field. Additionally, if a very heavy object compressed the mug quickly enough to cause rapid and brittle cracking, I think we would see more gross deformation of the entire mug. The two situations that make sense are either a *drop* or *impact* of the mug (**Figure 6**). In both of these situations, high stress would very quickly be applied to a small local area, which is consistent with the failure.

Figure 6 – Impact of travel mug.

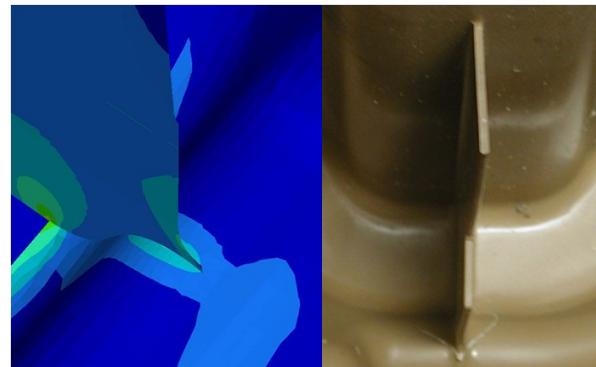
A visual examination of the failure revealed a smooth fracture surface that initiated at the base of the rib. The fracture surface was characteristic of a brittle fracture mechanism known as creep. Creep is a material response mechanism, commonly experienced by plastics and composites, in which the molecules of the plastic separate under the influence of a constant stress that is below the yield stress of the material.

The failure location coincided with high stress area.

It was the conclusion of the evaluation that the rain barrel failed through a brittle fracture mechanism known as creep. The combination of the rain barrel design and material selected resulted in a stress level that left the rain barrel susceptible to premature failure when filled with water. It was recommended that either the design of the rain barrel be modified or the plastic should be changed to a more creep resistant material.

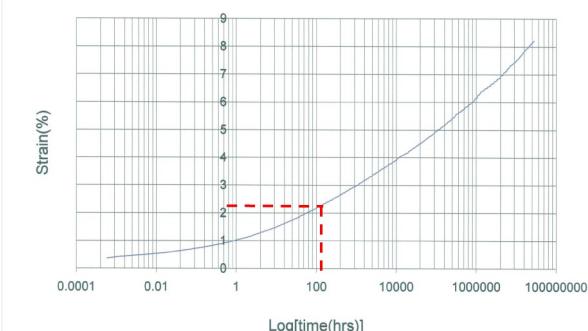
The design integrity of the rain barrel was evaluated by performing a series of material tests and structural finite element analysis (FEA). The material testing used dynamic mechanical analysis (DMA) to characterize the long-term mechanical properties of the resin while under load. The FEA was used to determine the stress distribution in the rain barrel when the barrel was filled with water. The FEA confirmed the area of high stress coincided with the failure location, and the stress remained below the yield point of the plastic material. Combining the results of the material testing and the FEA allowed for a prediction to be made regarding the amount of time until the rain barrel would fail. With the stress levels predicted in the FEA, the rain barrel was predicted to fail after approximately two weeks of service.

Failure was predicted to occur after two weeks of service.
