Failure Analysis of a Medicine Ball

William Aquite, Ph.D.

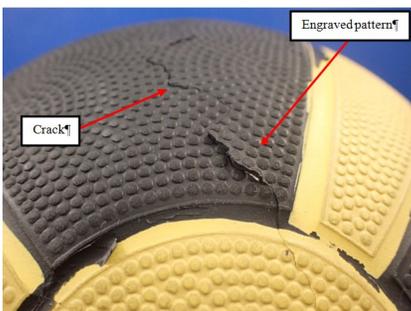
Figure 1-View of the continuous crack on the exterior of the medicine ball.

A single, continuous crack was observed on the exterior of the medicine ball. The crack appeared to extend through almost half of the circumference of the ball and followed a continuous, but irregular pattern with no visible bifurcations (Figure 1). The external surface of the ball featured an engraved pattern. However, the crack propagation did not appear to be

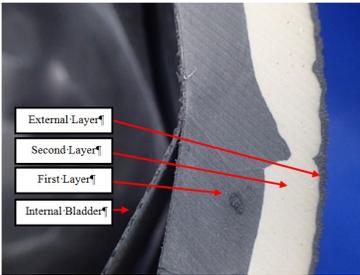
No evidence was found to indicate that damage, such as abrasion, gouging or cutting contributed to the failure of the medicine ball. The ball's ability to bounce was notably reduced after the failure and attempts to pump the ball up, showed it was deflated. In order to evaluate the medicine ball's construction and to further study its failure mode, the medicine ball was cross-sectioned.

Figure 2 – View of the internal construction of the medicine ball.

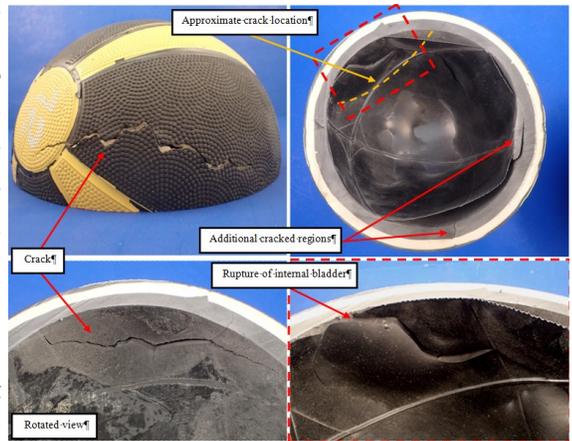
The bladder showed a rupture in the region adjacent to the main crack location (**Figure 3**). Therefore, it is possible that the rupture of the internal bladder was a post-failure event due to the effects on the structural integrity of the ball from the shell's failure.

Thickness measurements on the cross-section showed that cracking occurred at a region with reduced thickness along the circumference of the medicine ball (**Table 1**).

Figure 3-Views of the cross-sectioned medicine ball showing the crack location, the ruptured internal bladder and additional cracked regions observed on the First Layer of material.

The nature and causes of the thickness variation were associated with the manufacturing defects of the medicine ball. The presence of thickness variations can reduce the overall strength of the product, and could have made this region prone to crack development and failure.

Additional cracking on the First Layer was observed as a bifurcation of the main crack. Furthermore, two additional crack locations were identified on the First Layer at remote locations from the main crack (**Figure 3**). These cracks had only progressed through the First Layer of material. The progressive cracking may be an indication that after the cracks had propagated sufficiently to relieve stress, continued cracking occurred through low cycle fatigue associated with subsequent bouncing of the medicine ball.

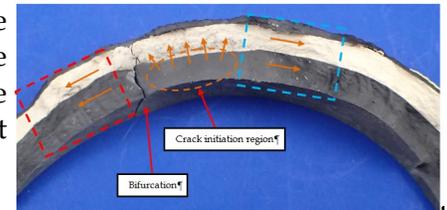
Figure 4 – Micrograph views of the exposed fracture surface. Arrows indicate crack propagation.

The region of failure showed no visual signs of material defect, degradation or aging. Microscopic examination of the crack surface showed a single crack origin location on the interior of the First Layer of material. The crack initially propagated radially through the shell. Subsequently, the crack extended circumferentially in both directions (**Figure 4**). This pattern of

crack progression was also observed through the Second Layer and External Layer of material. The observed fracture features were consistent with a progressive failure mechanism, as indicated by the presence of parallel indications. The form and relatively lower number of observed indications were thought to represent crack propagation through low cycle fatigue.

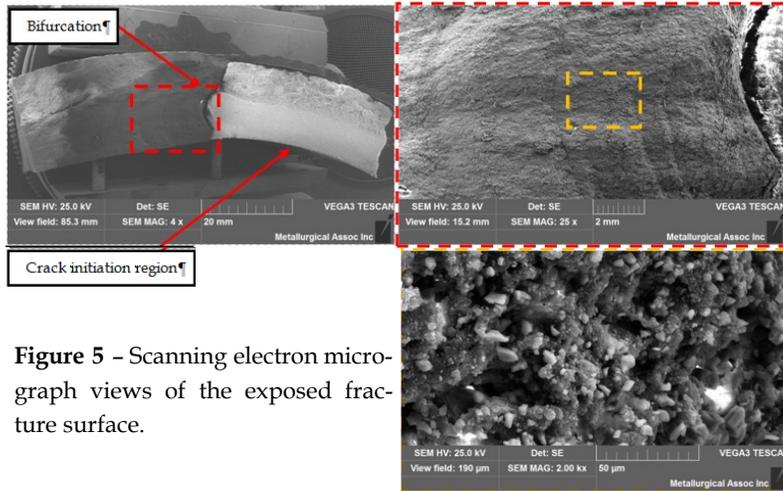
Figure 5 - Scanning electron micrograph views of the exposed fracture surface.

filler material in the First, Second and External Layers (**Figure 5**). The high magnification views did not reveal additional features on the crack progression through the materials in the medicine ball.

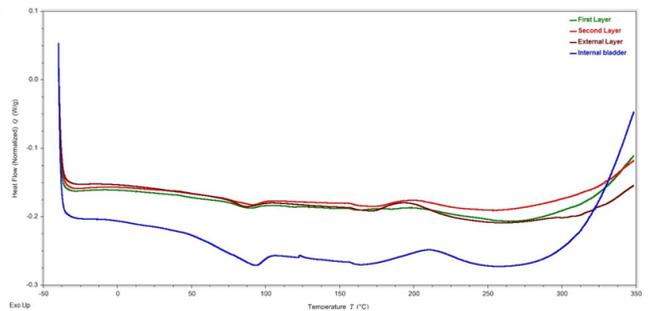
Analysis of the materials in the medicine ball via Differential Scanning Calorimetry (DSC) produced very similar results. The thermograms indicated that the materials underwent endothermic events that covered a broad temperature range, centered at approximately 90 °C during the first heating run. The totality of the DSC results obtained for the medicine ball components were indicative of thermoset materials. The thermal events were thought to be attributed to the continued curing of the thermoset resins (**Figure 6**).

Figure 6 - Initial heating DSC thermogram of the components of the medicine ball.

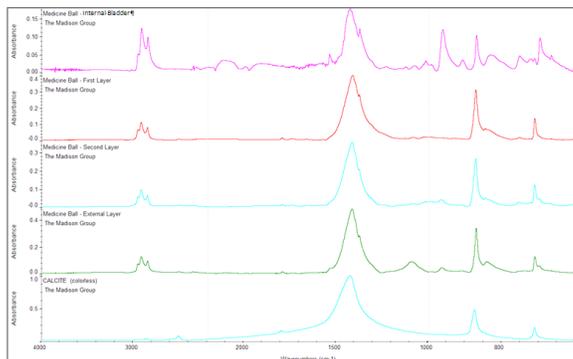
Figure 7 - FTIR spectra of the components of the medicine ball. Each of the components exhibited absorption bands characteristic of styrene-butadiene based materials. Furthermore, the spectra showed absorption bands characteristic of calcium carbonate.

components of the medicine ball indicated that the internal bladder and the First, Second and External Layers of material consisted of styrene-butadiene based materials. Furthermore, the spectra showed absorption bands characteristic of calcium carbonate (CaCO₃), a common filler in rubber formulations (**Figure 7**).

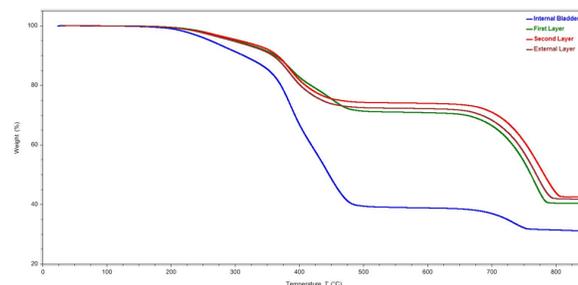
similar manner. Similarly, the Second and External Layers of the material showed comparable TGA profiles. The initial weight loss observed across the TGA profiles for all of the materials, was associated with the volatilization of hydrocarbon-based plasticizers within the material's formulation. The test also showed that the material for the First, Second and External Layers were identified as having approximately 70% of filler content, while the material in the internal bladder showed filler content of approximately 26% (**Figure 8**). Based on the results from the FTIR testing, a larger portion of the filler content could be attributed to a calcium carbonate filler.

Based on the material analyses performed on the components of the medicine ball, it is likely the internal bladder was made out of an SBR rubber based material while the layers in the shell of the ball were likely, EPDM rubber-based materials.

Figure 8 - TGA thermogram of the components of the medicine ball.
