# FAILURE ANALYSIS OF GASOLINE STORAGE ASSEMBLIES

*Jeffrey A. Jansen, Stork Technimet, Inc.*

## **Abstract**

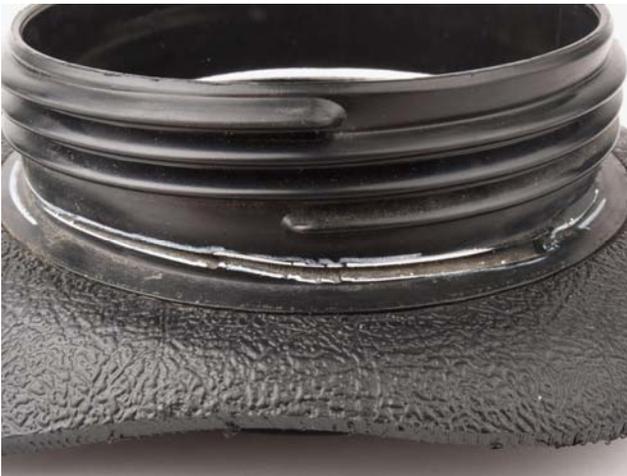
Examination of the two storage tank sections confirmed the presence of catastrophic cracking within the corresponding spouts. One of samples exhibited cracking that extended around the entire spout circumference, while the second part exhibited cracking approximately 350° around the spout circumference. The form and location of the cracking was consistent across the two parts. The crack was located immediately above the formed corner in the spout, as illustrated in Figure 1. This area would be immediately outside of the natural reinforcement of the spout wall created through bonding with the mating tank. The visual examination did not show signs of apparent macroductility, as would be indicated by the presence of stress whitening or permanent deformation. Conversely, the parts displayed features associated with brittle fracture. No signs of apparent mechanical damage or abuse were noted during the visual examination. However, adhesive caulk was evident where repairs were attempted on the cracks.

**Fig. 1 - Cracking was evident within the spout of the storage assembly.**

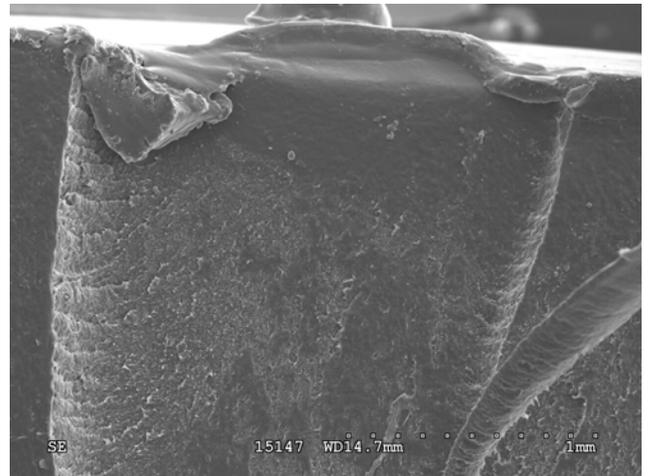
The storage assembly fracture surfaces were further examined via scanning electron microscopy (SEM). Examination of the fracture surface confirmed the presence of multiple individual crack origins along the outer diameter of the spout wall. The crack origin locations exhibited a relatively smooth morphology, indicative of slow crack initiation, as shown in Figure 3. No signs of microductility were noted within the crack origin zone. The observed features indicated that the cracking had initiated along the outer diameter and progressed in a transverse orientation through the spout wall. Examination of areas adjacent to the inner diameter of the spout wall showed an increased level of microductility, as indicated by the presence of stretched fibrils. This is illustrated in Figure 4. This increase in ductility is representative of variation in the stress dynamics responsible for cracking at these locations. Throughout the SEM evaluation, no evidence was found to suggest molecular degradation of the spout material, such as direct chemical attack or thermal deterioration. Additionally, no signs of molding defects, such as voids or inclusions, were apparent.

**Fig. 3 - Scanning electron image showing a crack origin area. This region displayed a smooth morphology and distinct crack unions.**

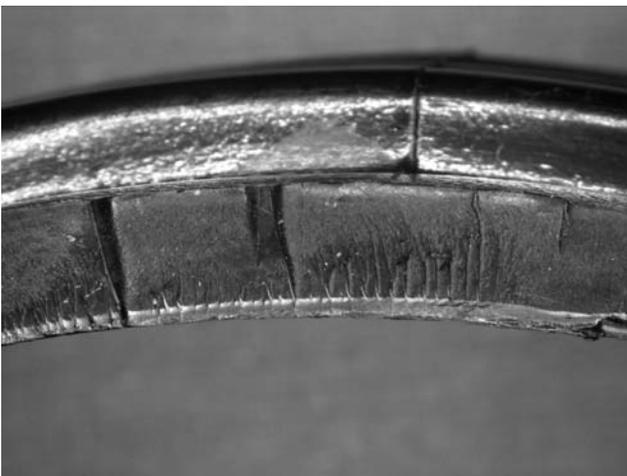
The two failed parts were further examined with the aid of an optical stereomicroscope at magnifications up to 50X. The microscopic examination revealed similar features across the two failed spouts. Both parts exhibited multiple apparent crack origins along the outer diameter of the spout wall. The cracking primarily extended inward toward the inner diameter of the spout wall, where river markings were observed indicating that the orientation of the applied stress had changed. The fracture surfaces showed crack unions

where the individual cracks had coalesced. A typical fracture surface is presented in Figure 2. Very little evidence of circumferential cracking was noted, with the predominant fracture orientation being through the part wall. Importantly, no signs of bending were noted within the fractures, indicating essentially tensile loading, basically pulling the upper section of the spout from the lower section. Consistent with the observations made during the visual examination, no signs of macroductility were apparent during the microscopic inspection.

**Fig. 2 - The fracture surface of the failed part showed cracking initiation along the outer diameter and no evidence of macroductility.**

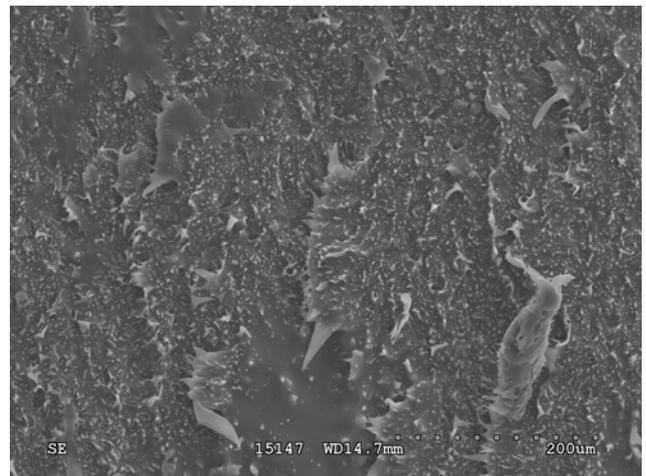
**Fig. 4 - Higher magnification view of the central portion of Figure 3 showing limited microductility.**

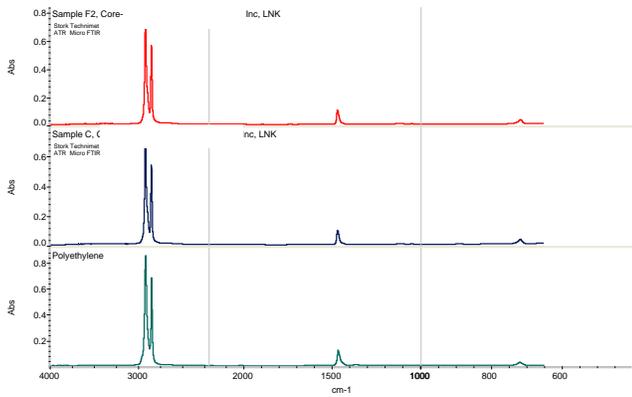
Core specimens representing the failed and reference parts were analyzed and a direct comparison of the results yielded an excellent match, without apparent differences. Subsequent library searching and interpretation indicated that the spectra exhibited absorption bands characteristic of a polyethylene resin. The results of the FTIR testing did not show evidence to suggest contamination or degradation of the failed or reference spout materials.

**Fig. 5 - FTIR spectral comparison showing good agreement between the results obtained on the failed and reference materials.**

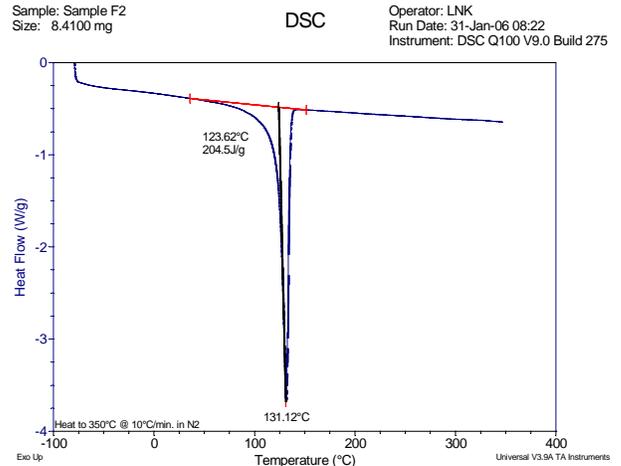
Analysis of the failed spout produced results showing a single endothermic transition centered at 130 °C and 131 °C during the initial and second heating runs, respectively. The material underwent recrystallization centered at 116 °C during cooling. A comparison of the heats of fusion showed good agreement, indicating that the failed part material achieved proper crystallinity during molding. The obtained DSC results are presented in Figures 6 and 7. Overall, the results obtained on the failed spout were comparable to those obtained on the reference part, with both materials producing results as expected given the description of the material, Alathon® M 5370.

**Fig. 7 - Second heating DSC thermogram obtained on the failed part material.**

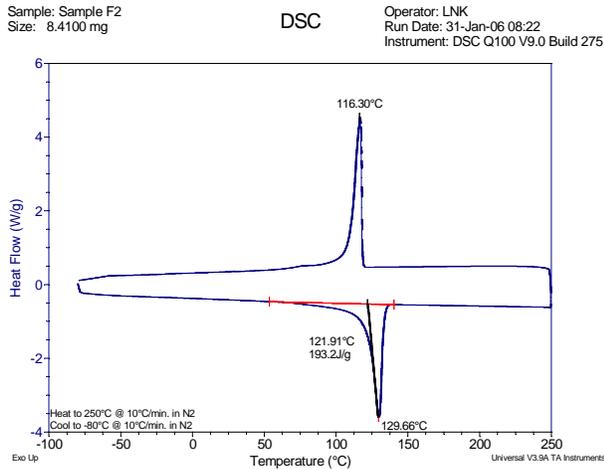
**Fig. 6 - Initial heating DSC thermogram obtained on the failed part material.**

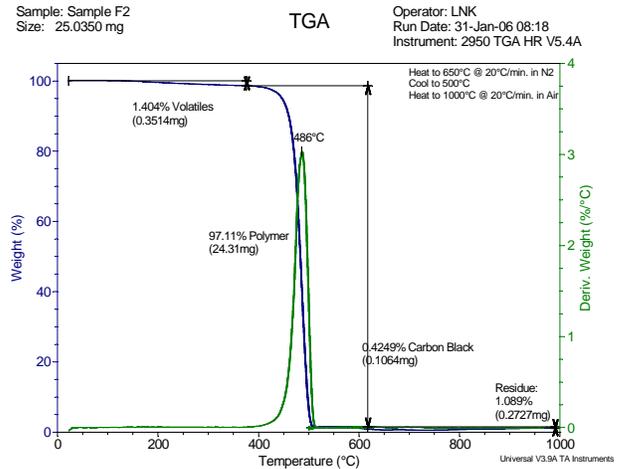
Analysis of the failed spout produced results that were generally similar to those obtained on the reference part, with a single notable difference. The results obtained on the failed spout material showed a weight loss of 1.4% while heating to moderate temperatures under the nitrogen purge. This weight loss corresponded to the evaporation of volatiles, such as gasoline, absorbed into the spout material. The remainder of the obtained results, including the polymer weight loss, the carbon black weight loss, and the non-combusted residue content were consistent with the results obtained on the reference part. The TGA thermogram obtained on the failed spout is included in Figure 8. The presence of absorbed gasoline is in agreement with the stated description of the material as a gasoline tank spout. At equilibrium, polyethylene resins can absorb between 10% and 15% of their weight in gasoline.

**Fig. 8 - TGA thermogram obtained on the failed part material.**
