FAILURE ANALYSIS OF AN OUTDOOR INSTRUMENT HOUSING

Jeffrey A. Jansen, The Madison Group, Madison, Wisconsin

Abstract

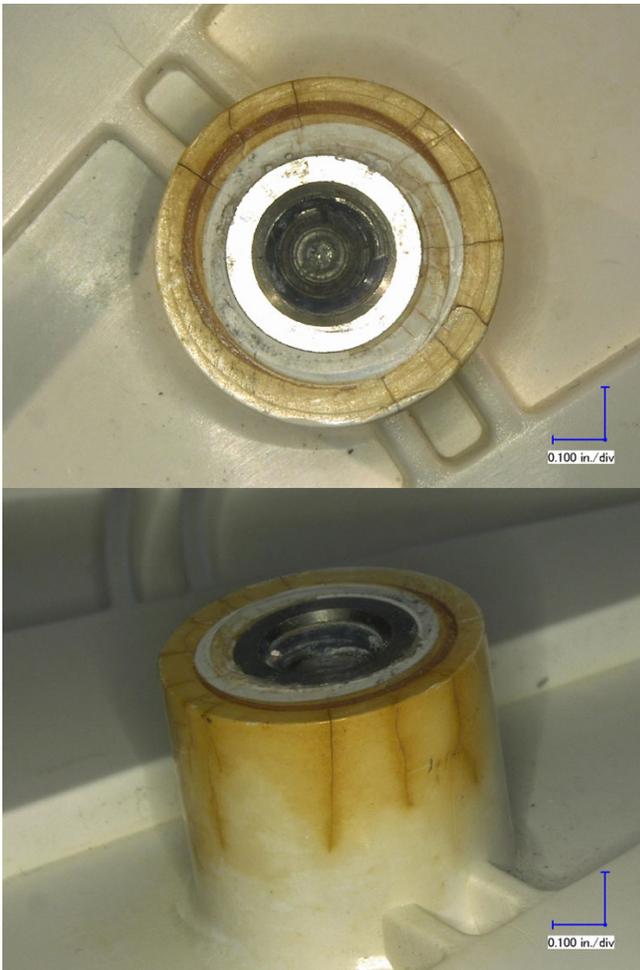
Examination of the failed housing confirmed the presence of cracking within several of the bosses corresponding to the threaded metal inserts used to secure the housing to the mounting hardware. The cracked bosses exhibited multiple individual parallel longitudinal fractures (Figure 1). The cracks appeared to be primarily toward the upper mounting surface of the boss. Significantly, the appearance of the cracking was very consistent across the various bosses.

The cracking within the bosses lacked features associated with significant macro ductility, as would be apparent in the form of stress whitening or permanent deformation. Conversely, the cracks exhibited characteristics of brittle fracture from the exterior examination. The cracked bosses displayed significant localized discoloration. Specifically, the mounting surface as well as the areas surrounding the cracks exhibited an orange-brown coloration.

Figure 1. Photomicrographs showing typical cracking and discoloration within one of the housing bosses. No significant macro ductility is evident.

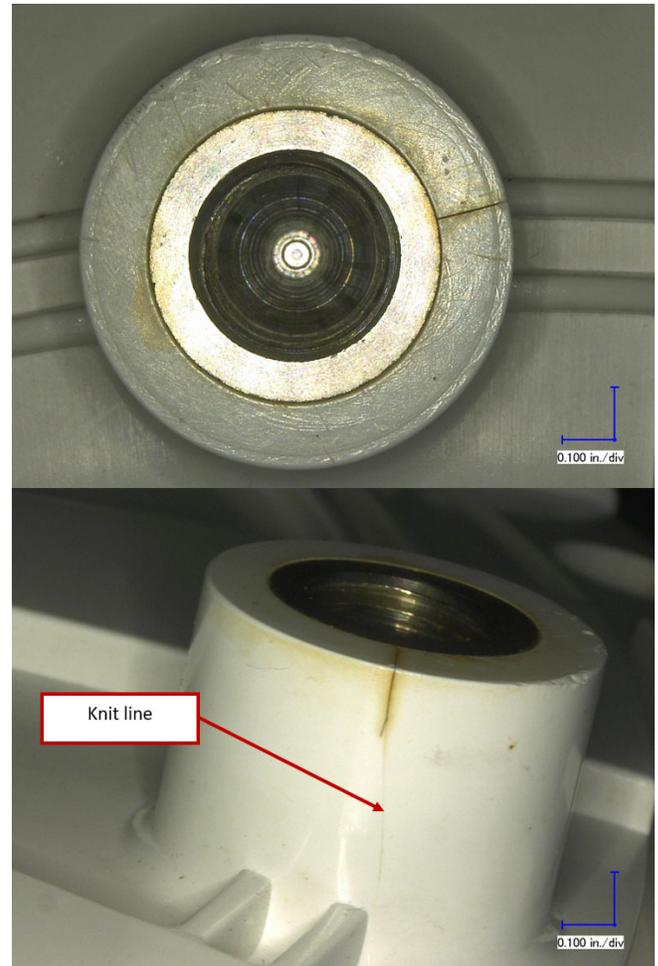
Some of the cracks were coincident with a distinct knit line in the boss wall (Figure 2). However, given the presence of multiple individual cracks on each boss, the fractures were not exclusively associated with knit lines.

Figure 2. Photomicrographs showing cracking corresponding to the location of a knit line. No significant macro ductility is evident.

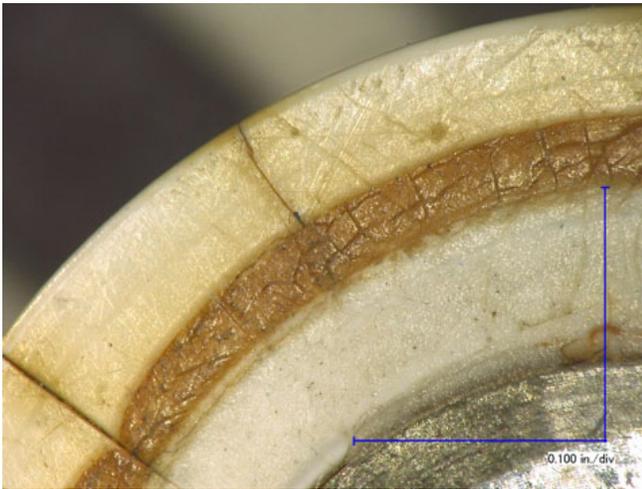
The microscopic examination of the mounting surface on several of the bosses showed a distinct circumferential band of discoloration. At higher magnification, it was apparent that this band corresponded to a zone of mud cracking on the surface of the boss (Figure 3). The form of the mud cracking was characteristic of localized molecular degradation of the boss material, resulting from contact with a deleterious chemical agent over a limited area. Further evidence of molecular degradation was apparent on the inner diameter of a number of the bosses toward the upper

Figure 3. Photomicrograph showing localized discoloration. The discolored material displays substantial mud cracking associated with molecular degradation.

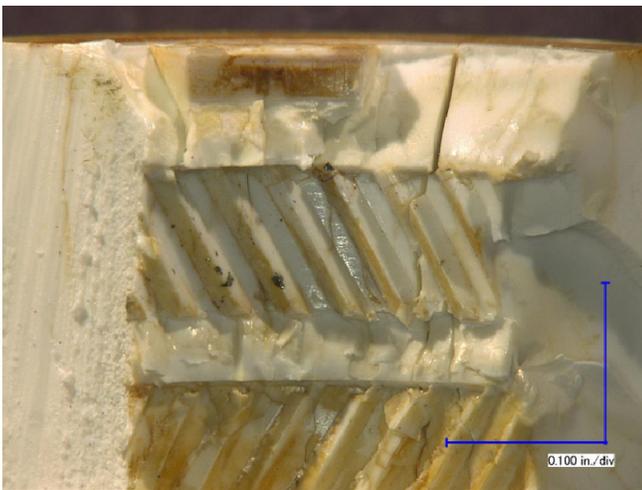
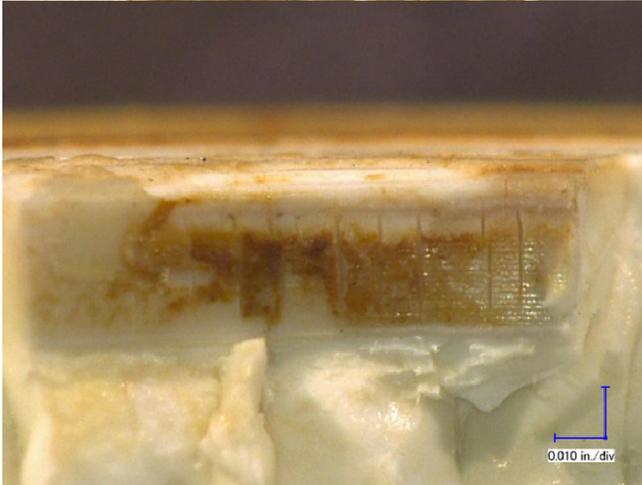
edge (Figure 4). Further, the inner diameter surface that corresponded to contact with the over-molded insert also showed the presence of a relatively high number of cracks. These cracks presented an irregular propagation pattern. In addition to the cracking, several of the bosses showed the presence of localized discoloration associated with adherent surface residue.

Figure 4. Photomicrographs showing features indicative of molecular degradation on the inner diameter of a typical boss.

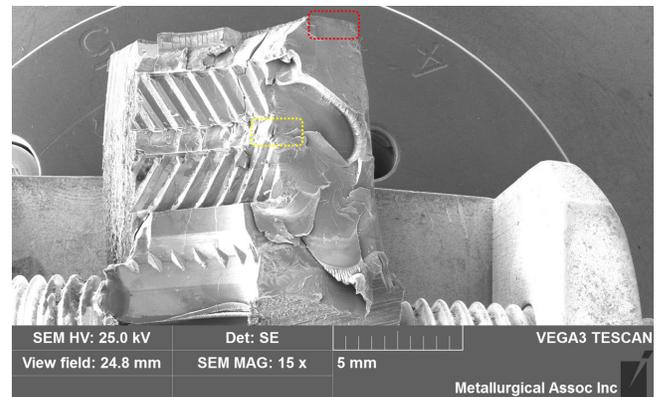
The scanning electron microscopic (SEM) examination of the fracture surfaces from several of the bosses showed evidence of similarities, with some important distinctions (Figure 5). Inspection of the fracture surfaces from most of the bosses revealed two general locations of crack initiation. The larger and primary crack origins were positioned along the inner diameter of the boss wall, immediately adjacent to the molded-in metal insert (Figure 6). These crack origins were located within sharp corners of the insert. The sharp corners likely acted as points of significant stress concentration within the over-molded plastic. The crack origins exhibited a relatively smooth morphology, without signs of significant micro ductility, as would be apparent in the form of stretched fibrils or flaps. Further, the smooth origin morphology lacked features associated with rapid crack extension. After initiation, the cracking extended radially and subsequently longitudinally through the part wall.

Figure 5. SEM image showing a typical boss fracture surface. Two distinct crack origin areas were identified.

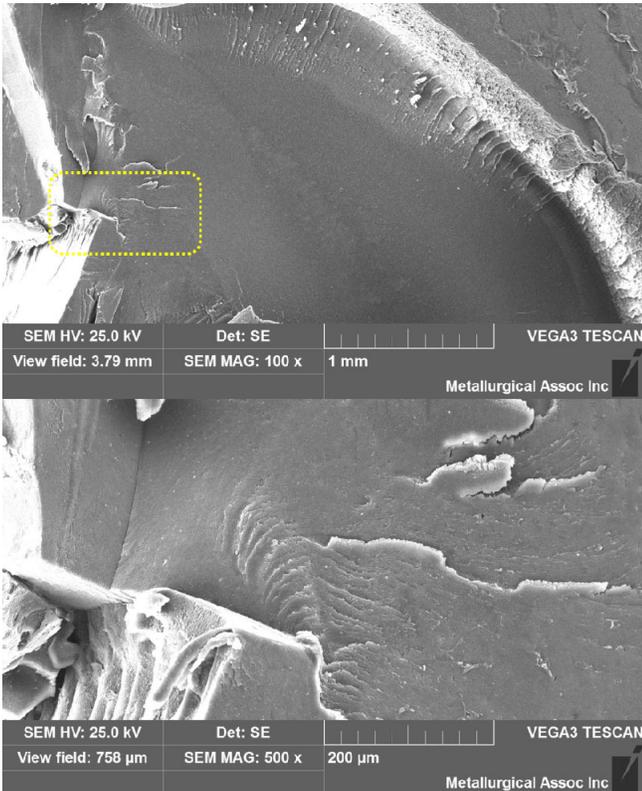
Figure 6. SEM images (yellow box in Figure 5) showing crack origin at a sharp corner corresponding to the metal insert. Brittle fracture features are present.

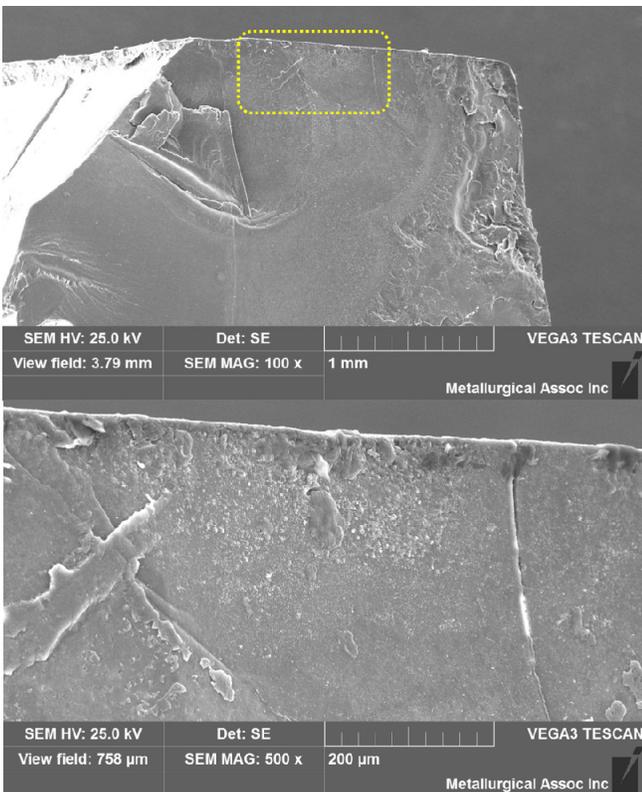
The boss fracture surfaces also showed areas of crack initiation along the mounting surface (Figure 7). These origins also presented relatively smooth features consistent with brittle fracture through a slow crack initiation mechanism. Evidence of adherent debris was present within the crack origins. This debris was thought to correspond to the orange-brown coloration noted during the visual and microscopic examinations. After initiating, the cracking extended longitudinally down the wall of the boss.

Figure 7. SEM images (red box in Figure 5) showing a crack origin along the mounting surface. Brittle crack features are present.

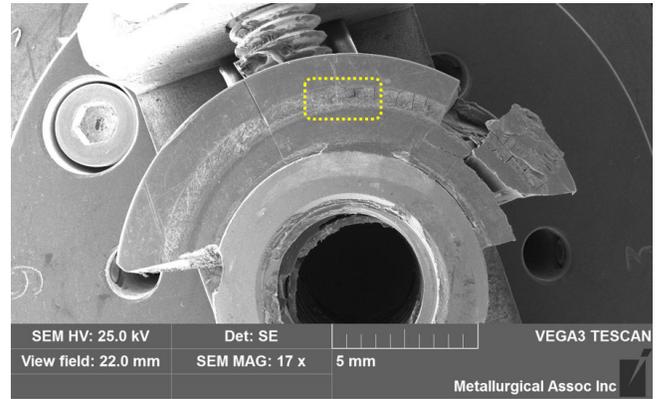
Given the evidence of crack initiation along the mounting surface on a number of the bosses, and the associated discoloration, a representative mounting surface was examined via SEM. The SEM examination confirmed the presence of a localized band of mud cracking on the upper mounting surface. (Figures 8 and 9). The surface exhibited a characteristic pattern of mud cracking indicative of molecular degradation of the boss material. Additionally, signs of deposits on the surface were also present. The surface deposits were thought to correspond to the localized band of orange-brown coloration found during the visual and microscopic examinations.

Figure 8. SEM image showing the mounting surface of a typical boss.

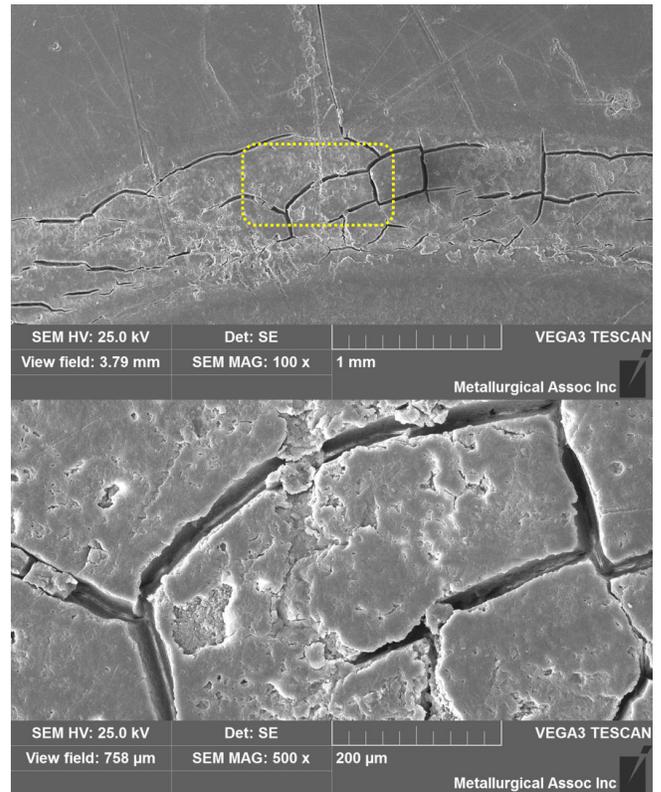
Figure 9. SEM images (yellow box in Figure 8) showing mud cracking associated with localized degradation of the housing material.

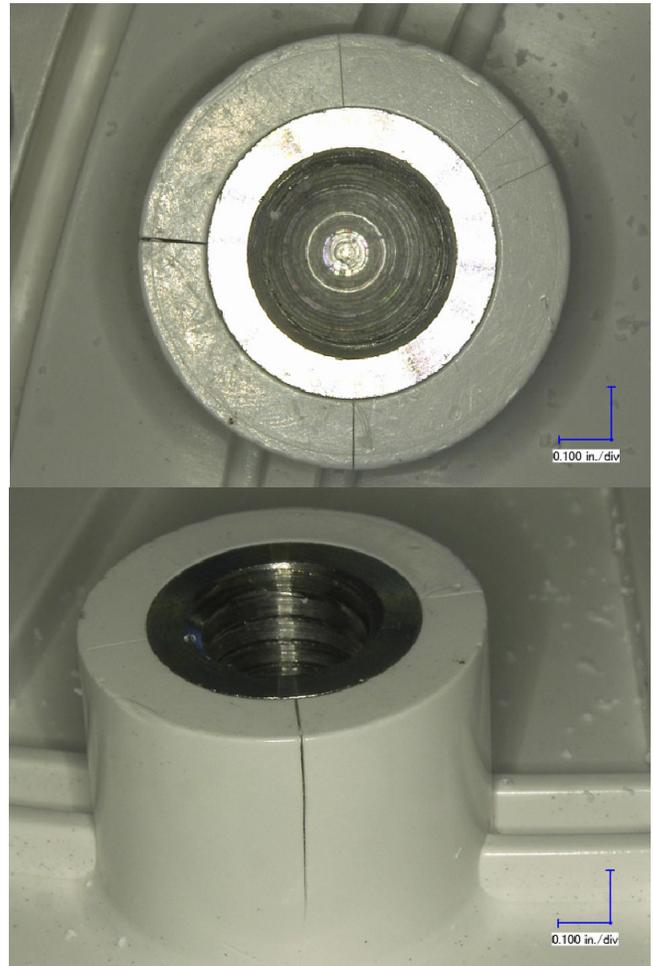
An examination of the supplied as-molded housing revealed the presence of cracking within several of the bosses (Figure 10). A number of the bosses exhibited multiple individual parallel longitudinal cracks. The appearance of the cracking was very similar to that observed within the failed housing. As was the case with the failed housing, the cracking was primarily located toward the upper end of the boss. The external examination revealed features associated with brittle fracture, with no signs of significant macro ductility. Unlike the failed housing, no evidence of discoloration was apparent on the as-molded housing.

Figure 10. Photomicrographs showing cracking within one of the bosses on the submitted as-molded housing.

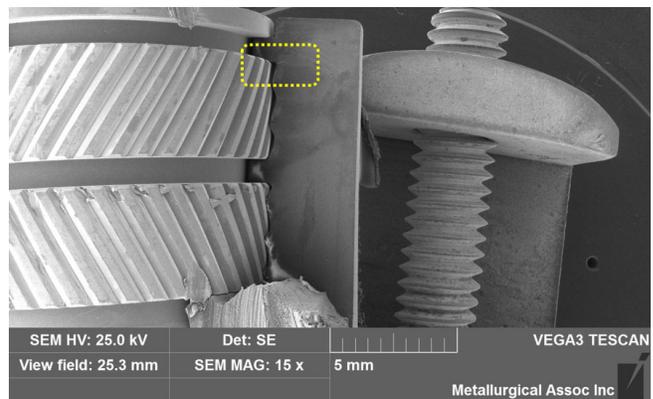
The fracture surfaces from the as-molded housing were also examined via SEM. The fracture surfaces showed a single area of crack initiation positioned immediately adjacent to the molded-in metal insert (Figures 11 and 12). Specifically, the origin was located within a relatively sharp corner of the insert. The crack origin displayed an extremely smooth morphology. The observed features were indicative of a brittle fracture slow crack initiation and growth mechanism. Further, the features were relatively consistent with those observed on the corresponding origins in the failed housing bosses.

Figure 11. SEM images showing one of the boss fracture surfaces from the reference housing.

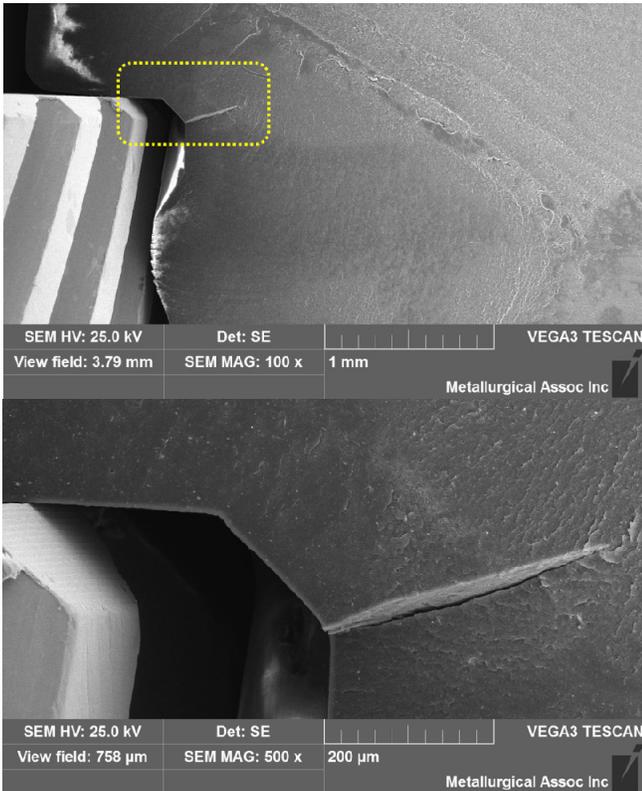
Figure 12. SEM images (yellow box in Figure 11) showing the crack origin location at a sharp corner corresponding to the metal insert. Brittle fracture features are present.

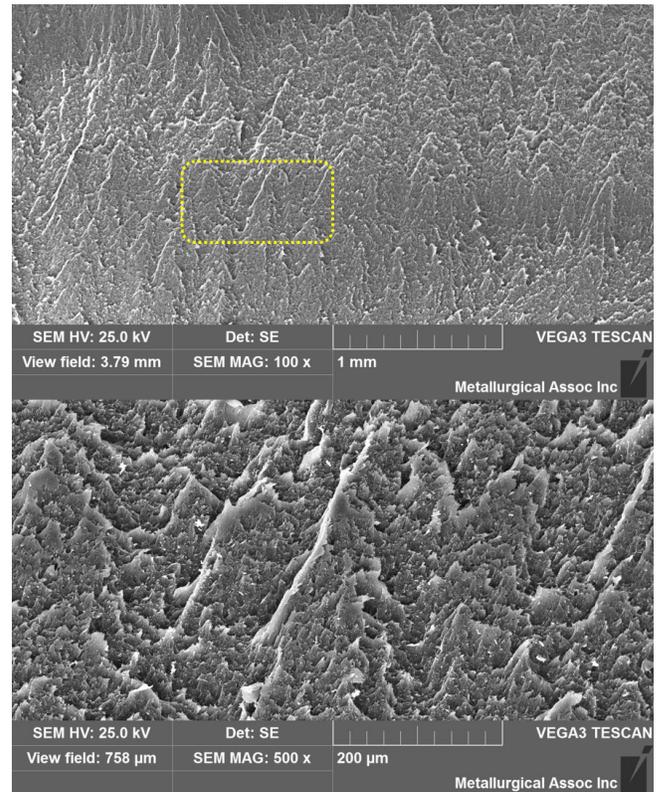
Examination of the overload specimen created through the application of slow bending stresses, showed a substantial level of macro and micro ductility. Visually, the sample showed a great degree of stress whitening and permanent deformation. Scanning electron images presented a relatively high concentration of stretched fibril formation (Figure 13). These fracture surfaces were in sharp contrast to those corresponding to the cracks within the failed and as-molded housings. Similar inspection of the impact specimen created through rapid loading showed minimal evidence of macro ductility. The specimen did not show evidence of significant stress whitening or permanent deformation. However, the SEM examination revealed a relatively high level of micro ductility. The SEM features were somewhat similar to the fracture surfaces remote to the crack origins on the failed and as-molded housings.

Figure 13. SEM images showing substantial micro ductility on the laboratory fracture surface.

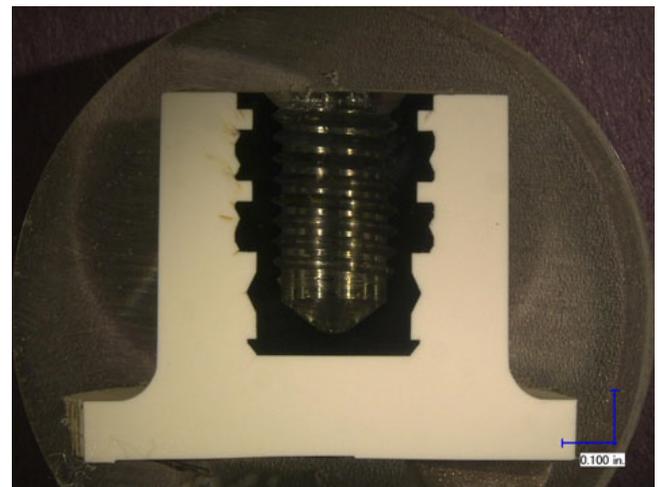
To further characterize the boss cracking, a cross-section was prepared through one of the bosses from the failed housing. A portion of the boss was excised, mounted in an epoxy medium, and polished to reveal the area of interest. The prepared cross-section revealed the extent of the relatively sharp corners created in the plastic by overmolding onto the metal insert (Figure 14). Such corners can act as points of severe stress concentration, thereby, multiplying any internal or external stress. Further examination of the cross-section revealed the presence of partial cracks extending out of the sharp corners. Some evidence of discoloration was apparent within and adjacent to the cracks. The cracking within the cross-section was

consistent with the observations made during the fractographic examination of the failed and as-molded housing, indicating crack initiation along the inner diameter of the boss wall, immediately adjacent to the metal insert.

Figure 14. – Photomicrograph showing the cross-section prepared through a cracked boss on the failed housing. Cracking is apparent extending from sharp corners corresponding to the metal insert.

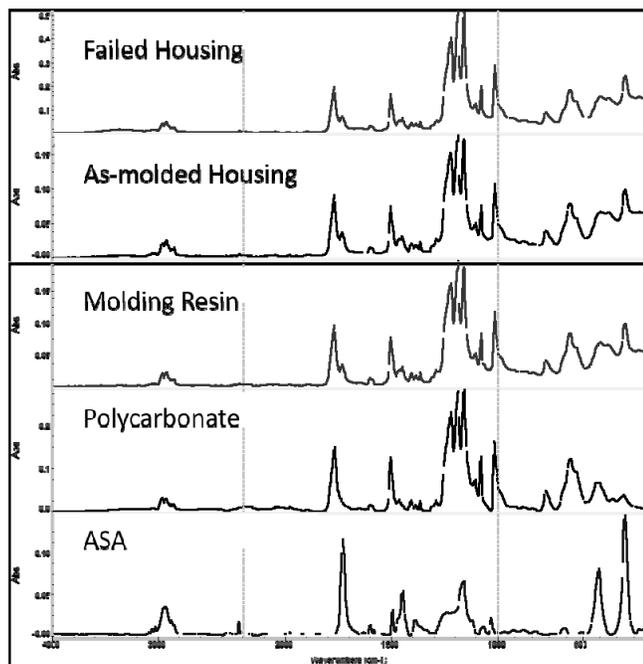
Compositional analysis of the sample materials was performed using Fourier transform infrared spectroscopy (FTIR). Analysis of a specimen representing the submitted molding resin, produced results characteristic of a polycarbonate / poly(acrylonitrile:styrene:acrylate) (PC+ASA) resin blend (Figure 15). Further testing was performed on core specimens representing the failed housing and the as-molded housing. A direct comparison of the results yielded an excellent match, without apparent spectral differences. No evidence was found through the FTIR analysis to indicate the presence of bulk contamination or other anomalies within the molded housing materials.

Figure 15. – FTIR spectra obtained on the housing samples.

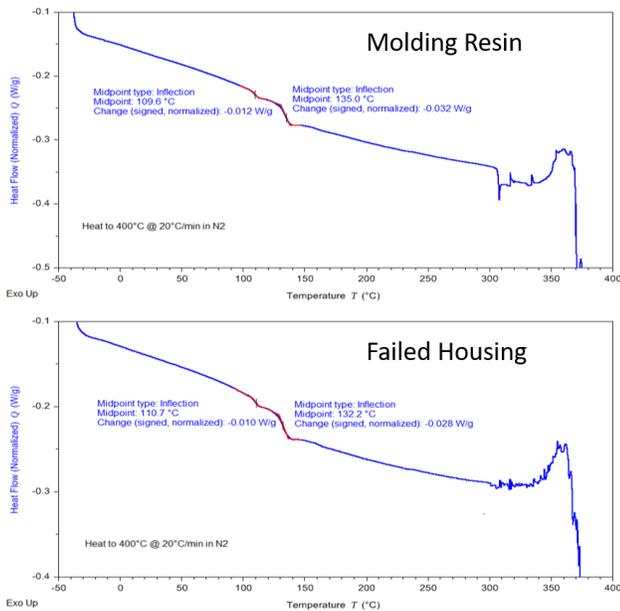
Differential scanning calorimetry (DSC) of the molding resin and the failed housing material produced relatively similar DSC thermograms (Figure 16). A review of the second heating results showed that the molding resin underwent a dual shift in heat flow associated with two individual glass transitions within the material. Glass transition temperatures of 110 °C and 135 °C were obtained, representing the poly(acrylonitrile:styrene:acrylate) (ASA) and polycarbonate (PC) constituents, respectively. The presence of two distinct glass transitions indicated that the material is a resin blend having a two-phase morphology. A disturbance in the thermogram baseline was observed at approximately 300 °C representing partial material degradation, likely within the flame retardant package.

The second heating DSC thermogram representing the failed housing material also showed the dual glass transitions. While the glass transition associated with the ASA remained relatively consistent, the glass transition corresponding to the PC was somewhat lower, 132° C. This reduction in glass transition temperature was thought to represent variation in molecular structure between the molding resin and the failed housing material, within the polycarbonate domain. Considering the DSC results, it was evident that some molecular structural differences existed between the molding resin and the failed part material.

Figure 16. – The DSC thermograms obtained on the molding resin and the failed housing material.

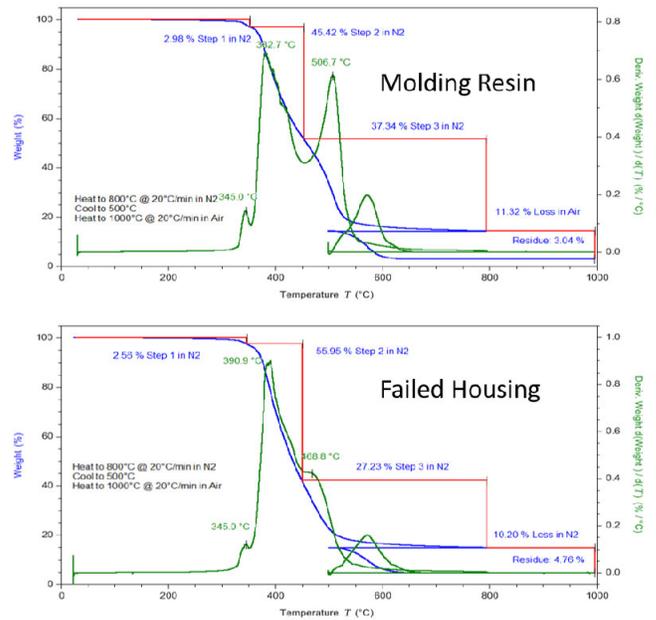
Thermogravimetric analysis (TGA) of the resin and failed housing was performed to further evaluate the compositions of the material (Figure 17). Analysis of the two materials produced generally similar weight loss profiles. Under the dynamic nitrogen purge, the samples underwent a multi-stage weight loss, with combined losses of approximately 86%. These weight losses were associated with the initial

While the two materials produced similar quantitative results, a direct comparison of the weight loss profiles revealed that the failed housing material underwent a weight loss at a significantly lower temperature. This variation in thermal decomposition was suggestive that the failed part material was less thermally stable. Specifically, the weight loss corresponding to the polycarbonate was shifted to a substantially lower temperature. This was also supported by a review of the localized maximum in the weight loss derivative curve. The molding resin showed the polycarbonate weight loss to be centered at 507 °C, while the temperature was reduced to 469 °C in the failed part material. The identification of molecular differences in the materials through TGA, was consistent with the results obtained during the DSC analysis. This type of variation is often associated with molecular degradation.

Figure 17. – The DSC thermograms obtained on the molding resin and the failed housing material.
