# FAILURE ANALYSIS OF HINGED HOUSING ASSEMBLIES

*Jeffrey A. Jansen, Stork Technimet, Inc.*

## Abstract

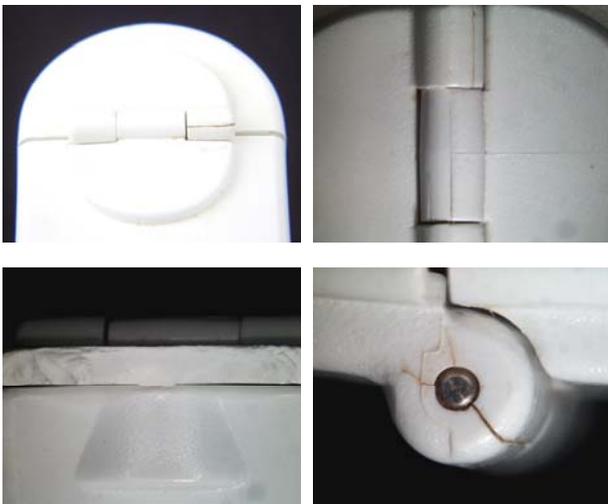
Examination of the housing assemblies confirmed the presence of numerous cracks within both the door and latch hinges. The cracks were located in the latch and door hinges, made up of the case, door and latch hinge bosses. In general, the location and appearance of the cracks were consistent across all of the failed parts. Additional samples exhibited catastrophic failure within the corner of the latch.

**Fig. 1 - Cracking was present within the housing assembly**

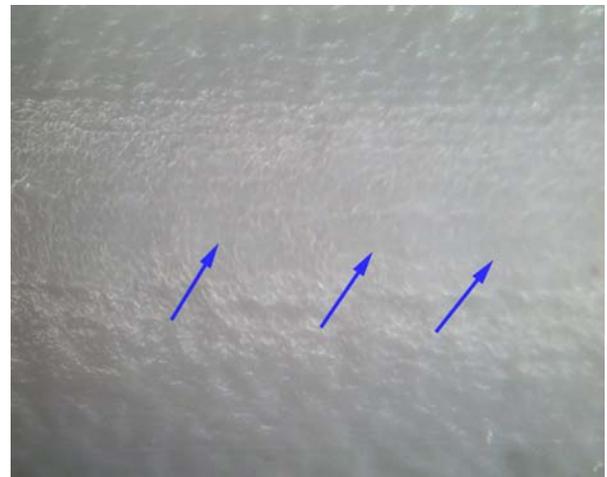
A visual and microscopic examination of the reference case, door, and latch components did not reveal signs of pre-existing cracks. However, the components did exhibit knit lines from the molding operation. These knit lines, as shown in Figure 2, corresponded to the approximate location of the failures that had occurred within the case, door and latch hinge bosses. Based upon the examination of the submitted reference parts and the uniformity of the failures, representative components were selected for further evaluation.

**Fig. 2 - A knit line was present on the hinge component.**

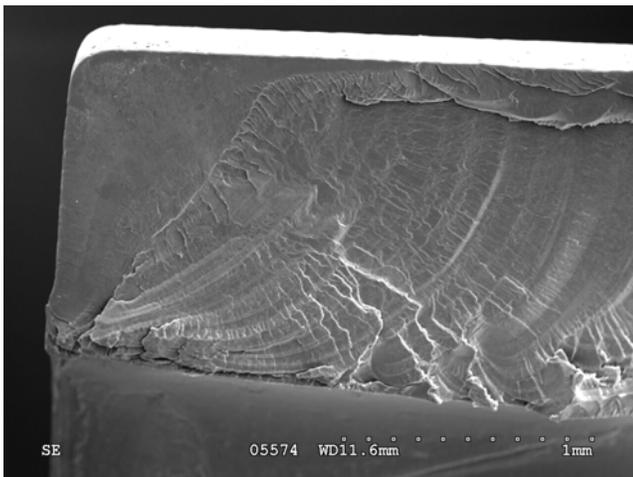
The fracture surfaces of typical failed components were further examined via scanning electron microscopy (SEM) in order to characterize the mode of crack initiation and extension. Examination of the fracture surface of one of the typical case hinge boss revealed features indicating that the cracking had initiated at both edges of the boss along the outer diameter, as represented in Figure 3. The crack origins exhibited a relatively smooth morphology, characteristic of brittle fracture associated with slow crack growth. No significant signs of micro ductility, as would be apparent in the form of stretched fibrils, were found within the crack origin locations. Areas remote to the origins exhibited additional signs of brittle fracture in the form of hackle marks and river markings. These features are normally associated with more rapid crack extension, indicating that the crack progressed relatively rapidly compared with the crack initiation step. The areas outside of the crack initiation zone exhibited evidence of limited micro ductility only at very high magnifications, as evidenced by the presence of stretched flaps.

**Fig. 3 - Scanning electron image showing a typical hinge boss fracture surface. The crack origin region displayed a smooth morphology**

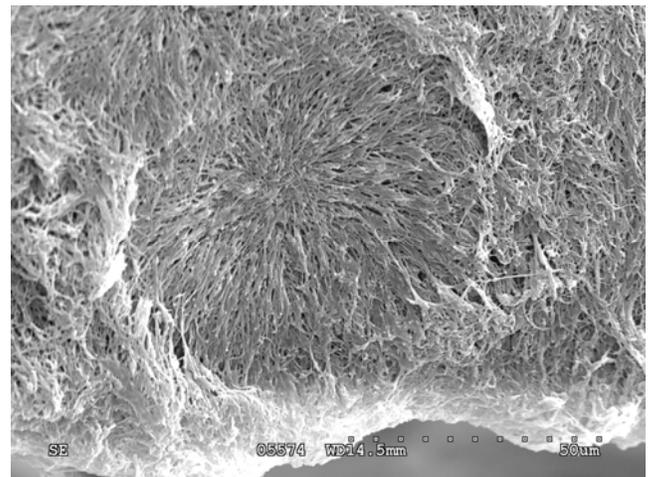
Outside of the immediate crack initiation zone, increased levels of micro ductility were apparent in the form of stretched fibrils. Conversely, a second area of crack initiation was apparent on the opposite end of the hinge boss along the inner diameter of the hole. This area, as represented in Figure 4, exhibited substantial ductility at, and adjacent to, the crack initiation site. The observed features, including a nested pattern of stretched fibrils which were suggestive of failure via a low cycle fatigue mechanism, associated with the application of cyclic stresses. Thus, the latch boss fracture surfaces exhibited two distinct modes of crack initiation and extension, which produced catastrophic failure resulting from the union of the two individual fractures.

**Fig. 4 - Scanning electron image showing features associated with low cycle fatigue on the fracture surface.**

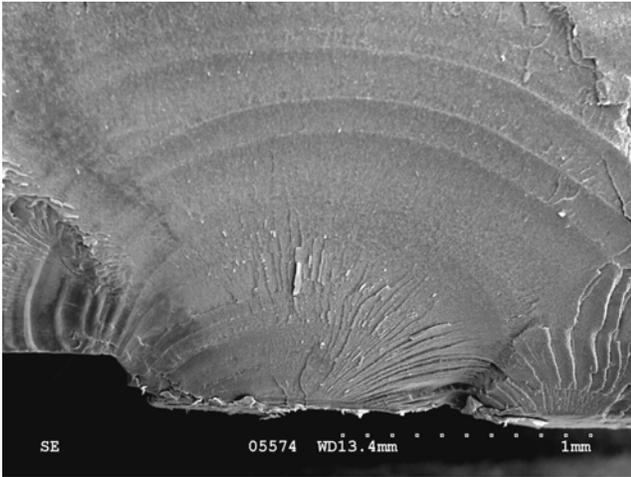
Examination of the fracture surface representing the failure within the corner of the latch revealed features associated with crack initiation through brittle fracture. The crack origin area exhibited a relatively smooth morphology, with the presence of stretched fibrils only indicated at relatively high magnification. The crack origin was located along the inner diameter of the latch corner at an area representing a relatively sharp corner design feature. This fracture surface is shown in Figure 5. A slight increase in the ductility of the fracture surface was observed within a mid-crack area. Locations remote to the crack origin, along the outer diameter of the corner, showed relatively brittle fracture features associated with final mechanical overload of the component.

**Fig. 5 - Scanning electron image showing a typical fracture surface on a corner latch failure. Arrest markings are evident.**

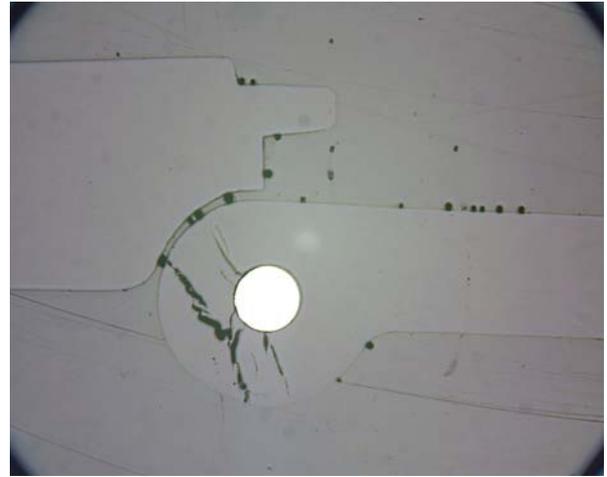
A cross section was prepared through a typical failed latch hinge to facilitate further examination of the cracking. The cross section was prepared by mounting a specimen in an epoxy media and subsequently polishing to reveal the areas of interest. An initial examination of the hinge within the latch boss revealed massive cracking within the component, as illustrated in Figure 6. The cross section revealed a significantly higher number of cracks than apparent from the external examination of the hinge. The cracks lacked features associated with apparent macro or micro ductility, and appeared to originate both within mid-wall areas and at the inner diameter immediately adjacent to the hinge pin. The general appearance of the fractures was consistent with cracks initiating through the exertion of stresses below the yield point for an extended period of time, via a creep mechanism. The sample was subsequently repolished in order to examine an area within the case hinge boss. Examination of the cross section revealed a significant level of cracking. The cracking closely resembled that observed within the latch boss. Catastrophic failure occurred at an apparent knit line, with additional cracking also present.

**Fig. 6 - The cross sectional examination revealed the presence of massive cracking within the hinge bosses.**

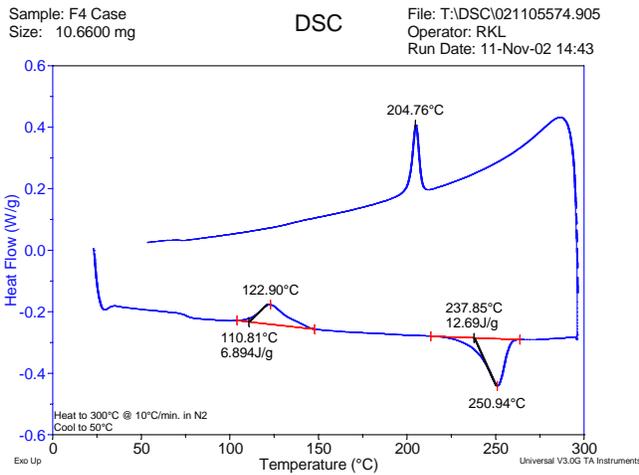
Analysis of a failed case at an area adjacent to the failed hinge boss produced results exhibiting melting endotherms at  $250\text{ }^{\circ}\text{C}$  and  $243\text{ }^{\circ}\text{C}$  during the initial and second heating runs, respectively. The results also showed the glass transitions associated with the poly(ethylene terephthalate) and polycarbonate resins. As such, no evidence was found to indicate contamination of the case material. Significantly, the initial heating run results also showed an exothermic transition centered at approximately  $123\text{ }^{\circ}\text{C}$ , as illustrated in Figure 7. This is associated with low temperature crystallization of the poly(ethylene terephthalate) resin, and represents undercrystallization of the material in the as-molded condition.

**Fig. 7 - DSC thermogram obtained on the failed part material.**

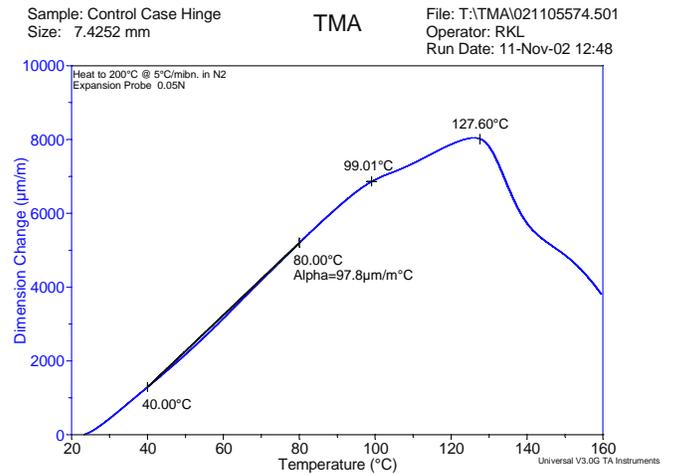
Thermomechanical analysis (TMA) of specimens excised from the hinge bosses of failed case and latch components was performed to evaluate and compare the physical properties of the part samples. The results showed a similar response to the thermal program, with the samples initially expanding in a steady, linear manner. This linear expansion continued through 105 to 130 °C, upon which the samples lost load bearing capabilities and contracted. This temperature was consistent with the glass transition temperature of the polycarbonate and represents the inability of the material to withstand loads. It is significant to note that upon reaching the glass transition temperature, none of the samples exhibited rapid expansion, which is indicative of substantial molded-in stresses within the component materials.

**Fig. 8 - TMA thermogram obtained on the failed part material.**
