# Plastic Failure Through Molecular Degradation

*Multiple mechanisms can attack polymer chains—here's what can go wrong*

By Jeffrey Jansen

The Madison Group, Madison, Wisconsin, USA

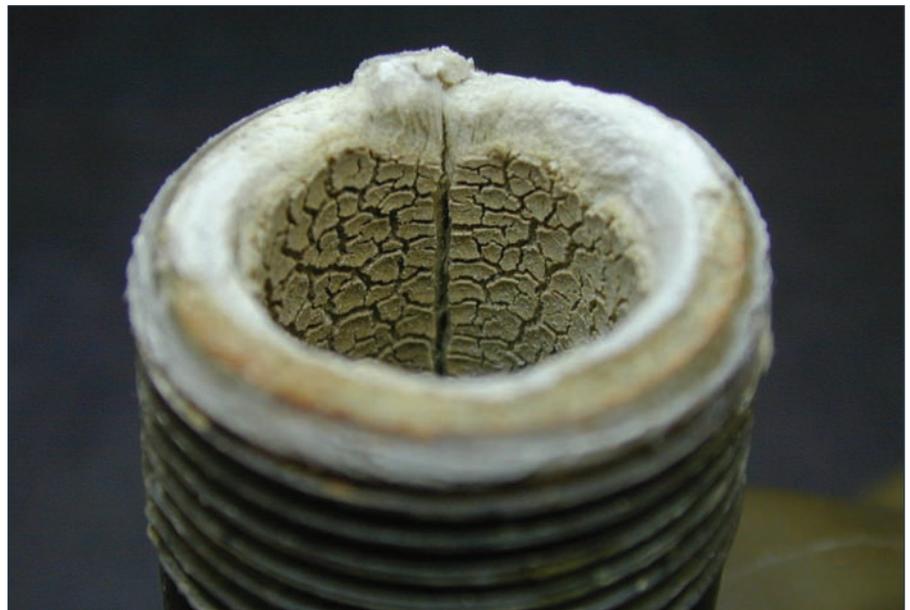
**Figure 1:** This nylon water-heater valve degraded through contact with chlorinated water at elevated temperatures.

Molecular degradation can occur throughout the lifecycle of a plastic component. Regardless of when the degradation occurs, the effects can lead to premature failure of the component. (An example of a failure is shown in *Figure 1*, and some typical circumstances are listed in *Table 1*.)

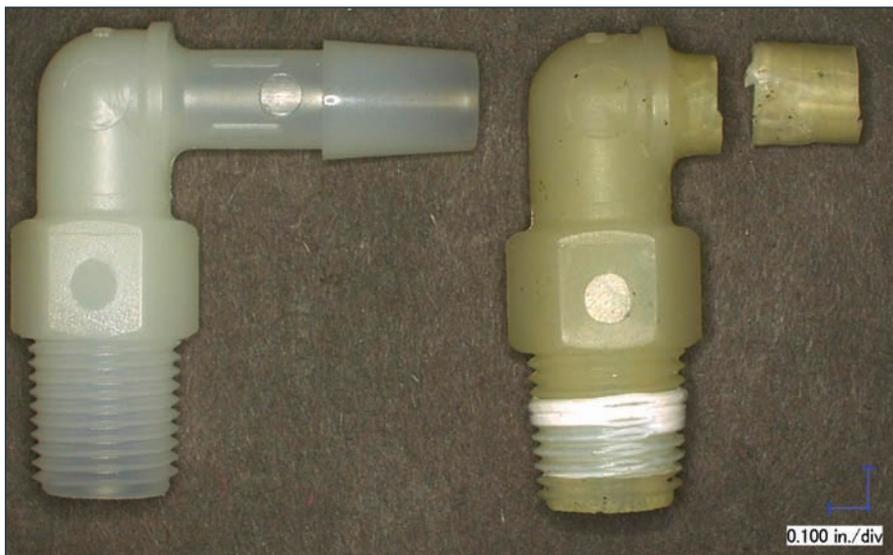
A plastic elbow connector used in a food service application failed while in service after approximately six months of use (Figure 2). A series of connectors installed within equipment at the same site had all failed prematurely, while parts at other locations

Figure 2: Reference and failed connectors, shown as received. The failed parts exhibited significant discoloration.

The exterior surface of the failed part showed significant discoloration in the form of yellowing; however, cracking was not found. The extent and form of the cracking was indicative of molecular degradation of the elbow

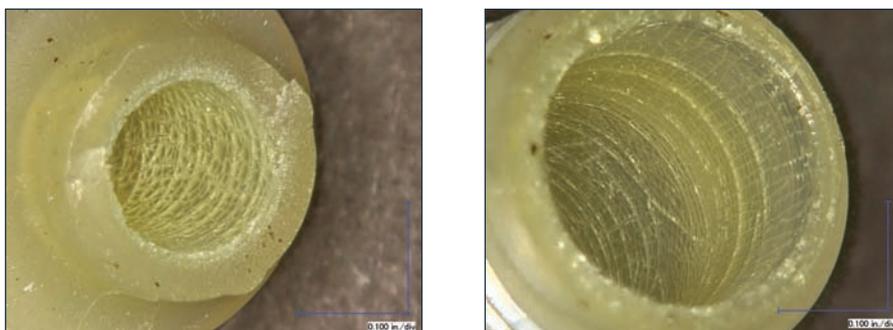
Figure 3: Photomicrographs showing features associated with brittle cracking on the transverse fracture surface of the connector (left) and an interconnecting series of cracks on the interior surfaces at both the nipple end (left) and threaded end (right).

Microscopic examination of the failed connector confirmed a catastrophic transverse crack within the nipple end of the elbow. The fracture surface displayed features associated with brittle cracking. Inspection of the interior surfaces of the elbow revealed widespread cracking in an intersecting pattern, commonly referred to as mud cracking (Figures 3-4).

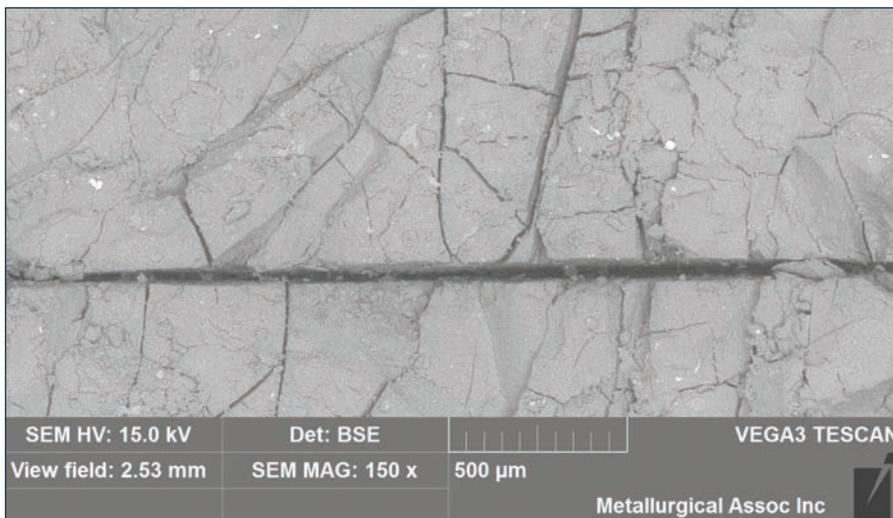
Figure 4: SEM image showing mud cracking, characteristic of severe molecular degradation, on the interior surface of connector.

material initiating from the interior. Scanning electron microscopic (SEM) examination revealed further evidence indicating molecular degradation was severe and consistent with chemical attack associated with exposure to an aggressive, incompatible chemical agent

It was the conclusion of the evaluation that the elbow connector failed as a result of severe molecular degradation of the nylon plastic resin. Degradation was indicated by the significant mud cracking and discoloration, as well as the oxidation indicated by FTIR.

The degradation, and subsequently the cracking, initiated on the interior surface of the connector, indicating that the chemical agent responsible for the degradation was contained within the equipment. Analysis of the interior surface of the failed part showed the presence of potassium, and because of the lack of other elements, this was thought to represent the presence of potassium hydroxide. Given the internal nature of the degradation, the general classes of materials that produce molecular degradation in nylon 6/6, and the presence of potassium, the likely potential source of the deleterious chemical agent was the cleaning products used in conjunction with sanitation of the food service equipment.

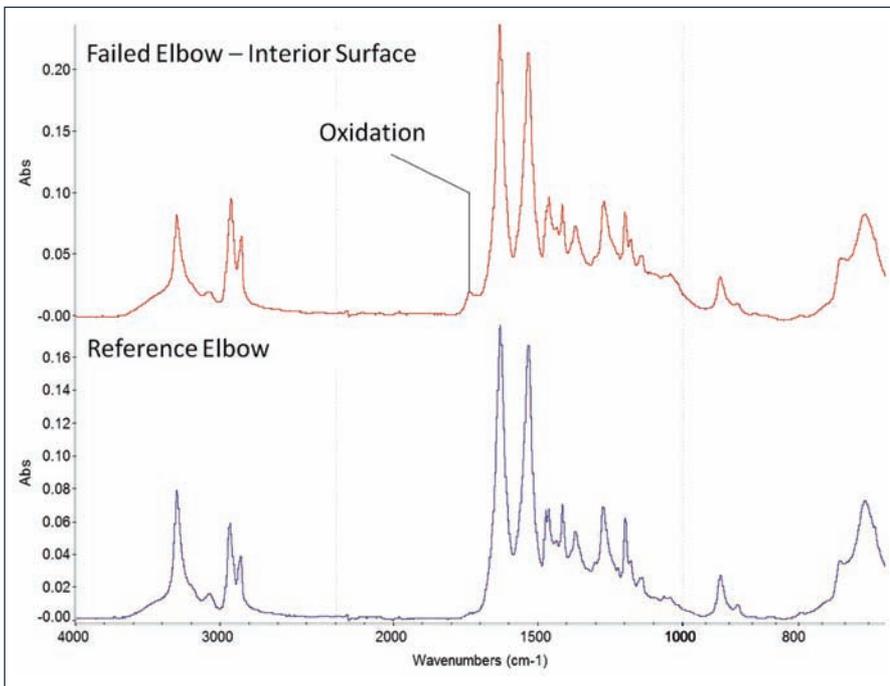
Fourier transform infrared spectroscopy (FTIR) was performed on the reference elbow, and the obtained results were consistent with a nylon resin (Figure 5). The interior surface of the failed elbow was also analyzed, and the resulting spectra contained absorption patterns associated with the nylon base material. However, additional absorption bands indicative of carbonyl functionality were also present, consistent with oxidative degradation.

Figure 5: FTIR results on the failed elbow of the connector showed an absorption band indicative of oxidation.
