# Plastic Failure through Environmental Stress Cracking

*ESC, "the plastic killer," is a frequent cause of field failures*

**By Jeffrey Jansen**

The Madison Group, Madison, Wisconsin, USA

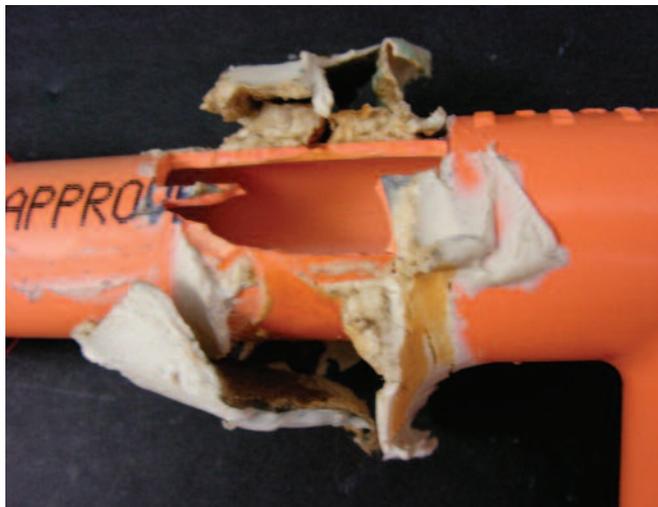
**Figure 1: Catastrophic failure occurred in a CPVC pipe through ESC associated with contact with an incompatible sound-proofing caulk.**

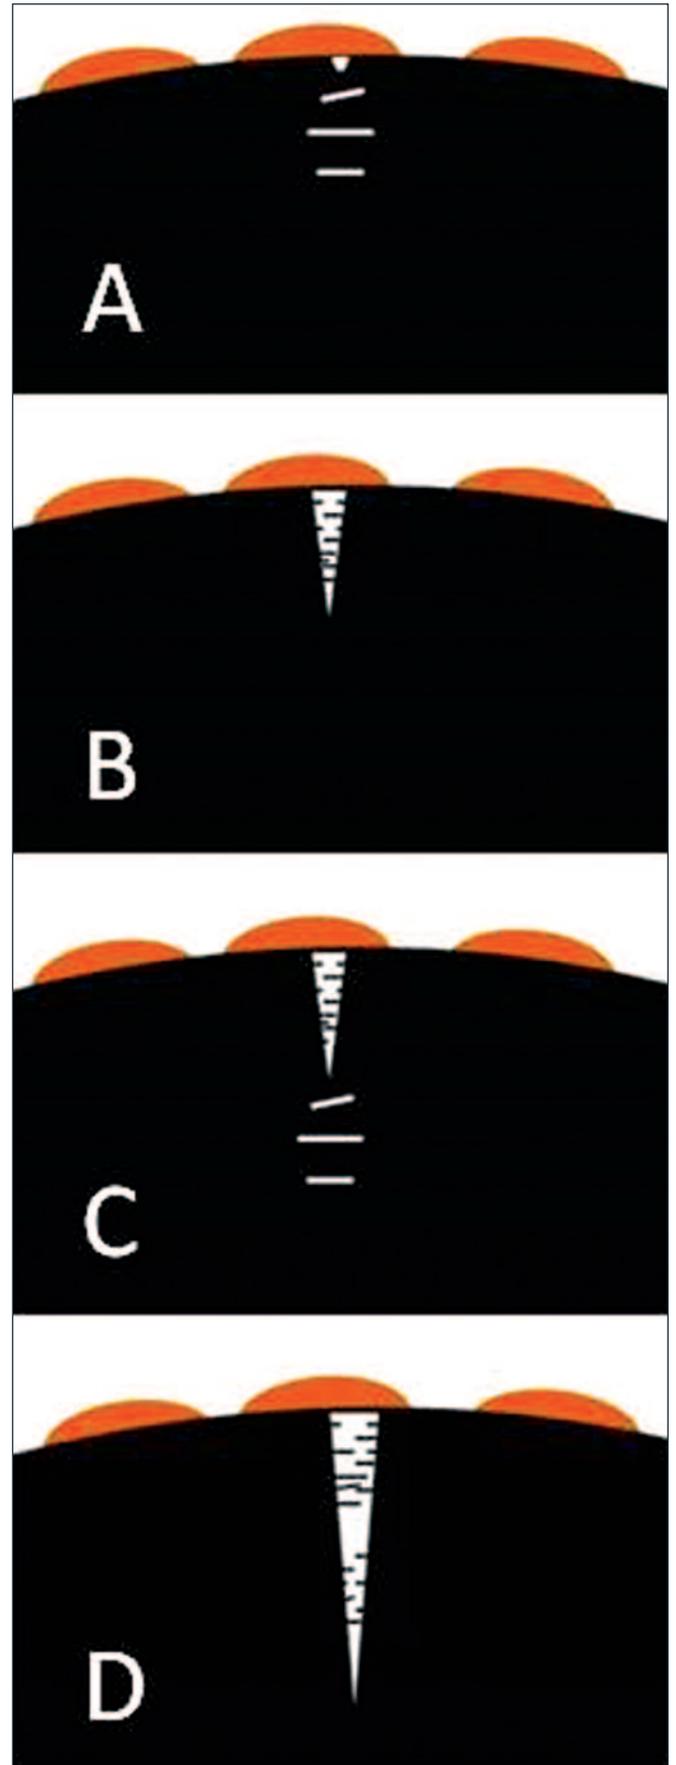
Figure 2: Illustration of the ESC process.

In response to the stress and facilitated by the plasticizing effect of the chemical, the individual segments of the chains rotate, and become aligned parallel to the direction of the maximum strain. Crazes are formed as planar arrays of fine voids normal to the tensile stress (*Figure 2a*). The voids are separated by ligaments of highly aligned polymer chains.

Crazes form and grow within the chemically affected zone. Eventually, the crazes rupture to form a crack (*Figure 2b*). This crack then serves as a stress concentrator, and crazes form and grow within the chemically affected zone in front of the crack, and this process continues (*Figures 2c and 2d*). Environmental stress cracking can take place through

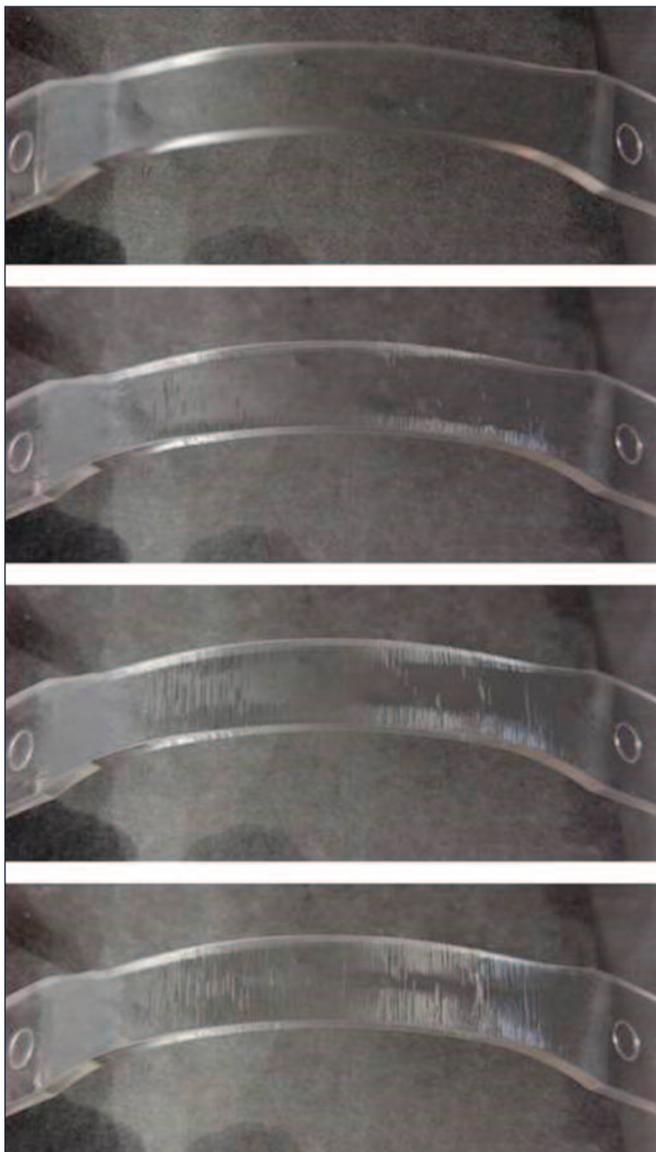
continuous crack growth or via a stepwise progressive mechanism of cracking and arrest, depending on the molecular structure of the plastic, the composition of the chemical agent, the level of stress, and other environmental conditions (Figure 3).

**Figure 3:** Time-lapse images showing the progression of ESC within a bent strip sample.

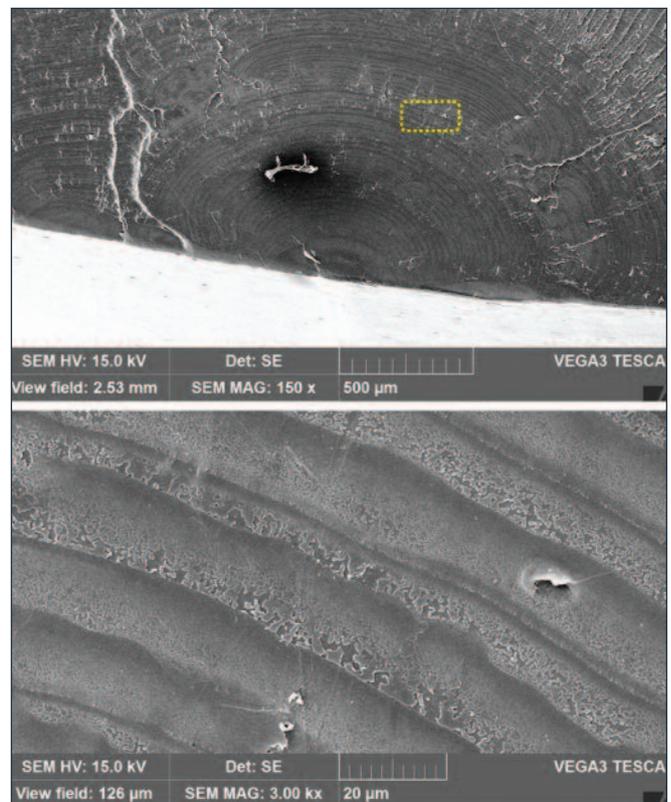
**Figure 4:** Scanning electron micrographs showing a typical ESC fracture surface. At high magnification, radiating bands of opened craze remnants are evident.

The presence of opened craze remnants, often in a series of radiating bands, can be indicative of environmental stress cracking. However, not all ESC failures exhibit these bands, and some creep rupture failures will present these features. In many cases, the final fracture zone will exhibit features associated with mechanical overload. This occurs once the remaining ligament of the fracture surface can no longer withstand the applied load.

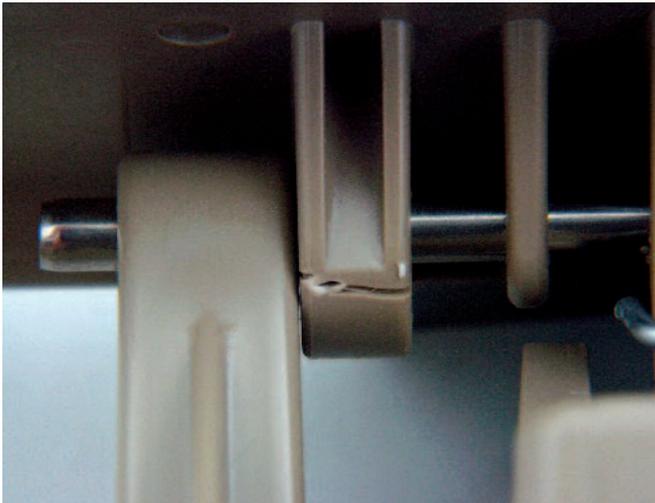
**Figure 5: A typical latch-handle fracture surface is shown, displaying features associated with multiple crack-initiation sites.**

Visual and microscopic examinations of the failed parts revealed significant cracking (*Figure 5*), which was consistent across all of the handles. The cracks were present within the molded boss that secured the roll pin. When the parts were disassembled, numerous additional, non-catastrophic cracks were apparent at similar locations around the boss hole. The crack surfaces exhibited features characteristic of brittle fracture, and the crack origins were primarily located adjacent to the inner diameter. An oily residue was evident on and adjacent to the fracture surfaces, and on the mating roll pin (*Figure 6*).

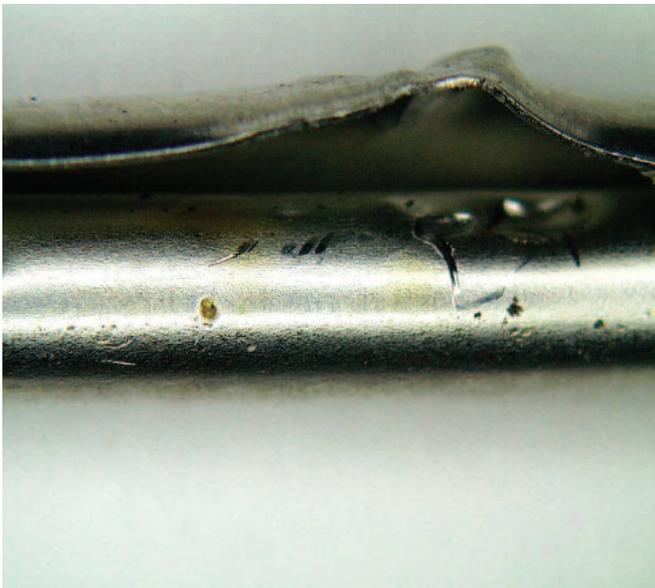
**Figure 6: A high concentration of oil was present on the hinge roll pin.**

Analysis of the oily residue found on the fracture surface using spectroscopy produced results indicative of a hydrocarbon oil containing an ester-based additive. The residual oil within the roll pins was also analyzed, and the obtained results produced an excellent match with spectra representing the fracture surface residue. Spectral library searching generated very good matches with commercial fluids for metal processing.

This is a typical example of a secondary chemical agent causing ESC. Ester-based materials are known to be active ESC agents for both ABS and PC resins. The oil had not been properly cleaned from the roll pin, as mandated by the handle manufacturer. This inadequate cleaning was the main factor

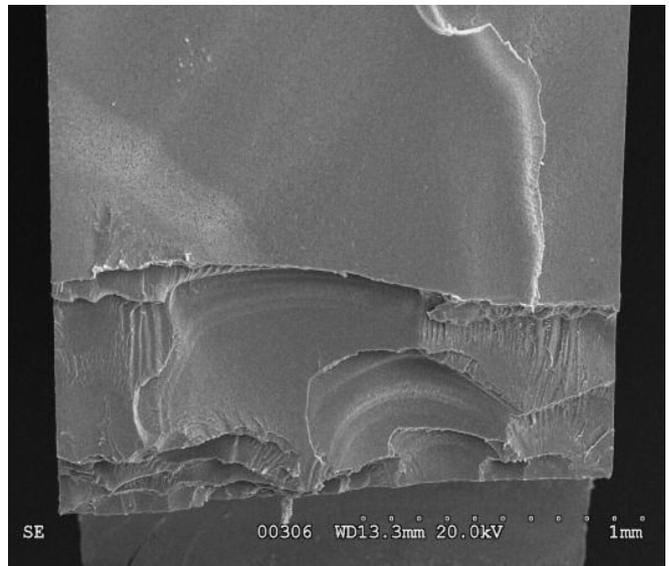
**Figure 7: SEM micrograph showing the fractured surface. Multiple cracks initiated along the interior edge of the part wall and coalesced to produce the fracture.**

Scanning electron microscopic (SEM) examination of the fracture surface confirmed the presence of multiple crack origins at the inner diameter of the boss hole, at areas that had been in direct contact with the roll pin (*Figure 7*). The surface morphology within the crack origin areas included craze remnants, suggestive of craze formation as part of the crack initiation mechanism. The fracture surface outside of the origin locations showed features indicative of brittle fracture, including hackle marks and secondary cracking.
