# A Study of the Freezing Phenomena in PVC and CPVC Pipe Systems

*Javier Cruz, Bruce Davis, Paul Gramann, Antoine Rios*  
*The Madison Group*  
*Madison, WI 53711*

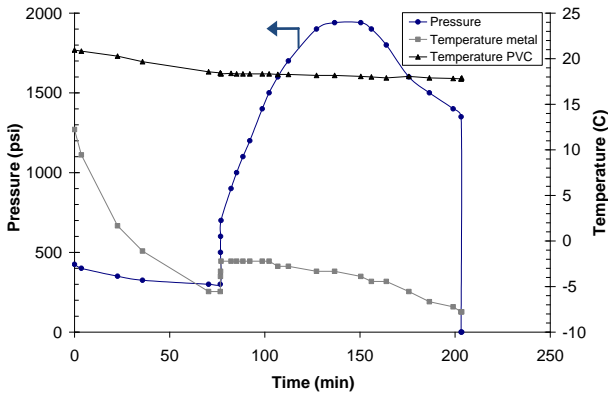
Exposure of the metal pipe to subfreezing temperatures resulted in burst failures of the  $\frac{1}{2}$  inch CPVC and PVC pipes. A larger metal pipe was used because the plastic would expand during freezing, allowing a significant amount of volumetric expansion to take place prior to failure. In these experiments an ice plug was not required to create a pressure rise since the system is fully closed. However, the overall behavior of the ice formation and pressure rise were similar to that observed in a residential setting after an ice plug formed [1]; the primary difference being the time at which the pressure rise occurred. Figure 3 and Figure 4 show graphical results of pressure and temperature obtained for PVC and CPVC, respectively. The temperature of the plastic was monitored on the exterior surface to provide a reference value to relate to the stiffness of the material. Due to the reduced size of the experimental setup the temperature of the plastic pipe would also drop slightly over time. The curve "Temperature metal" refers to the surface temperature measured on the lower end cap of the metal pipe. As shown in the figures, a sudden rise in temperature occurs at the same time the pressure increases. This sudden rise results from the latent heat of fusion and generates dendritic ice (Figure 1). Since the temperature recorded is not the actual internal water temperature, but that of the exterior metal surface, the sudden rise in temperature does not stabilize at the phase transformation temperature. For a situation where an ice plug needs to form to create a closed system, the pressure will also rise rapidly. However, the pressure rise does not occur during the first ice formation but after a complete ice plug has formed.

Figure 3: Pressure\* and temperature during a freezing event for a 1/2 inch (12.5mm) PVC pipe.

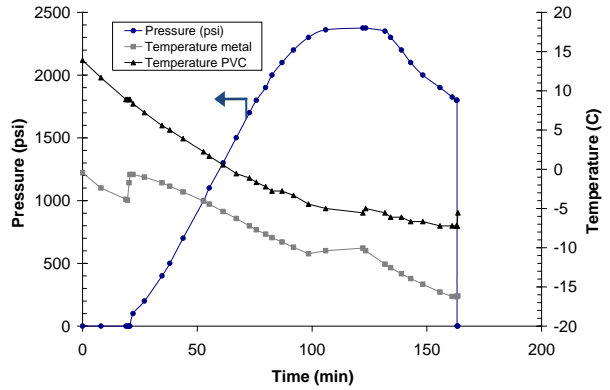
Figures 5 and 6 show results obtained with a different experimental setup in which both the plastic and metal pipes were located inside the freezer. In this case, a thin insulation layer was placed over the upper portion of the metal pipe while the entire plastic pipe was covered with heavy insulation. The insulation layers prolonged the heat release from the plastic pipe section and allowed freezing to initiate on the lower end of the metal pipe. Similar to Figures 4 and 5, the pressure reached a maxima followed by yielding and permanent plastic deformation. This eventually led to catastrophic failure. PVC shows greater levels of expansion than CPVC prior to failure—an effect clearly noticeable when examining the fracture modes.

Figure 5: Pressure\* and temperature during a freezing event for a 1/2 inch (12.5mm) PVC pipe insulated and exposed to subfreezing temperature.

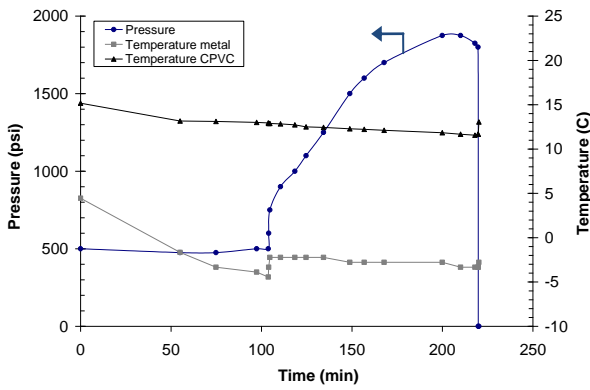
Figure 4: Pressure\* and temperature during a freezing event for a 1/2 inch (12.5mm) CPVC pipe.

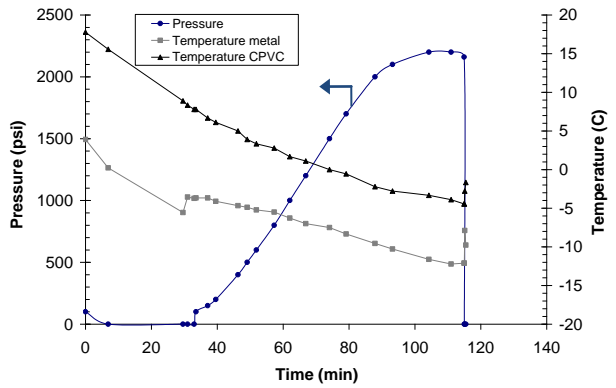
Figure 6: Pressure\* and temperature during a freezing event for a 1/2 inch (12.5mm) CPVC pipe insulated and exposed to subfreezing temperature.
