Failure Analysis of a Medicine Ball

William Aquite, Ph.D.

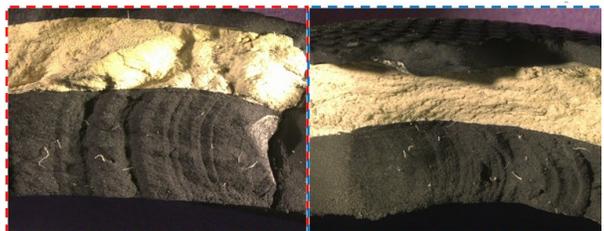
crack progression was also observed through the Second Layer and External Layer of material. The observed fracture features were consistent with a progressive failure mechanism, as indicated by the presence of parallel indications. The form and relatively lower number of observed indications were thought to represent crack propagation through low cycle fatigue.

Through Scanning Electron Microscopy (SEM), it was possible to observe the progressive cracking features and significant amounts of

Figure 5 - Scanning electron micrograph views of the exposed fracture surface.
